Impact of Tsunami and Earthquake On Traditional Huts of Car Nicobar Island

The Sumatra earthquake of December 26, 2004 ($M_s = 8.6$ IMD; $M_w = 9.3$ USGS) and the tsunami that followed took a heavy death toll (240,000) on the rim of the Indian Ocean. In stark contrast to this dismal scenario, response of traditional huts in Car Nicobar Island was observed to be almost exemplary in the earthquake and in the tsunami. It was observed that the traditional practice of house making, which has evolved over time, incorporated all known elements of earthquake engineering. Due to the recent restriction on use of timber as a construction material and due to several other reasons, this traditional building practice has changed gradually. This paper deals with the practice of traditional hut making in Car-Nicobar, recent adverse changes observed in this construction practice, and response of these to the earthquake and the inundation and run up of the 15 - 30 m high tsunami.

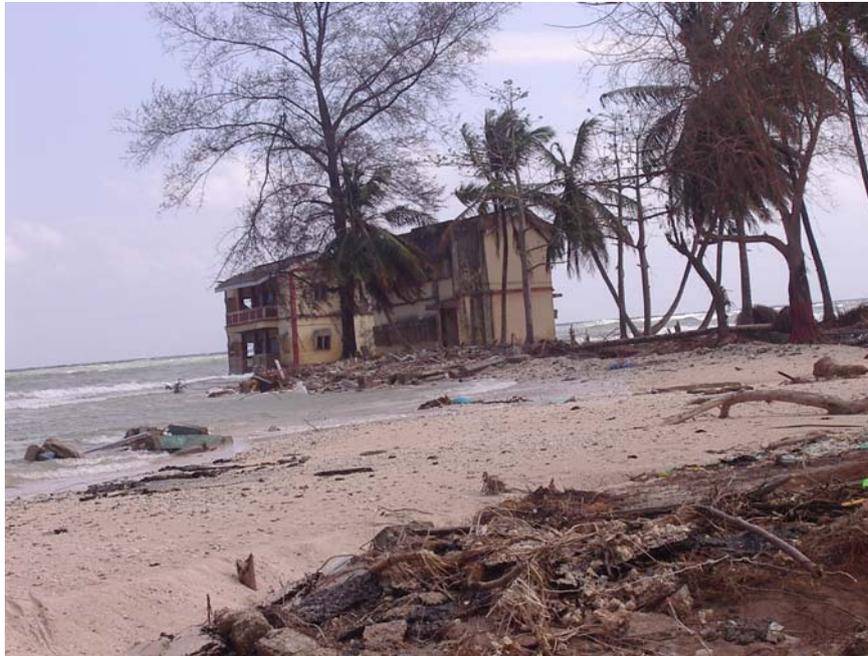
Figure 2.1 Surviving government building in Malacca was marooned by the tsunami.

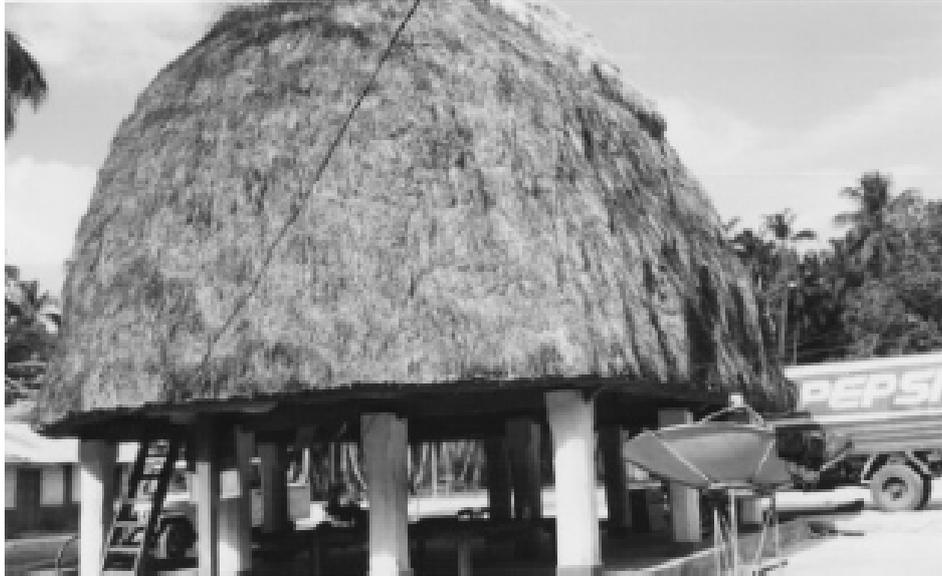
The traditional Nicobarese hut, shown in Fig. 3.1, was lifted six to eight feet above the ground. It was supported on 6 to 8 vertical timber posts. These were very sturdy, each of almost 4 inch diameter. The floor of this raised hut was usually a wooden platform, and consisted of a stiff mat with perforations. This was supported on horizontal timber members, running in two mutually perpendicular directions, which were supported on vertical peripheral posts. The timber skeleton of walls was covered with another mat. A tall central post supported the dome shaped roof. The domical skeleton was formed from local thin stems of wood. The skeleton was covered by thick dry bushes and grass, locally known as '*Bhent*'. For horizontal and inclined members coconut tree stems were used. Structural detailing of timber material was elegant. A timber ladder was attached to climb up and go into the hut at night.

Figure 3.1 A tribal hut in Car Nicobar Island

In stark contrast to the disaster to the newly built habitat around the coastline, life went on as usual in Nicobarese huts. The long term solution was amply evident in their traditional mode of constructing their houses, popularly referred to as Nicobarese huts. Even the long stilts were not displaced in most cases and there were no visible signs of structural stress either. Moreover, as these were located far away from the coastline and on high and firm ground most of these were safe from the tsunami too. One such surviving hut is shown in Figs 3.1 and 3.2.

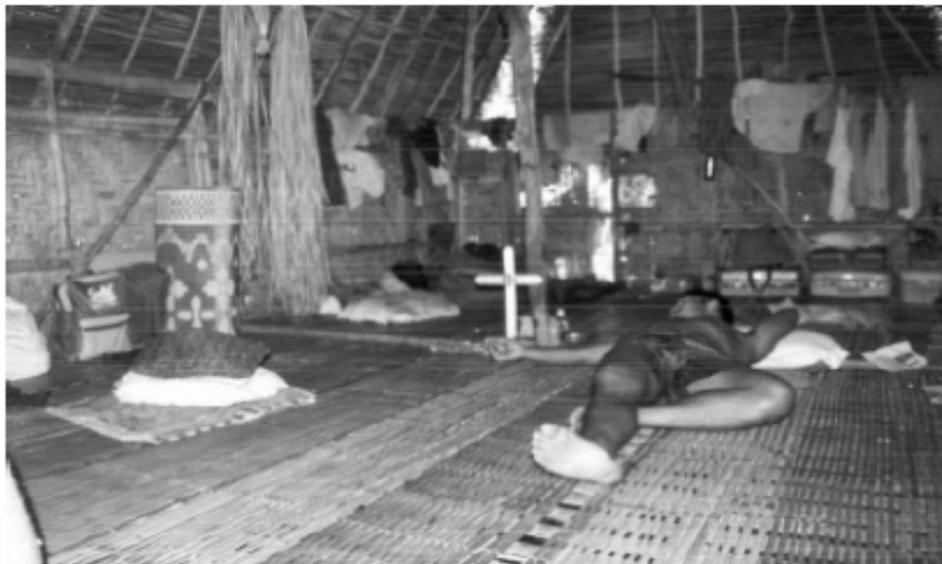
Non-structural elements within the hut were also fully taken care of. An appropriate storage space was made in the floor mat for crockery so that it did not topple during the frequent strong earthquake shaking. Moreover, the indigenous islanders chose sites for constructing their houses very carefully. These were located in the interior of the islands, far away from the coastline and on high ground. Traditional Nicobarese huts are made of locally available light building material. Timber and bamboo are used in plenty together with coconut, melon tree wood, '*bhent*', bushes, stems, and grass, as revealed by residents of these huts. The huts are constructed by their occupants. Many such huts existed on the inhabited islands of the Nicobar archipelago. These indigenously designed huts are thoroughly ventilated in the hot and humid tropical climate, are very comfortable, eco friendly and earthquake resistant.

Figure 3.2 A comfortable and eco friendly interior of a hut that is rectangular in plan.

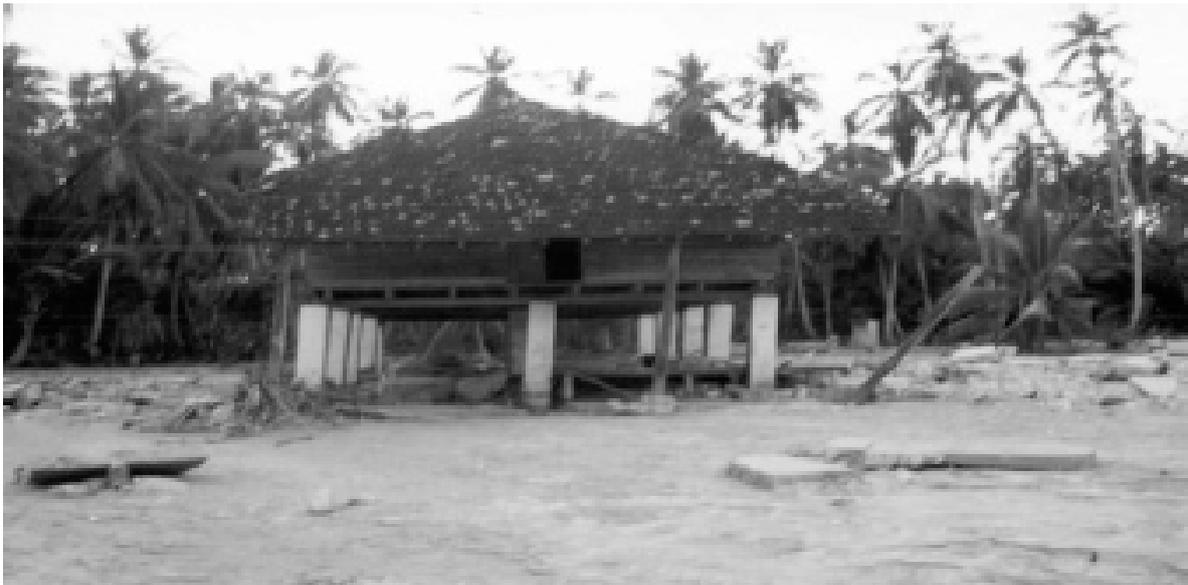
The plan of the house changed from circular to either a square or a rectangle. Masonry walls were introduced in the newer houses. However, stilts and floors continued to be made of timber. Gradually, timber stilts were replaced by plain concrete stilts. Their size varied from 25 cm x 25 cm to 30 cm x 30 cm, Fig. 3.3, with a very shallow footing, only 90 cm deep. Quality of material used for making stilts also deteriorated. Poor quality concrete mix consisting of sea gravel (mostly of corals), sand and cement was used, in the ratio 4:6-10:1. Water was mixed without any measure, to make the concrete workable. No steel was used in these vertical members. Sometimes, the traditional timber house was built on top of these concrete stilts. Any structural connection between stilts and horizontal timber members was absent in many such huts.

Figure 3.3 A rectangular timber hut supported on plain concrete columns.
