Analytical Estimation of Seismic Response of a Typical R/C Building Damaged by the 2009 West Sumatra Earthquake in Indonesia

H. Choi & Y. Nakano

Institute of Industrial Science, The University of Tokyo, Japan

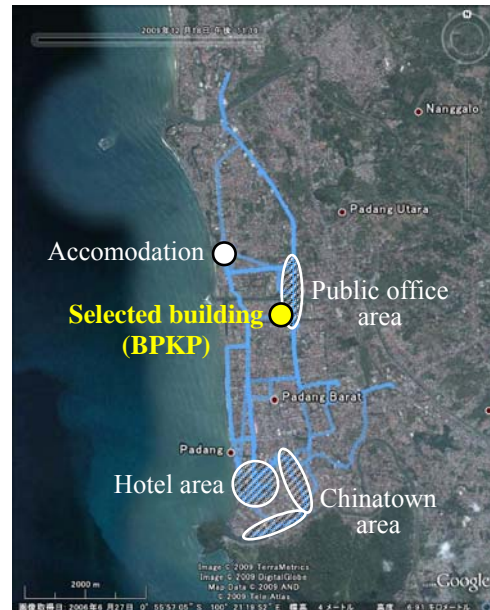
Figure 1.2. Damage survey areas

Authors conducted two earthquake damage investigations in Padang city as shown in Fig. 1.2. These investigations were performed during December 13 to 20, 2009 and August 25 to 30, 2011, respectively. During the investigations, a typical five story R/C public office building located in damage survey areas as shown in Fig. 1.2 are selected, and the evaluation of the damage classes to each member based on the Japanese guideline (JBDPA, 1991) and the ambient vibration measurement using micro tremor are carried out in detail.

In this study, Finance and Development Audit Agency building (BPKP: Badan Pengawasan Keuangan Dan Pembangunan), which is a five story R/C public office building built in 2003 located in the central part of Padang city as shown in Fig. 1.2, is selected to analytically assume the seismic responses after the earthquake.

In these damage surveys, the ambient vibration measurements of ground level were performed at east and south side in the building site, public office area, Chinatown area, and Andalas university (refer to Fig. 1.2), respectively. Fig. 3.4 (a) and (b) show the Fourier spectrum ratio (H/V spectrum) at each ground level. As can be found the figure, it is revealed that the grounds of BPKP building site, public office area and Chinatown area have quite long periods as 2.06second, 1.61 through 1.65second and 1.75 through 1.79second, respectively. On the other hand, since H/V spectrum ratios of Andalas university located in the foot of a mountain are distributed in the range of about 1.0, its ground is judged to be near a bedrock.

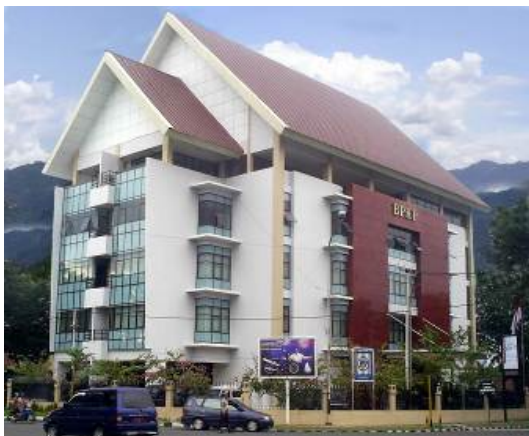
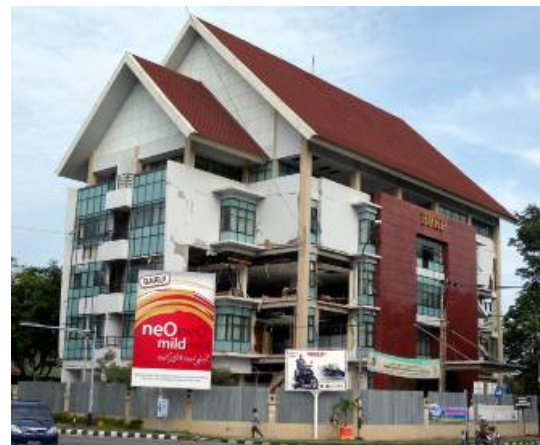
Photo 2.1. Whole view before and after earthquake damage of BPKP building

Photo 2.1 shows the whole view before and after earthquake damage of BPKP building, and Fig. 2.1 shows the second and the third floor plans together with the damage classes of R/C columns and unreinforced masonry (URM) infills evaluated using the Japanese guideline (JBDPA, 1991). The basic concept of this guideline is briefly described in Appendix. Since some structural plan was not able to be obtained, non-destructive tests using Schmidt hammer and re-bar locator were carried out during the investigations. Column cross-sections are shown in Table 2.1.

(a) Before earthquake damage

(b) After earthquake damage

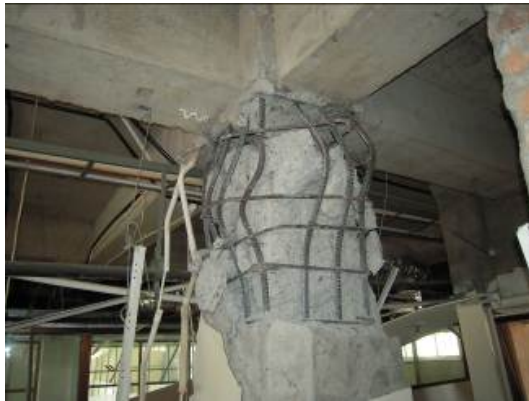
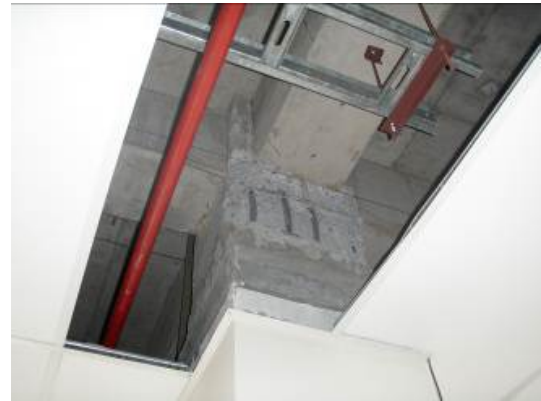
Photo 2.2. Damage classes of R/C columns

In the third floor suffered the most serious damage, the damages to west side of the building are relatively severe as shown in Fig. 2.1(b), and the buckling and the rupture of reinforcing bars are found in some columns of rows 4 and 5 as shown in Fig. 2.1(b) and Photo 2.2(a). In rows 2 and 3, exposed reinforcing bars are also observed in many columns as shown in Fig. 2.1(b) and Photo 2.2(b). The residual seismic capacity ratio index R values calculated by Japanese guideline are shown in Table 2.2. The R value for the transverse (EW) direction of the third floor is evaluated to be 54.1%, and the damage rating is judged as “Heavy”.

(a) Damage class V

(b) Damage class IV

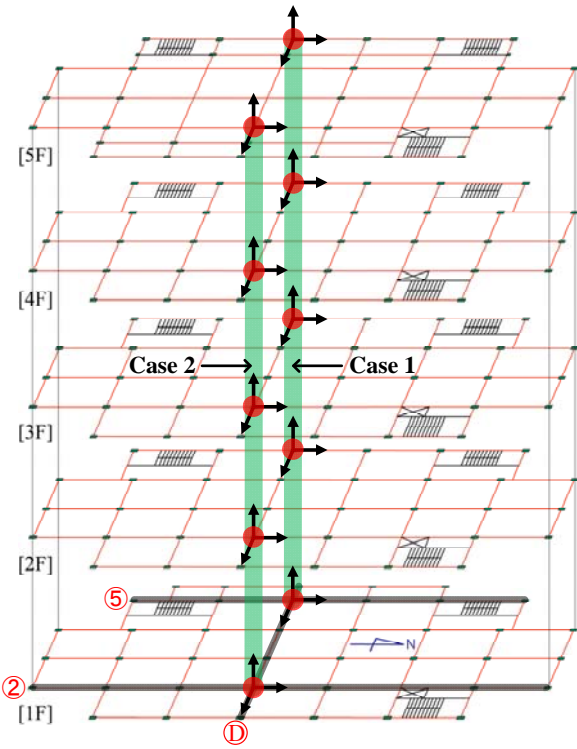
Figure 3.1. Two measurement cases

Micro tremor data-logger (GEODAS-10-24DS by Buttan-Service Corporation in Japan) and pick-up equipment (velocimeter CR4.5-2 by Buttan-Service Corporation) are used for measuring ambient vibrations. Sampling frequency is set for 100Hz and record duration is 300seconds. The measurement positions of two cases used for calculating periods and mode shapes among all the 7 cases are shown in Fig. 3.1, and the situation at the measurement is shown in the Photos 3.1 and 3.2. In Case 1 and Case 2, the velocimeters are installed in the vertical directions of row D-5 and row D-2, respectively, as shown in Fig. 3.1.

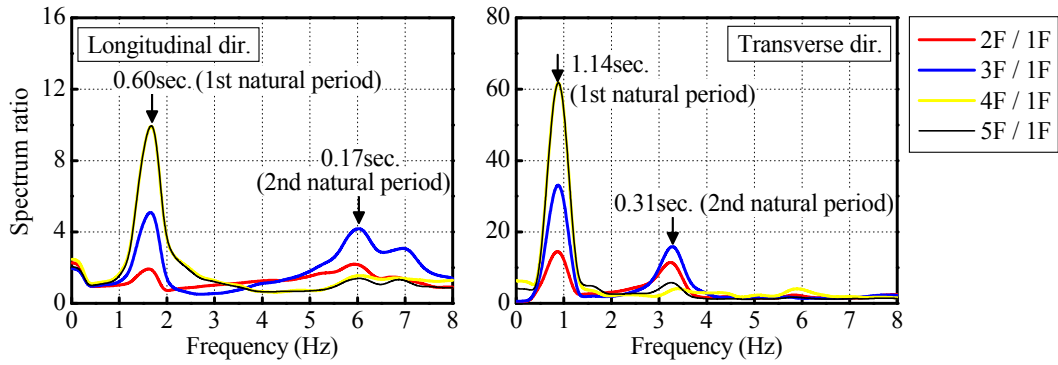
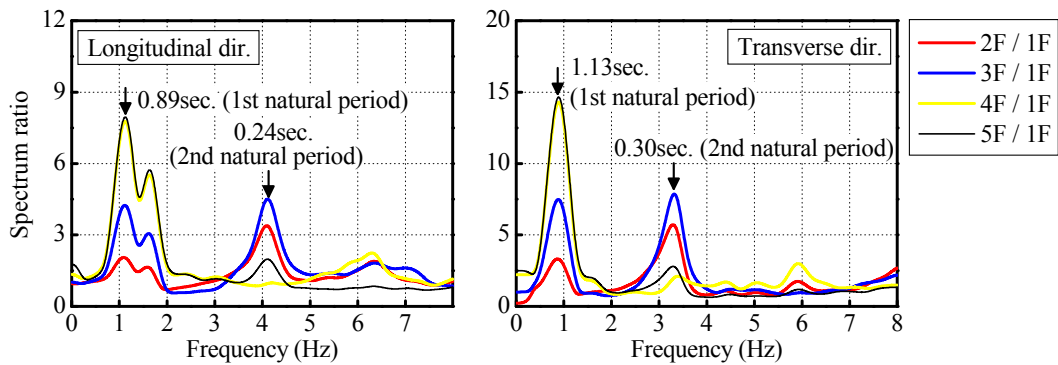
Figure 3.2. Fourier spectrum ratios (H/H Spectrum) of each floor to first floor

Fourier spectrum ratios (H/H Spectra) of each floor to first floor in Case 1 and Case 2 are shown in Fig. 3.2(a) and (b), respectively. As can be found in these figures, first natural periods of the longitudinal (NS) direction of the building after the earthquake are about 0.60second in Case 1 and 0.89second in Case 2, respectively, while those of the transverse (EW) direction have approximately the same value of 1.14second in both cases. The natural periods of the transverse direction is larger than those of the longitudinal direction, and this result corresponds well with the actual damage condition of the building.

(a) Case 1 (row D-5)

(b) Case 2 (row D-2)

- (2) The first natural periods of the longitudinal (NS) direction are about 0.60 and 0.89seconds in Case 1 and Case 2, respectively, while those of the transverse direction are approximately 1.14second in both cases. The natural period of the transverse direction which the damage is relatively severe is larger than that of the longitudinal direction, and this result corresponds well with the actual damage condition.

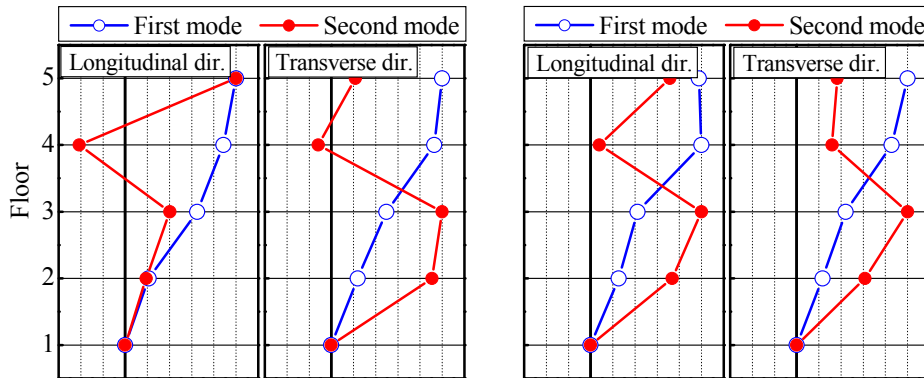
Figure 3.3. First and second mode shapes in vertical plane

The first and the second mode shapes in vertical plane of the building after the earthquake are shown in Fig. 3.3. The phase differences $\Delta\theta$ between the maximum value and the other values at each natural period point shown in Fig. 3.2 are calculated from the Fourier phase spectrum. In this paper, it is assumed that each spectrum ratio value multiplied by $\cos\Delta\theta$ represents the mode shape of each floor. As shown in Fig. 3.3, this building has almost the same mode shapes for each predominant period regardless of measurement positions and directions. In particular, second mode shapes are consistent well with the actual damage condition that the damage to column capital of third story is the largest.

(a) Case 1 (row D-5)

(b) Case 2 (row D-2)

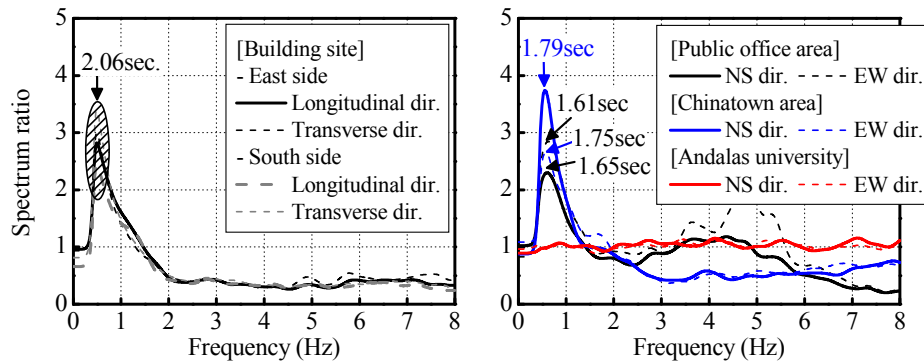
(a) BPKP building (b) Public office area, Chinatown area & Andalas univ.
Figure 3.4. Fourier spectrum ratios (H/V Spectrum) of each ground level

- (3) The ground predominant periods at the building site, public office area and Chinatown area are calculated about 2.06, 1.61-1.65 and 1.75-1.79second, respectively. On the other hand, since the H/V spectrum ratios of Andalus university are distributed in the range of around 1.0, its ground is judged to be near a bedrock.

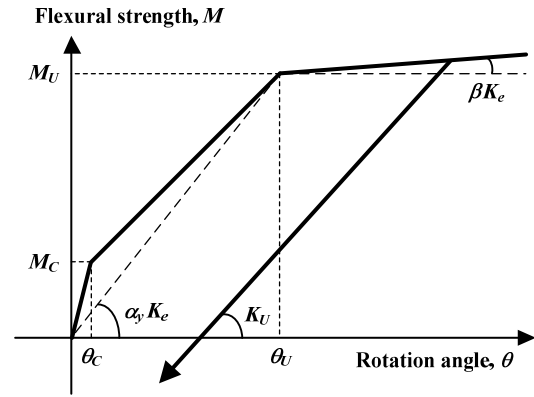
Figure 4.1. Hysteretic characteristic of column

- (1) The lateral force distribution is assumed as the elastic first mode shape.
- (2) The foundation, the slab, and the beam-column joint are considered as fix, rigid diaphragm, and rigid zone, respectively.
- (3) R/C columns are modelled as having the nonlinear flexural springs to their both ends, and having the elastic shear spring and the elastic axial spring to their center, respectively. The Takeda model (Takeda, T et al., 1970) is employed for the nonlinear flexural spring as shown in Fig. 4.1. Each value shown in Fig. 4.1 is calculated by Eqns. 4.1 through 4.4 (AIJ, 1999 and 1988).
- (4) Since the damages to beams are slight, they are assumed to be elastic.
- (5) The URM walls located in frames are disregarded.

$${}_iK_U = \begin{cases} K_e & {}_i\theta < \theta_c \\ \frac{{}_iM + M_C}{{}_i\theta + \theta_c} & \theta_c \leq {}_i\theta < \theta_U \\ \frac{M_U + M_C}{\theta_U + \theta_c} \sqrt{\frac{{}_i\theta}{\theta_U}} & \theta_U \leq {}_i\theta \end{cases} \quad (4.4)$$

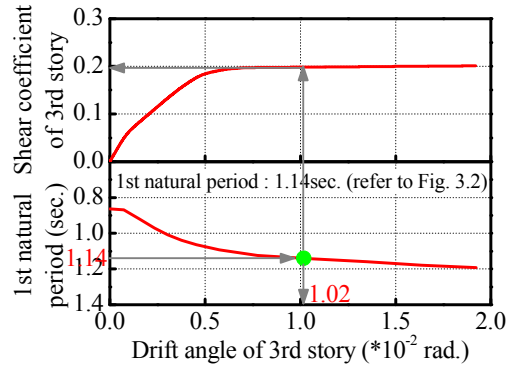
Figure 4.3. 1st period vs. drift angle of 3rd story

The relationship between story shear coefficient and inter-story drift angle of the third story is shown in Fig. 4.3 together with the development of the first natural period with respect to the its inter-story drift. As shown in the figure, the drift angle of the third story when becoming the same as the first natural period obtained from ambient vibration measurements (1.14sec., refer to Fig. 3.2) is

approximately 1.02×10^{-2} rad., and the shear coefficient value of the third story at its drift angle is about 0.20.

- (4) The drift angle of the third story when becoming the same as the first natural period obtained from ambient vibration data is approximately 1.02×10^{-2} rad. based on the proposed procedure.

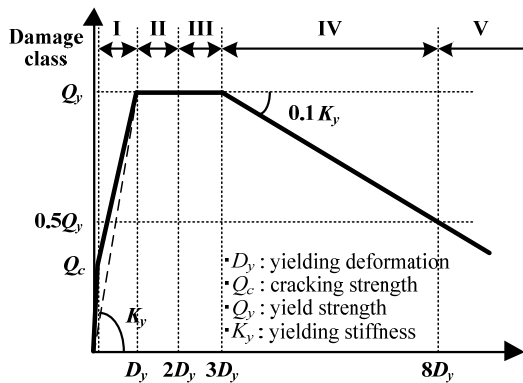
Figure 4.4. Schematic illustration of damage class vs. load-deformation curve

In this paper, the relationship between the load-deformation curve and the damage class for ductile member is defined as shown in Fig. 4.4 (Uchida, T. et al., 2005). Fig. 4.5 shows the damage classes of each column estimated by the proposed procedure together with the surveyed damage classes shown in parentheses. As shown in the figure, the surveyed damage classes of columns are approximately reproduced by proposed procedure in the stage of the assumed maximum deformation, although the estimated results to west side of the building are evaluated relatively smaller and those to east side are evaluated larger. It is seemed that the estimated damage classes of R/C columns are closely reproducible to the surveyed damage classes if the varying axial force of the building is taken into account. In future research, URM walls and/or lateral force distributions including the varying axial forces will be taken into consideration in order to evaluate the seismic responses of BPKP building more precisely.
