Influence of the 1999 Chi-chi Earthquake on the Cultural Heritage Conservation System in Taiwan

Chen-Yu Nien and Yu-Chun Lin

Department of Architecture, National Cheng Kung University, Taiwan

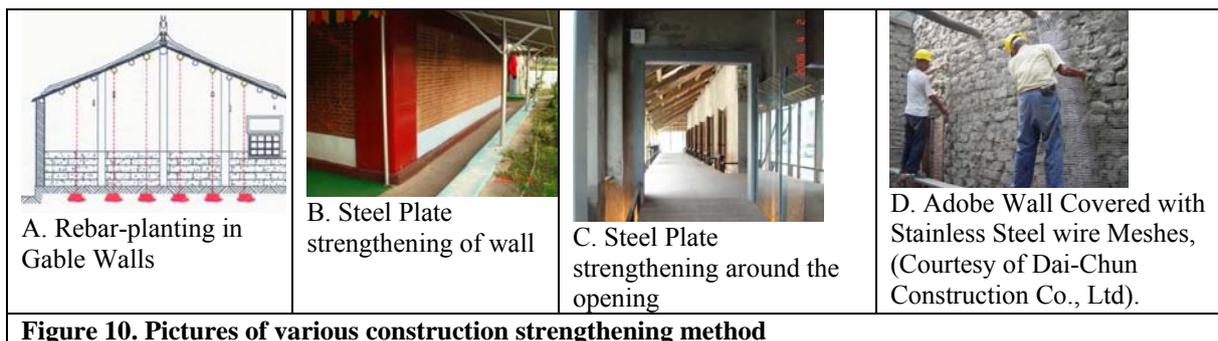
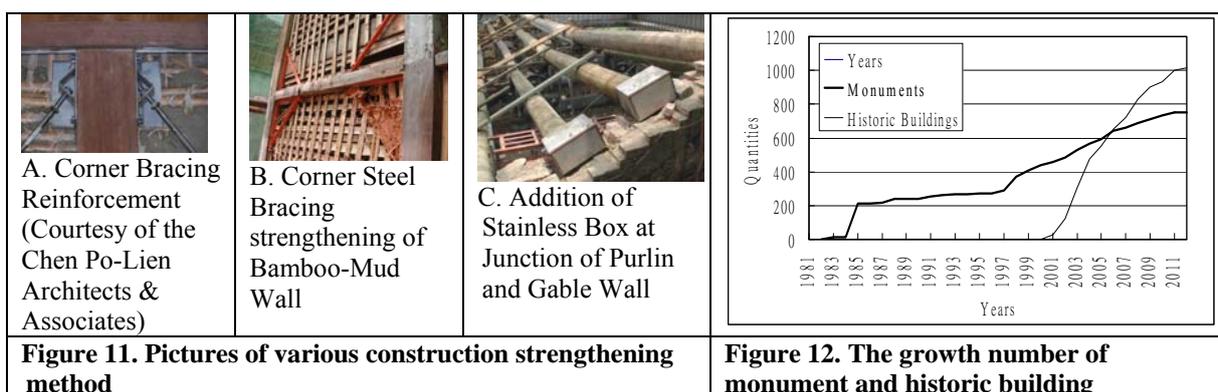
It includes the attached steel plate (Figure 10B), additional steel frame, joint imbedded with stainless steel strips, attached steel wire mesh reinforcement, attached CFRP reinforcement, wall center rebar-planting reinforcement (Figure 10A), wall crack U-shape iron reinforcement and top of the wall with steel confine beam reinforcement. And other reinforcement techniques such as RC shear wall or wall thickening were added.

The generally-adopted strengthening methods include wall body surface paved with steel or flax mesh (Figure 10D), wall surface paved with bamboo strips, crack filled with wood members, embedded with bamboo strips, steel H beam reinforcement, wall top covered with steel plate and moisture control of the wall.

This kind of wall damage modes include: 1. Diagonal crack of bamboo-mud wall, the surface plaster work decoration is stripped; 2. Wooden frame is tilted, the joint breaks; 3. Wall foundation shifts. The designers have the following strengthening method against these damage modes: 1. diagonal bracing strengthening (Figure 11A); 2. corner strengthening by steel plate (Figure 11B) and other techniques.
