# Seismic Assessment of a 15-Story Building Damaged in the Chile Earthquake of February 27<sup>th</sup> 2010

This paper considers the seismic assessment of a 15-storey RC structural wall building, Alto Rio, located in the city of Concepción that collapsed in the M8.8 Chile earthquake of Feb 27<sup>th</sup> 2010. Different methods of assessment, based on FEMA356, are applied to examine if the observed damage could have been anticipated. Results show that FEMA356 assessment methods would have identified that the building was likely to be damaged in a major earthquake. Severe irregularities and discontinuity of walls at the base of the structure, in general, and lack of ductile detailing in walls and coupling beams are identified as the likely reasons for the damage. In addition to this assessment, the design procedures that are expected to have been used for the original design of the building are reviewed. The results showed that in applying the code design procedure, wall axial tensile forces were probably underestimated and improved capacity design procedures should be implemented.

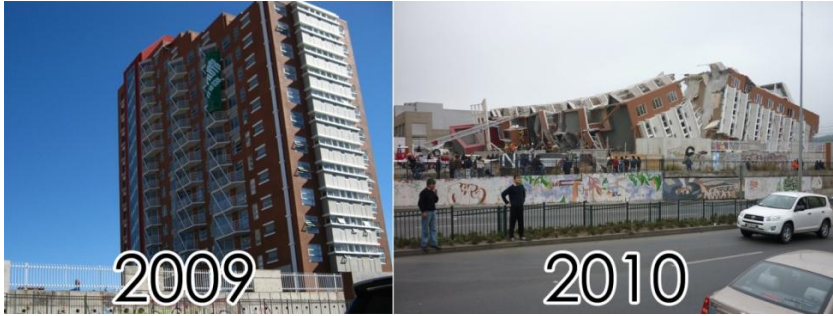
A number of buildings in the vicinity of the Alto Rio building were badly damaged by the very intense and long shaking duration, but did not collapse like the building as shown in Figure 1.1. As reported by (Elnashai et al., 2010), the building appears to have structurally failed at the connections between the first floor and the two basements. Subsequent motions then caused the building to collapse on its side as shown.

**Figure 1.1** Picture of Alto Rio building before and after the Chile earthquake, Feb 2010 (Concepción under Construction, 2010 left; El Periodista, 2010 right)

These observations would suggest that failure of the building was expected in the X direction. However, the photos of the building after collapse suggest that the collapse occurred in the positive Y-direction (refer Figure 2.1a). Although severe damage and failures could have been predicted in the structure on grids “I” and “A” by the assessment procedure, it might be questioned: “how can these results explain the collapse of the structure in the Y-direction?” One probable scenario is that, if the building experienced significant damage to the four walls of WI-1, WI-2, WI-3 and WI-4 and the transfer beams of BI-2, BI-5 and BI-6 (see Figure 2.1) of the structure on grid I the gravity load carrying capacity along this side of the building could have been lost, provoking the collapse of the building in the Y-direction, in a manner like removing two legs of a chair on one side.

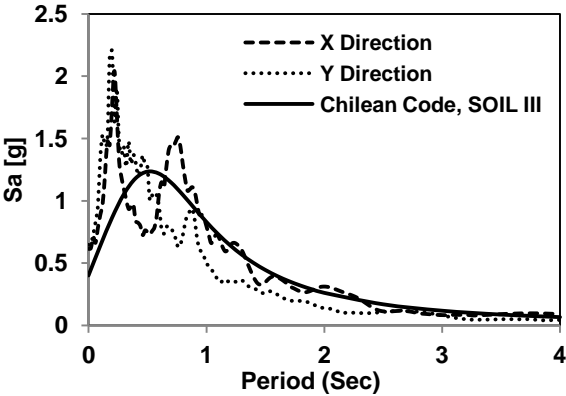
Figure 2.2 Response and Design spectra according to Chilean seismic code

Two response spectra of the records in the perpendicular directions (named as X, Y) are compared with the design spectrum of the Chilean code (NCh-433/96) in Figure 2.2. In calculating the design spectrum for this study, zone 3 with soil type III according to the Chilean seismic code is considered. An interesting observation is that the design spectrum of NCh-433/96 matches closely with the response spectrum obtained from a recording of the earthquake 8km from the site. The 27 February 2010 event could be considered a design intensity scenario for the city of Concepcion.

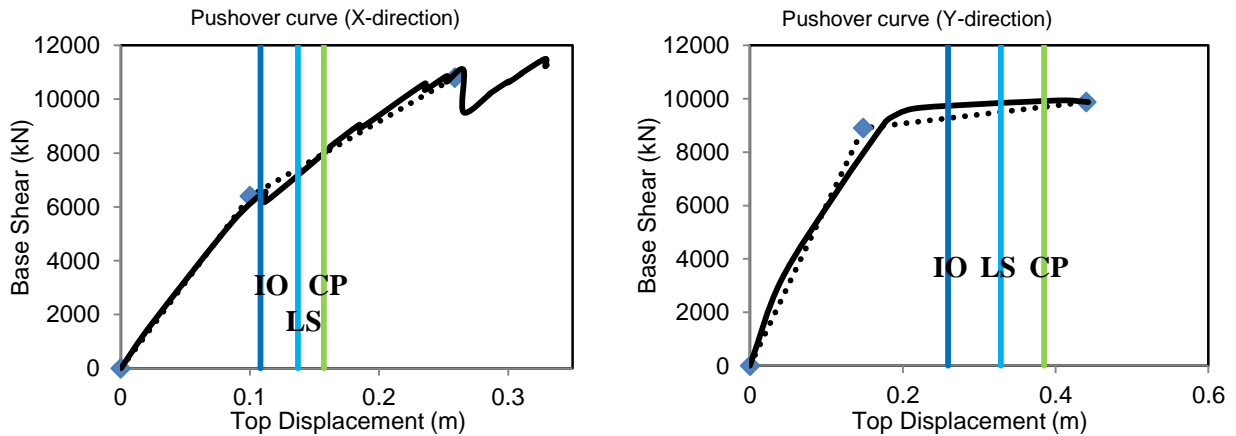
$C_0, C_1, C_2, C_3$  are modification factors defined according to FEMA356,  $S_a$  is the spectral acceleration and  $T_e$  is the effective fundamental period of the building. The values of target displacement demands for two orthogonal directions have been derived equal to 0.26m and 0.43m for X and Y directions, respectively. In Figure 3.1 pushover curves are depicted. In addition, the stage in which the first element reaches the predefined local limit state is shown. For the X and Y directions the first elements that pass the limit states are WI-4 and W5-1, respectively.

In the X-direction, as it was also suggested by the linear static analysis, the wall elements that suffer most are the ones that are subject to high axial tension loads especially in the first storey of the building. On gridlines “I” and “A” (see Figure 2.1a), because of the coupling behavior of the walls, the axial load has exceeded the axial tension load capacity of the walls in the first storey. Whereas, the walls that have been subject to axial compression, have rarely passed the LS (Life Safety) limit state. As such, at target displacement, most of the walls in the first story in elevation “I” and “A” pass the CP (Collapse Prevention) limit state. This fact is also observed for the transfer beams in elevation “A” and “I” in which most of the beams pass in to the CP limit state.

**Figure 3.1 Pushover curves of the structure for X and Y direction**

In the Y-direction, at the target displacement all of the walls on gridlines 8, 13, 20, 26, 34 & 35 (see Figure 2.1a), have remained in the IO (Immediate Occupancy) limit state except in one case at the second storey of grid 8, where the LS limit state is reached. In this direction, only the walls at the base of the second storey of grid 5 exceed the CP limit state due to high axial tension forces. Shear hinges were not observed in both directions except for a few cases in elevation “A” and “I” in which shear plastic hinges reached the IO limit state. In addition, some of the coupling beams in elevations “A” and “I” developed shear hinges but demands did not exceed the IO limit state. According to these analyses, in the X-direction of the building in which there are severe irregularities over the height of the structure, more damage is predicted and is concentrated in elevations “A” and “I”. In contrast, all the structural walls in the Y-direction, except those on grid “5”, successfully satisfy the LS limit state.
