# Structural Vulnerability of Nepalese Pagoda Temples

M. Shakya<sup>a</sup>, H. Varum<sup>a</sup>, R. Vicente<sup>a</sup> & A. Costa<sup>a</sup>

<sup>a</sup> Civil Engineering Department, University of Aveiro, Portugal

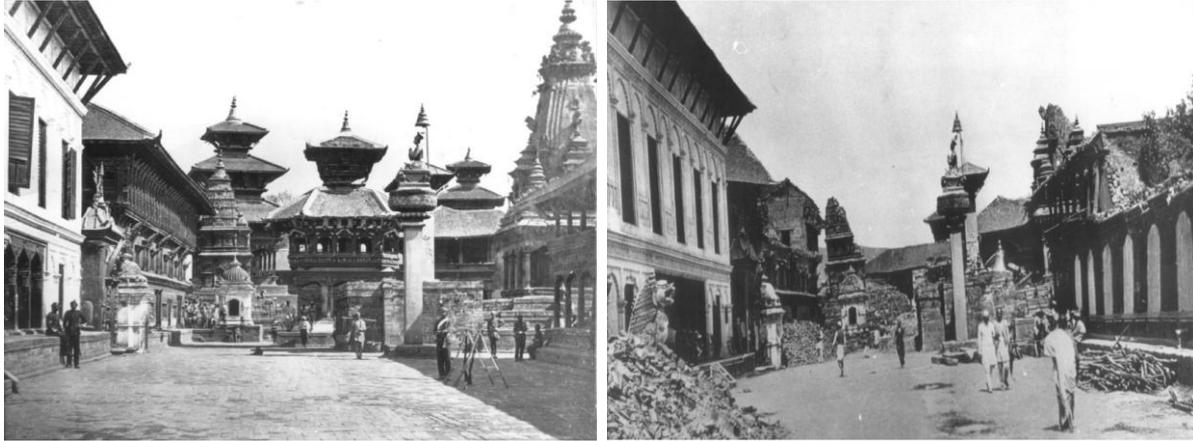
**Figure 1.** Bhaktapur darbar world heritage site before and after 1934 earthquake [Ranjitkar, 2000]

Record of past earthquakes show that Nepal felt two major earthquakes in last 100 years i.e. 1934, Bihar-Nepal earthquake (magnitude 8.4), which caused over 200,000 buildings and temples to heavy and severe damage, nearly 81,000 of which were in Eastern Nepal completely destroyed. In Kathmandu alone 55,000 buildings were affected, 12,397 of which were completely destroyed. Similarly in 1988, Udayapur (magnitude 6.5), epicentre in the Southeast of Nepal, caused 66,382 buildings to collapse [MoHA/DPNet, 2009]. The 1934 earthquake pre and post earthquake photographic information as shown in Fig.1 is reveal that not only public buildings were damaged, but also a vast number of monuments, which represents the valuable cultural heritage of a nation, were destroyed by the quake. As no photographic evidence of the earlier earthquakes exists, we cannot imagine how much was lost and in what ways the cityscape changed.
