Seismic Performance Of Existing Residential Buildings

Based on the performance design, this paper presents an approach for the study of the seismic vulnerability of existing mid-rise buildings.

This study evaluated two apartment complexes built with obsolete regulations, both located in the city of San Juan, Argentina.

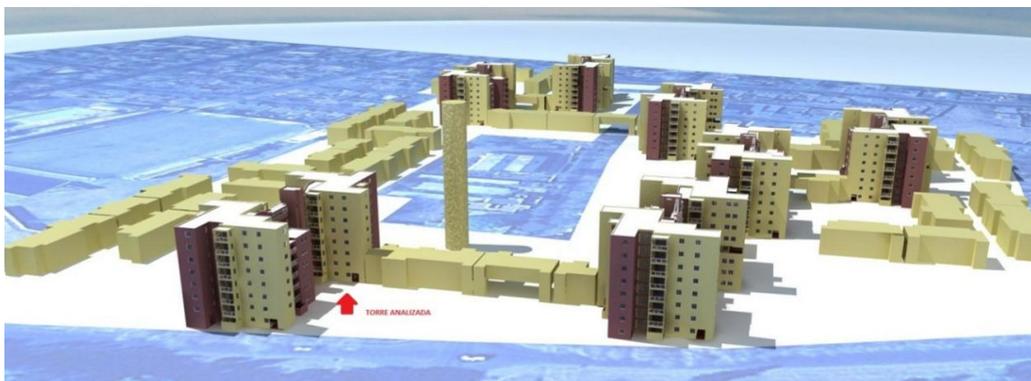
This is an urban neighborhood that has a school, a police station, shops and recreational areas. The apartments are located in two types of formations: towers of eight and three levels, Figure 2. Groups of two towers of eight levels are linked to different levels by horizontal circulations that also allow access from the elevator (central position). These bridges are structurally isolated seismically of the towers, so that each tower can be seen as an independent structure, Figure 3. Of the visual inspection and analysis of graphic documentation (drawings of structures, forms of structural elements and memories of calculation) could not check the disruption of some walls on the third floor, a similar situation occurs in some parts of the ground floor, Figure 4. While the quality of the materials used is good and the dimension of the elements is generous, there were some structural defects that are characteristic of obsolete rules, including:

Figure 2. View of the neighborhood "San Martín".

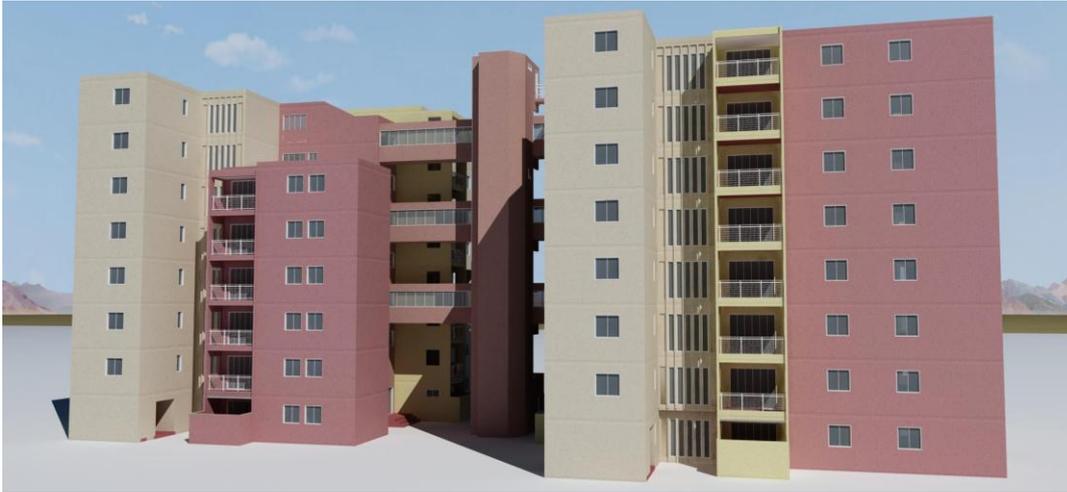
Figure 3. View of two towers and horizontal linkages.

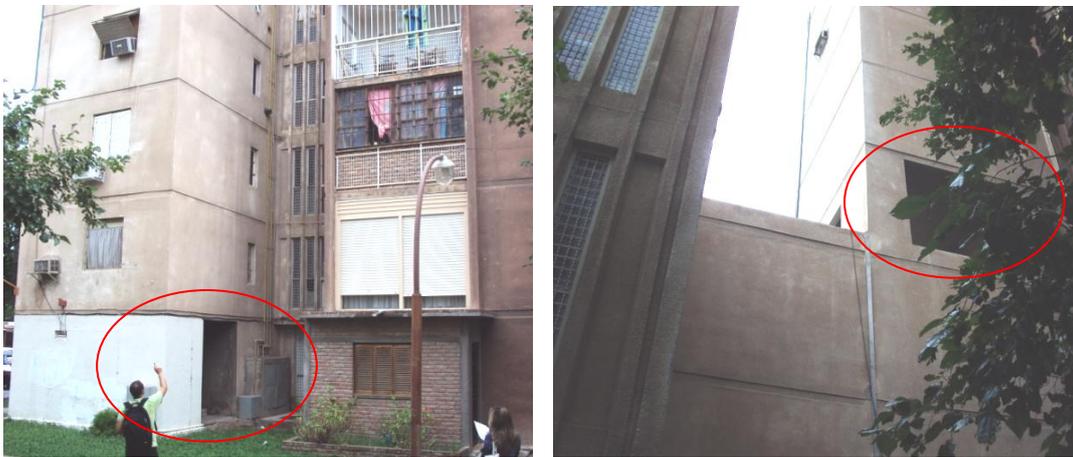
Figure 4. Discontinuity walls in the first and fourth floor.

Problems in architectural design, such as those found in the discontinuity walls to San Martin tower or flexible floor of the 9 de Julio tower.

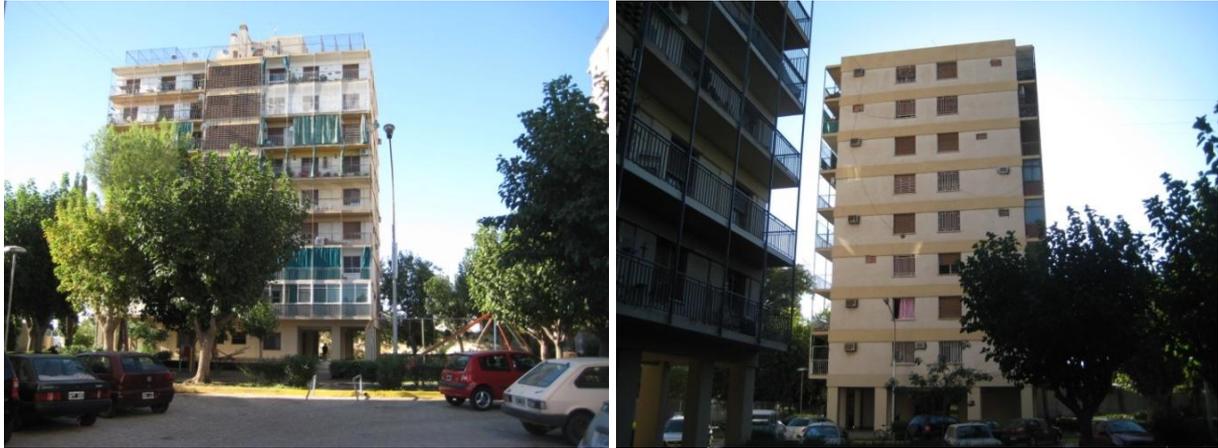
Figure 5. Views of a tower of the consortium on July 9

The consortium 9 de Julio is a housing complex that consists of four towers on nine floors each one. In this case, the seismic structure consists of reinforced concrete frames in the two main directions of the building. These towers are vertical irregularity. This irregularity is manifested by the presence of a ground floor free while masonry has been used to close the openings of the perimeter frames in the rest of the levels. The balconies on each floor were built using slabs cantilever, dibujo5. The visual inspection and analysis of the graphic documentation provides the following information:

- Vertical irregularities caused by partial disruption of the masonry at the ground floor.
- The balconies in many cases have been closed completely incorporating considerable weight to the structure of the building and causing displacement of the mass center of each level.
- Sanitary maintenance free cause moisture problems in walls and gates

The marked irregularity of stiffness in height (ground floor flexible) indicates that perhaps this is a factor that may compromise the overall behavior of the structural system.
