Interface Debonding Defect of a Concrete-Filled Steel Tube Using PZT Technology

SUMMARY:

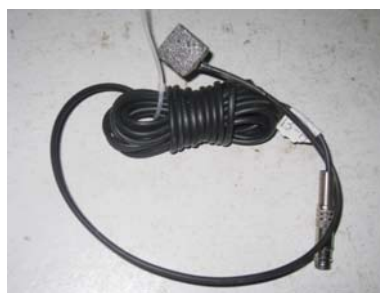
Figure 2.1. SA with embedded PZT patch and wire **Figure 2.2.** Cross section of the CFST specimen

Piezoelectric material can be utilized as both actuators and patches in structural health monitoring. In the term of monitoring the interfacial condition of CFST members, the PZT actuator should be pre-embedded into the concrete core. In order to protect the brittle piezoelectric transducer from damage, smart aggregates (SAs) which package a PZT patch to be used as an actuator in a small cement mortar block are used. Before being packaged in the cement mortar block, the piezoelectric patch is applied with an insulation coating to protect it from the influence of water and moisture. The employed PZT patch has a dimension of 10mm×10 mm×0.3 mm and then the piezoelectric patch is embedded into a 10mm×10mm×10mm cement mortar block. Figure 2.1 shows an example of the SA with a PZT patch embedded.
