Field Investigation and Dynamic Analysis of Damaged Structure on Pile Foundation during the 2011 off the Pacific Coast of Tohoku Earthquake

15 WCEE
LISBOA 2012

SUMMARY:

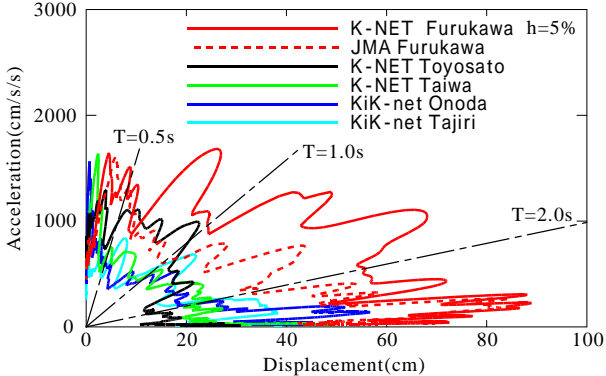
Figure 2. Response spectra of observed motions (EW)

Fig. 2 shows the relationships between acceleration and displacement response spectrum of the observed motions at K-NET and JMA Furukawa. The response spectra of the observed motions at several points around Furukawa district are also shown in this figure. These observation points are K-NET or KiK net station by NIED and located about 20 km away from Furukawa district. The spectral amplitude of the observed motions at K-NET and JMA Furukawa are larger than the amplitude of other points at the period of around 1s. From these observed motions, it is shown that a ground motion at Furukawa district was larger than other points during the earthquake.

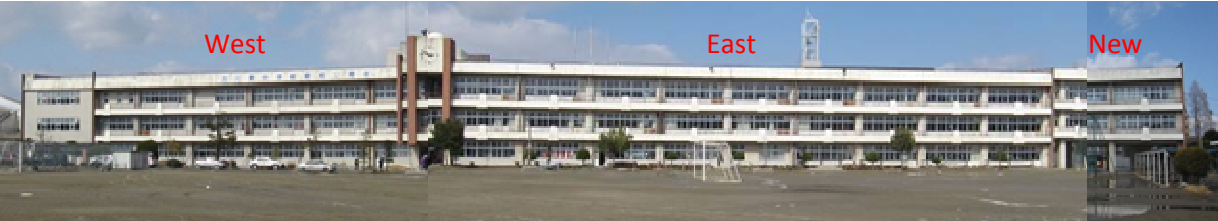
Photo 1. South view of damaged school buildings

Photo 1 shows the south view of the damaged school buildings, and Fig. 3 shows the plan of the school buildings and the pile foundations. This junior high school comprises four buildings. The main buildings are the west and east school buildings, and two small-scale buildings, which are called the north and new school buildings in this paper, are connected with the east school building through the Exp. J. The west and east school buildings were constructed in 1979, and the north and new school buildings were added each in 1989 and 1991. The superstructure of the west and east school buildings, and the new school building comprises a three-story RC structure, and that of the north school building comprises a one-story RC structure.

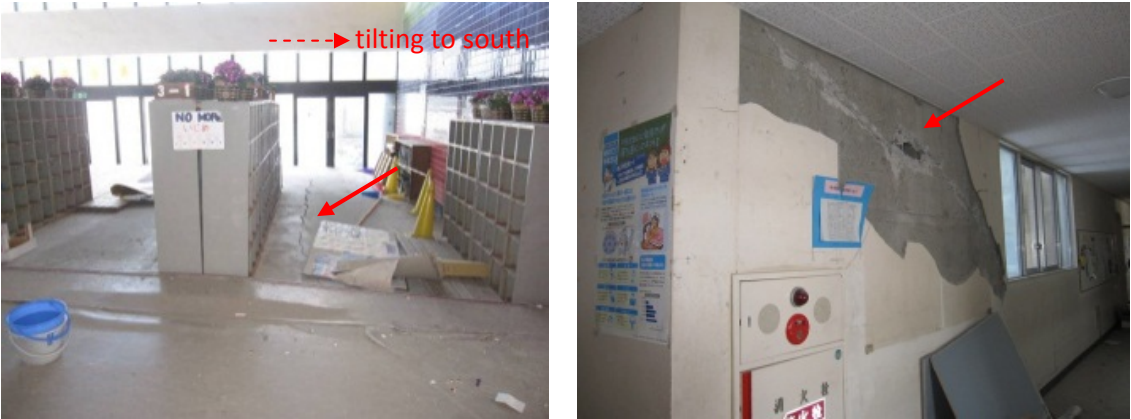
Photo 2. Crack of entrance floor (left) and shear failure of RC non-structural wall in east school building (right)

Photo 2 shows the crack of the entrance floor of the west and east school buildings. The damage was caused by the tilting damage to the south side. Photo 2 also shows the shear failure of the RC non-structural wall of the long side direction of the east school building. Shear cracks of a width of from about 0.2mm to 2mm occurred on other columns. Photo 3 shows the settlement of the east school building and the level difference between the east and new school buildings. The level difference was caused by the differential settlement of the both buildings.

As mentioned above, although the superstructure of the west and east school buildings had from minor to moderate damage, it was judged that damage level was severe by the settlement and tilting damage.

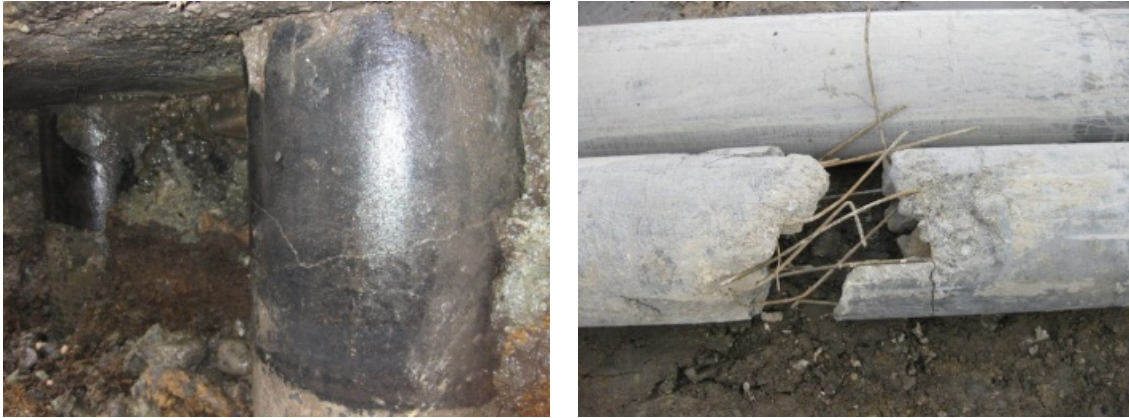
Photo 4. Pile damage of west school building (D14 in Fig. 3)
Flexural crack at pile head (left), Partial deficiency of pile at a depth of about 4m (right)

Photo 4 shows the damage around the pile head of the west school building (D14 in Fig. 3). The pile head had only a few flexural cracks of a width of from 1 to 2 mm, no severe damage was observed on the pile. From this damage, it is thought that a joint condition at the pile head was a pin joint. And the maximum tilt angle observed among the investigated piles was about 15%. It is thought this tilting was caused by an effect of a rotation of the pile head. The extraction survey of this D14 pile was conducted. A partial deficiency of the pile caused by a failure at a depth of about 4m was observed as shown in Photo 4. From these result, it is judged that the factor of the settlement damage of the west school building was the damage of the pile at the position which is deeper than the pile head.

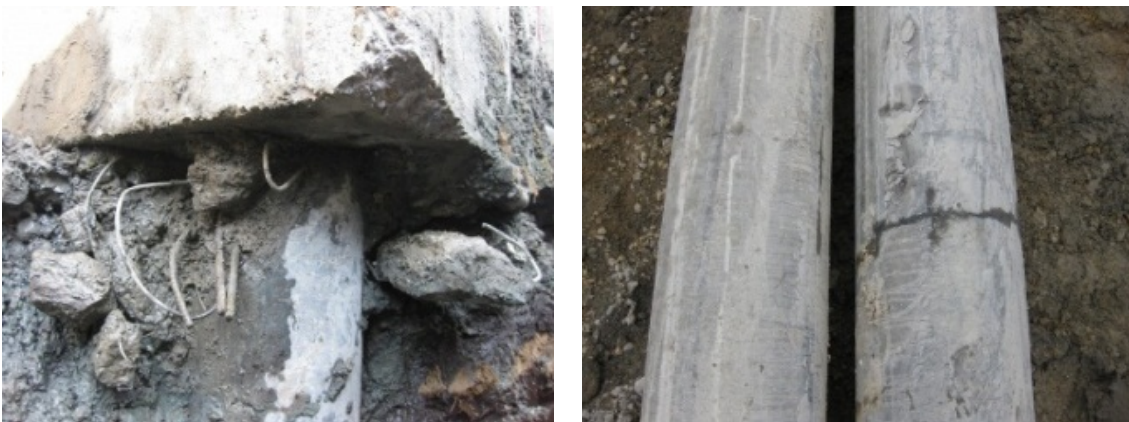
Photo 5. Pile damage of east school building (A9 in Fig. 3)
Compression failure at pile head (left), Flexural crack at a depth of about 15m from pile tip (right)

Photo 5 shows the damage around the pile head of the east school building (A9 in Fig. 3). The pile head had a compression failure. From this damage, it is thought that a joint condition at the pile head was a fixed joint unlike the west school building. The extraction survey of this pile was conducted. A flexural crack of a width of 2 mm was observed at a depth of about 15m from the pile tip as shown in Photo 5, no failure occurred on the pile unlike the west school building. From these result, it is judged that the factor of the settlement damage of the east school building was the damage of the pile head.

As a result, it is presumed that the flexural compression failure occurred at the pile head, the pile foundation could not support an axial force by the failure at the pile head and the failure caused the settlement and tilting damage of the east school building.

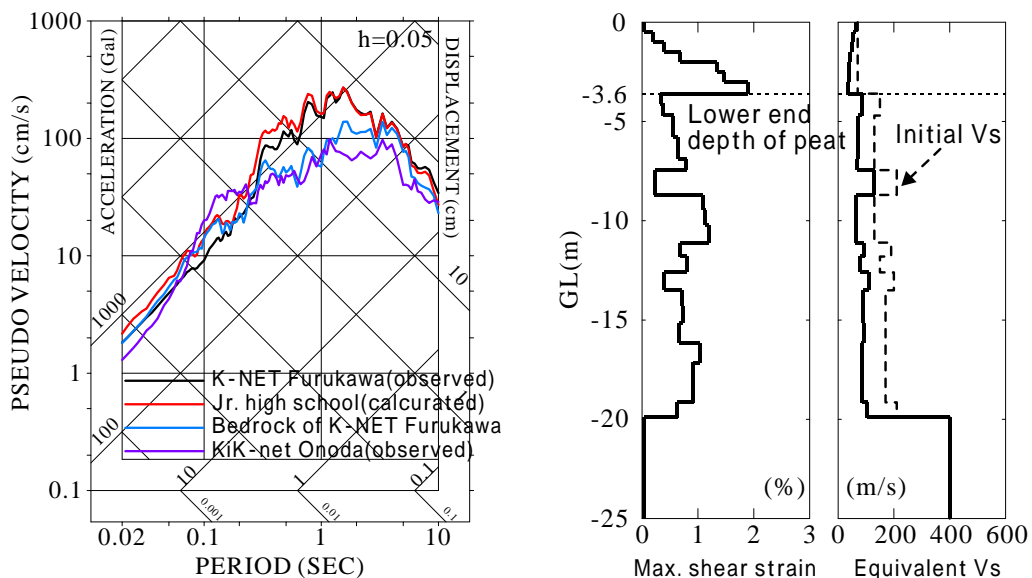
Figure 6. Result of soil response analysis

Fig. 6(a) shows the pseudo velocity response spectra for a damping ratio of 5% of the bedrock motion of K-NET Furukawa and the calculated ground surface motion of the junior high school. Because of an effect of a soil amplification in the layer over 71m depths, the spectral amplitude of the bedrock motion at the period of around 1s decreases in a half in general to the observed motion on the surface at K-NET Furukawa. The spectrum of the observed motion at the ground surface of KiK-net Onoda by NIED, which is located about 16 km west of K-NET Furukawa, is shown in Fig. 6(a). The S-wave velocity at the ground surface of the KiK-net Onoda is generally the same as that at the bedrock of K-NET Furukawa. Since the calculated bedrock motion corresponds to the observed motion of KiK-net Onoda, it is evaluated that amplitude of the calculated bedrock motion is appropriate as amplitude of a bedrock motion in this area.

Fig. 6(b) shows the distributions of the maximum shear strain and the equivalent S-wave velocity in the layers over 25m depths in the EW direction. The shear strain becomes about 2% at a depth of 3.6m, which is lower end depth of the very soft layer of peat with $V_s=70\text{m/s}$. The equivalent S-wave velocities in the layers over 19.9m depths decrease in a half in general to the initial S-wave velocities.

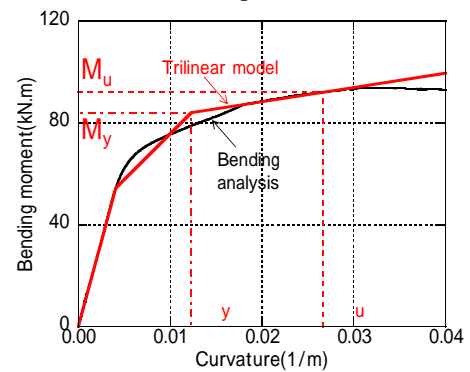
Figure 8. Trilinear model

Table 3 shows the height and weight for each story of the superstructure. The relationship between the shear force and the shear deformation of the superstructure is assumed to be trilinear model for each story, as shown in Fig. 8(a). The strength of the superstructure is based on the value shown in the report on the seismic capacity evaluation for the junior high school. The nonlinear property of the pile foundation is incorporated into the relationship between the bending moment and the curvature, as shown in Fig. 8(b). This is evaluated by a bending analysis with a fiber-model using a material property of the pile, considering a stationary load. Here, the concrete compressive strength and the yield strength of the steel bar of the pile are assumed to be each 50N/mm^2 and 1275 N/mm^2 , and the stationary load is set to the weight of the building per one pile, 277kN . The trilinear model is set so that the model fits the analysis result, then the ultimate point is set as the point which a compression strain of the concrete at the edge of the pile become 0.3% .

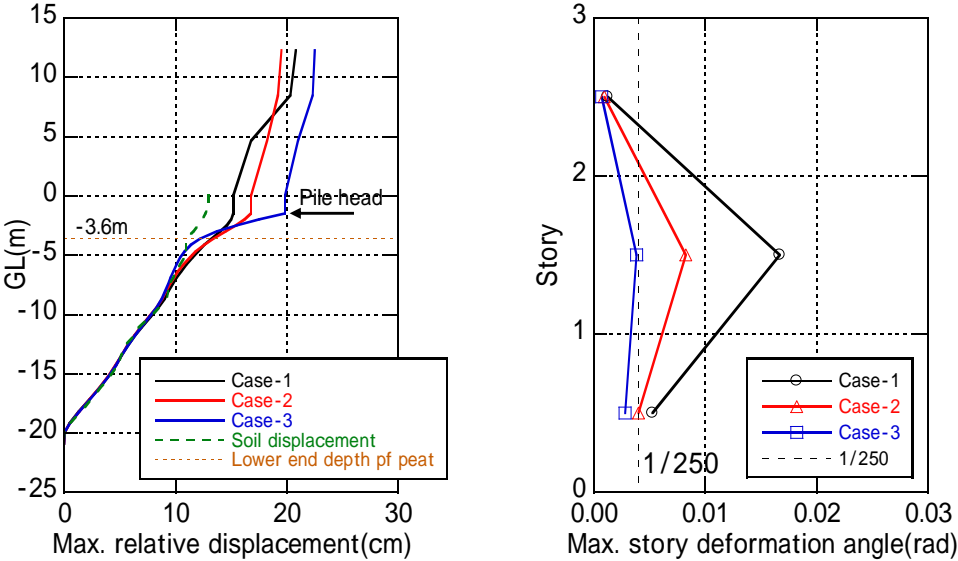
Figure 9. Distributions of maximum relative displacements of pile-structure system and maximum story deformation angles of superstructure

Fig. 9 shows the distributions of the maximum relative displacements of the pile-structure system and the maximum story deformation angles of the superstructure. The relative displacement at the pile head of Case-2 is larger than that of Case-1 by the effect of nonlinearity of the pile and the interaction spring. As a result, the story deformation angle of Case-1 is larger than that of Case-2 and exceeds $1/100(0.01)$ rad at the second story. The relative displacement at the pile head of Case-3 is larger than that of Case-2 by the effect that the joint condition at the pile head is a pin joint, and this result cause that the story deformation angle of Case-3 is smaller than that of Case-2 and becomes about $1/250(0.004)$ rad at the first and the second story.

It is thought that the joint condition at a pile head of Case-2 corresponds with the actual condition of the east school building, since the damage of the pile heads was observed in the field investigations. And the shear cracks in the RC columns and the non-structural walls at the first story of the east school building were observed in the field investigations. Therefore, it is presumed that the first story deformation angle of Case-2, about $1/250$ rad, is generally in agreement with the actual damage.

The maximum relative displacement of the soil with respect to the pile tip is also shown in the figure of the relative displacement. In comparison with the soil displacement, the pile displacement under 3.6m depths, which is lower end depth of the very soft layer of peat, is generally the same as the soil displacement. On the other hand, the pile displacement over 3.6m depths is larger than the soil displacement by the effect of the shear force from the superstructure. It is presumed that since almost the entire shear force from the superstructure was transmitted to the pile foundations by the effect of the very soft layer of peat, the pile displacement over 3.6m depths became larger than the soil displacement

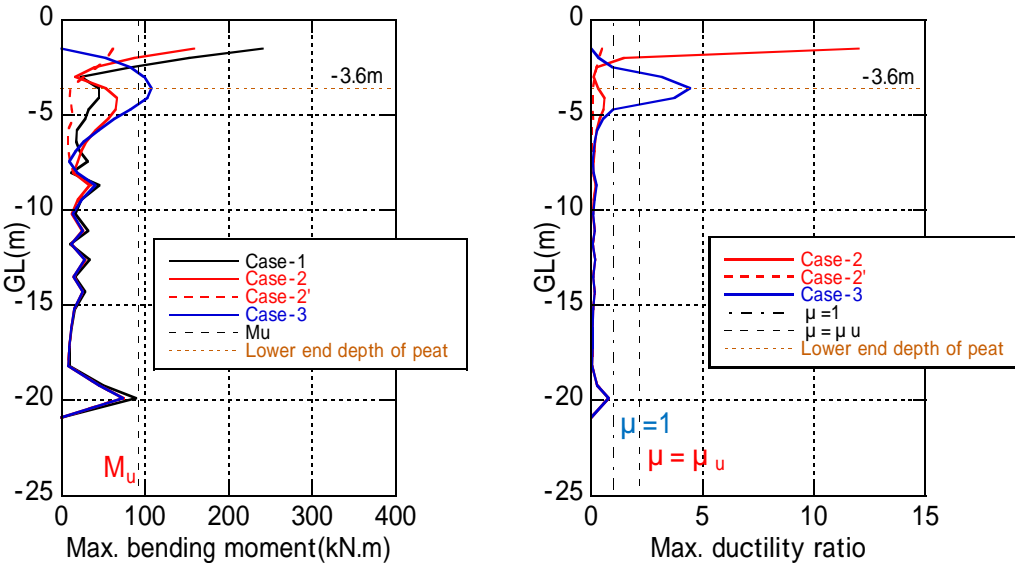
Figure 10. Distributions of maximum bending moments and maximum ductility ratios of pile foundation

Fig. 10 shows the distributions of the maximum bending moments and the maximum ductility ratios of the pile foundation. The ductility ratios are the ratios of the maximum curvature to the yield curvature. In the case of Case-2, the bending moment exceeds the ultimate bending moment M_u , and the ductility ratio exceeds the ultimate ductility ratio μ_u , which is the ratio of the ultimate curvature to the yield curvature. Therefore it is presumed that the result of Case-2 is generally in agreement with the actual damage, which is the flexural compression failure at the pile heads of the east school building. In the case of Case-3, in which the joint condition at the pile head is a pin joint, the bending moment and the ductility ratio exceed each M_u and μ_u at a depth of 3.6m, which is lower end depth of the very soft layer of peat. Although the analyses for the east school building, it is presumed that the result of Case-3 is generally in agreement with the actual damage at the west school building. The damage is the partial deficiency of the pile caused by the flexural compression failure at a depth of about 4m.

In the case of Case-2', in which a superstructure is removed from a soil-pile-structure system, the bending moment is less than M_u , and the ductility ratio is less than 1.0. From this result, as mentioned earlier, it is presumed that the effect of the shear force from the superstructure (inertial component) is dominant to the response of the pile foundation.

From these results, the factor of the damage of the pile foundation observed in the field investigations of the east school building is confirmed that the response of the pile foundation exceeded the ultimate limit state. It is thought that the response was caused by almost the entire shear force from the superstructure was transmitted to the pile foundation by the effect of the very soft layer of peat over 3.6m depths.
