# Evacuation Behavior and Evacuation Sites in Miyako after the 2011 Great East Japan Earthquake

## SUMMARY:

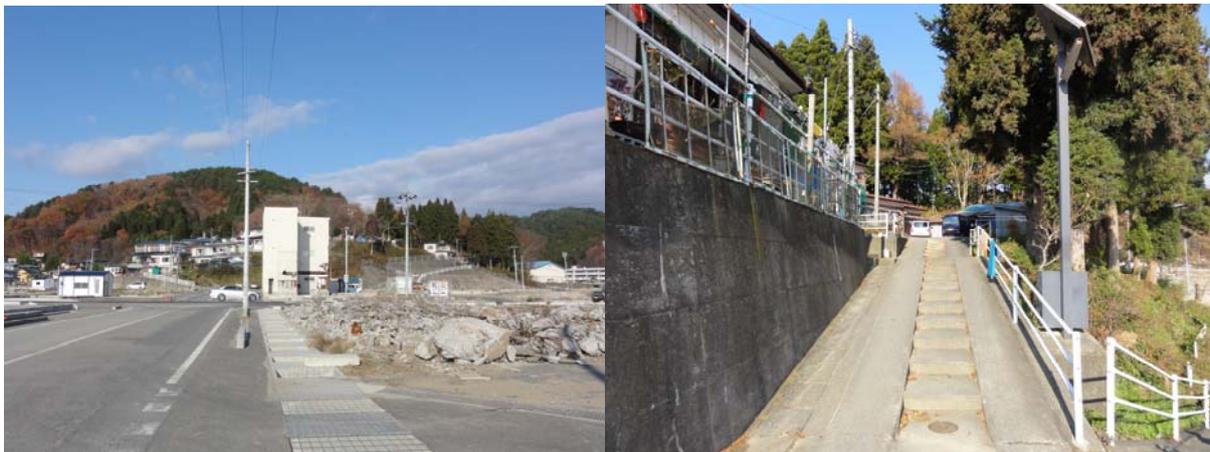
Figure 3.1. Evacuation Routes in Taro

Human damage was less when compared to past disasters in this earthquake, but most buildings have been washed away. Taro in the district, the lesson of the earthquake in the past, road maintenance in a lattice shape the book as a baseline number of evacuation road parallel to the road, leading to the hill to intersect the baseline, such as the angle of intersection is a corner cut have been devised.

Considered were able to evacuate in a straight line from where most of the housing for it. Also have been scattered around the mountain refuge Akanuma, secondary evacuation is possible in about 5 to 10 minutes walk has been developed for evacuation routes leading to the mountain refuge Akanuma from which one (Figure 3.1.). Evacuation routes to the mountain Akanuma has become the type of evacuation route features a stair slope, it is possible to light car.

On the other hand, in the district Taro has been developed to advanced evacuation routes, evacuation was possible in the shortest distance to a hill or site. Evacuation site next to two can be quickly when the next one site was flooded because it was also been secured site and evacuation route in between the primary and secondary evacuation site also.
