Seismic vulnerability of the ‘Palazzo degli Uffici Statali’ a public building realized in Italy at the beginning of last century

A. Acciai & R. Nudo

Department of Constructions and Restoration, University of Florence, Italy

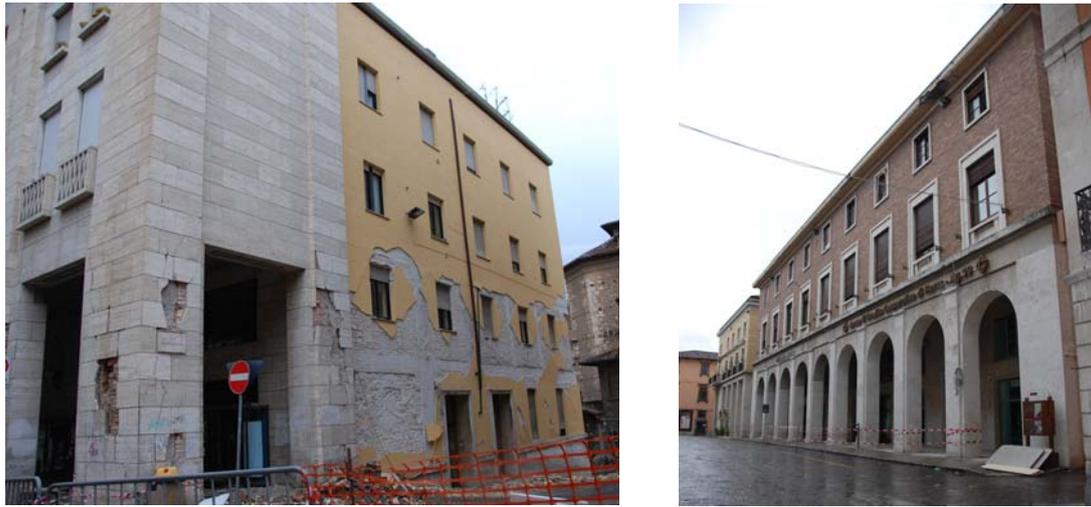
Figure 1. Public buildings of the 30s in L'Aquila (central Italy) affected by the earthquake of April 6, 2009.

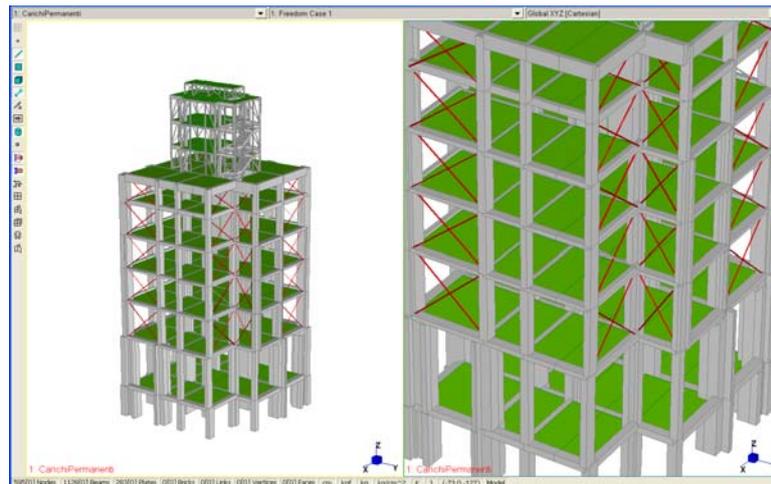
Figure 8. Building model with the turret and metal bracings.

The analysis of results provided by the model representing the building under present conditions pointed out activation of significant torsional modes due to the irregular distribution of lateral stiffness. For that reason a traditional upgrading intervention was hypothesized, based on the insertion of metal bracing (diagonal steel elements) positioned at the less stiff sides of the building, starting from the first storey (thus excluding the basement and ground floor). Through a suitable calibration of steel element sections it was possible to regulate lateral stiffness distribution. The reconstruction of the turret was also considered, assuming for it a steel structure. Figure 8 illustrates the geometric model with highlighting of the frame meshes interested by bracing elements; in the model, the lower ends of columns of the first level were assumed as fixed joints.
