# Estimation of Tsunami-Inundated Areas in Asahi City, Chiba Prefecture, after the 2011 off the Pacific Coast of Tohoku Earthquake based on Satellite Images and Numerical Simulation

Yoshihisa Maruyama, Ken Kitamura & Fumio Yamazaki  
Chiba University, Japan

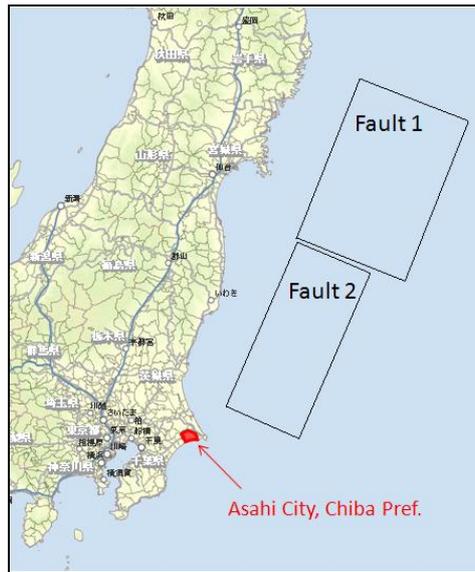
**Figure 1.** Locations of Asahi City, Chiba Prefecture, and the fault model developed by the Geospatial Information Authority of Japan (GSI)

The tsunami also hit Chiba Prefecture. With 13 fatalities in Asahi City (Fig. 1) and two people reported still missing, the eastern part of the prefecture was severely affected. In Asahi City, 336 family units collapsed as a result of this event (Asahi City, Chiba Prefecture, 2011). These buildings were mainly affected by the tsunami, and some by liquefaction. The people in Asahi City suffered from both tsunami and liquefaction, although the city was away from the most severely affected areas.

Numerical simulation of tsunami propagation was also performed to estimate the tsunami-inundated areas in Asahi City. The seismogenic fault model developed by the GSI (GSI, 2011b) was employed to estimate the vertical displacement of the seabed (see Fig. 1). The specifications of this fault model are listed in Table 1. Figure 7 shows the vertical displacement estimated by Okada's method (Okada, 1985). Assuming the water layer to be incompressible, the estimated vertical displacement of the seabed was regarded as the initial profile of the tsunami.

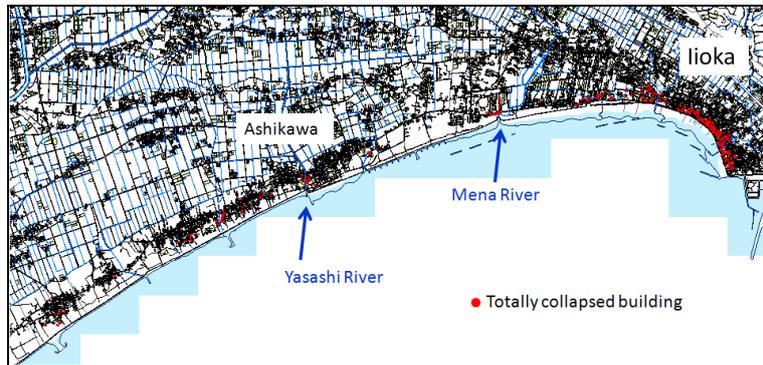
Figure 2 shows the distribution of totally collapsed buildings by tsunami in Asahi City. The dataset was compiled by the city and the number of totally collapsed buildings was reported as 229. The damage to buildings was concentrated in the Iioka district in the eastern part of the city.

**Figure 2.** Distribution of totally collapsed buildings after tsunami in Asahi City, Chiba Prefecture

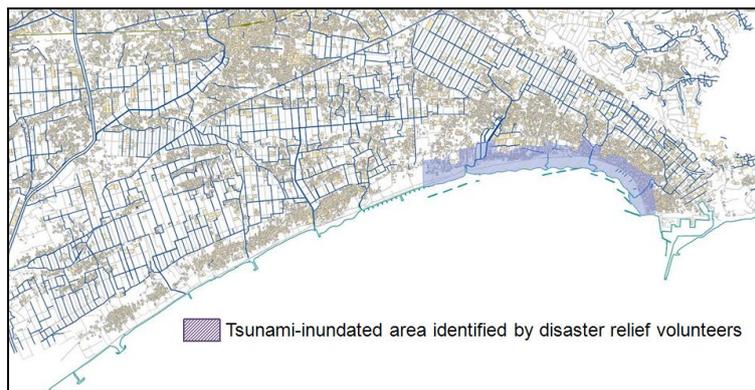
**Figure 3.** Tsunami-inundated areas identified by disaster relief volunteers in Asahi City

the extent of tsunami inundation was provided by the city government during the second field survey conducted on April 12, 2011. The tsunami-inundated areas identified by the volunteers were highlighted on a city map. The authors obtained photographs of these maps and developed polygons demonstrating the tsunami-inundated areas. These were then projected onto a geographic information system (GIS) as shown in Fig. 3. The map mainly covered the Iioka district in the eastern part of Asahi City.

interpreting satellite and aerial images taken after the earthquake (GSI, 2011a). Comparing this result with Figs. 3 and 4, the final estimates of the tsunami-inundated areas were developed in Fig. 5.

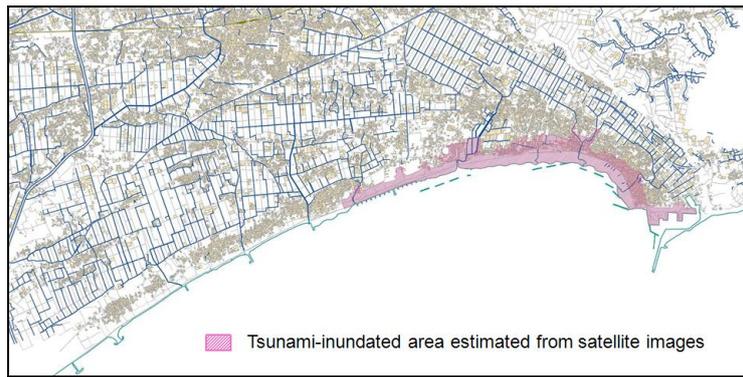
**Figure 4.** Tsunami-inundated areas identified by visual inspection of satellite images

Remotely sensed imageries are effective tools for identifying the tsunami-inundated areas (Inoue et al., 2007; Kouchi and Yamazaki, 2007; Koshimura et al., 2009a; Chen et al., 2005). To this end, critical information about the tsunami of March 2011 was resourced from Google Crisis Response (Google Crisis Response, 2011). The satellite images of the eastern part of Asahi City, captured by DigitalGlobe on March 12, 2011, were used. The change in color on the ground was mainly used to identify the tsunami-inundated areas. Figure 4 shows the tsunami-inundated areas identified by the visual inspection of the satellite images.

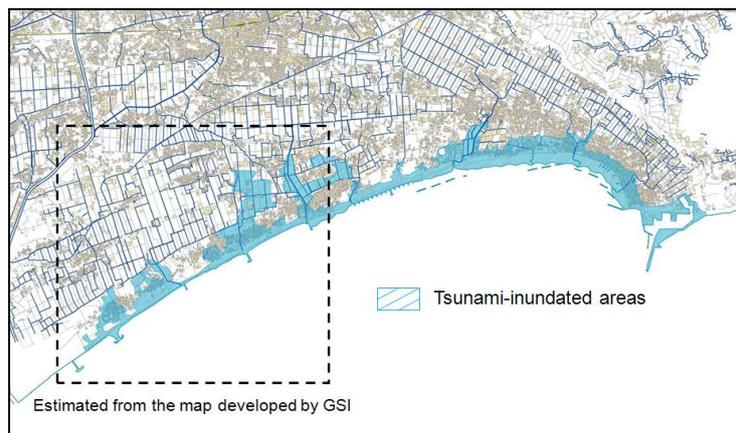
**Figure 5.** Final estimates of tsunami-inundated areas in Asahi City, Chiba Prefecture, after the 2011 off the Pacific coast of Tohoku Earthquake

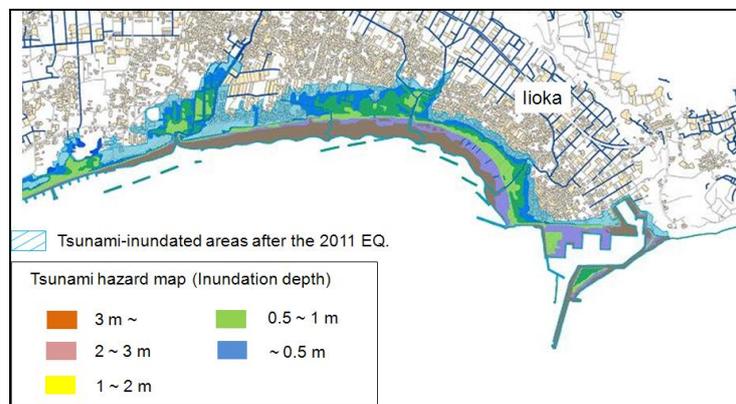
**Figure 6.** Comparison between tsunami hazard map and identified tsunami-inundated areas in Asahi City, Chiba Prefecture, after the 2011 off the Pacific coast of Tohoku Earthquake

Tsunami hazard maps have already been developed for Asahi City (Asahi City, 2008). In these maps, the areas of tsunami inundation were estimated in the context of the 1677 Empo Boso-oki and the 1703 Genroku Kanto earthquakes (Iwabuchi et al., 2008). Figure 6 shows a comparison of a tsunami hazard map with the identified tsunami-inundated areas of the city after the 2011 Tohoku Earthquake. It can be observed that the eastern parts of the city, such as Iioka, were affected more severely than expected. However, despite the installation of seawalls approximately 4 m in height in Iioka, the tsunami waves climbed over the walls and struck the residential areas.

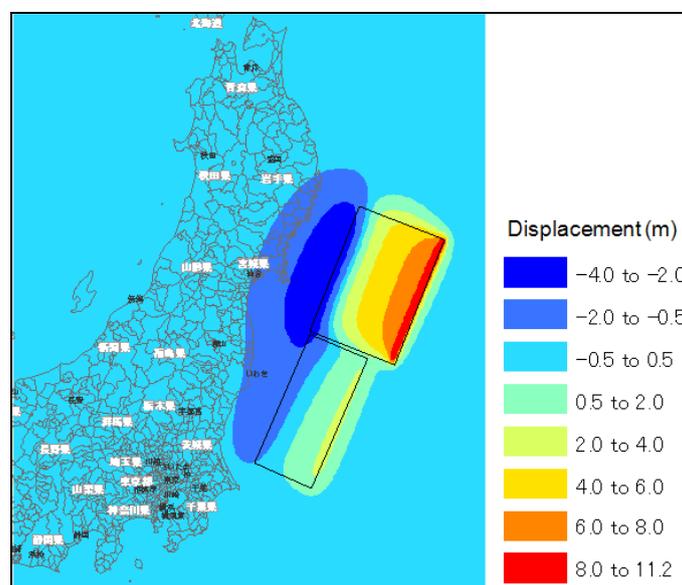
**Figure 7.** Vertical displacement of seabed as estimated by Okada's method (1985)

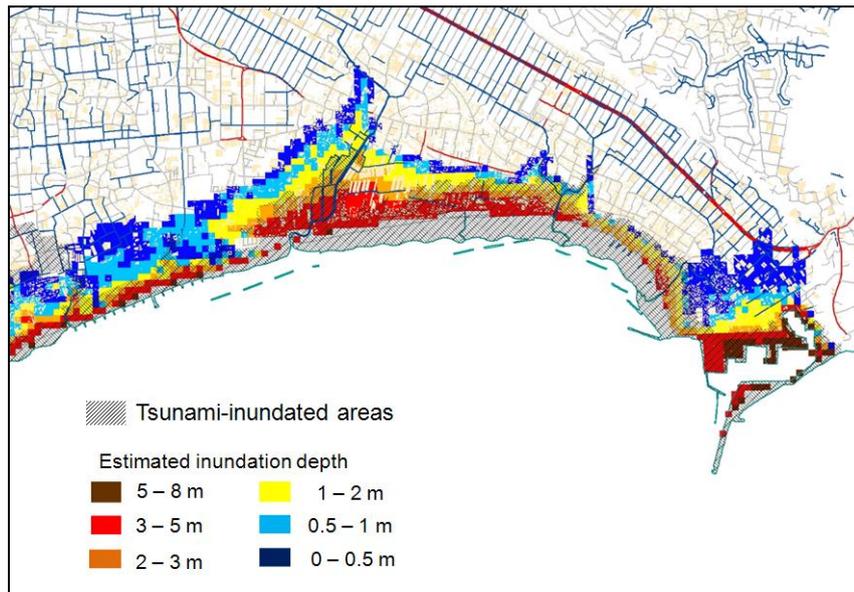
**Figure 8.** Comparison between inundation depths estimated by numerical simulation and the tsunami-inundated areas identified in this study

Figure 8 shows a comparison of the tsunami-inundation depths obtained by the numerical simulation with the tsunami-inundated areas identified in this study. We focus on the eastern part of Asahi City, where the inundated areas were verified through different sources. The simulated distribution of the tsunami-inundated areas and the distribution identified through the surveys show similar trends. The

tsunami-inundated areas include almost all the surveyed areas with a simulated inundation depth greater than 1 m. The tsunami-inundated areas were identified primarily through the satellite and aerial images captured a few days after the earthquake. Hence, the areas inundated with shallow waters might have been identified with limited accuracy. This may explain the difference between the inundated areas determined by the simulation and those identified in this study.

A comparison of the simulated and identified tsunami-inundated areas revealed that the latter covered almost all the areas where the estimated inundation depth was more than 1 m. Since the tsunami-inundated areas were mainly identified based on the satellite images captured a few days after the earthquake, only the areas completely inundated with deep water could be detected. This may explain the difference between the simulated results and those obtained by imagery.

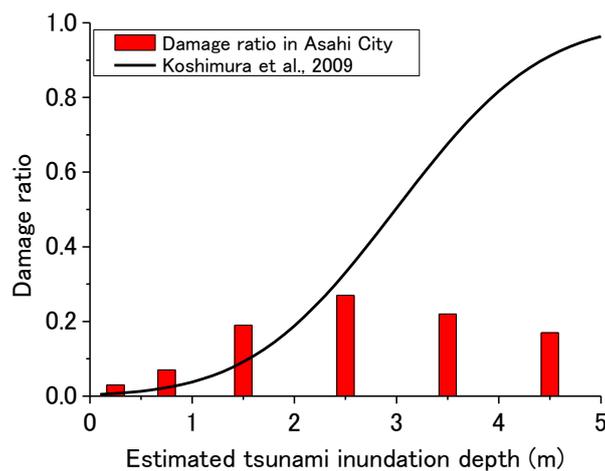
**Figure 9.** Relationship between the damage ratio of buildings and the estimated tsunami-inundation depth

The structural performance due to tsunami forces has been investigated by various research teams (Bertero et al., 1985; Saatcioglu; 2006; Ruangrassamee et al., 2006). This study tries to obtain the statistics related to structural damage. Since the exact locations of the totally collapsed buildings following the tsunami were available (see Fig. 2), a dataset of the actual damage could be established. Then, the damage ratio of buildings—the ratio of totally collapsed buildings to the total number of buildings—in terms of the inundation depth was evaluated by combining this dataset with the results of the numerical simulation. Building inventory compiled by Zenrin, a Japanese map publisher, in 2009 was used in this study (Zenrin, 2012). Figure 9 shows the relationship between the damage ratio of buildings and the estimated tsunami-inundation depths. The figure also shows a fragility curve constructed after the 2004 Sumatra–Andaman earthquake (Koshimura et al., 2009b). In the study, pre- and post-event satellite images were employed to perform visual damage inspection. The buildings were interpreted as “survived” and “destroyed” by detecting the roofs were remained or not, and the fraction of “destroyed” buildings was used as the damage ratio. The damage ratios in Asahi City were the same as those in Banda Aceh, Indonesia, with an estimated inundation depth of around 3 m. However, the damage ratios associated with the inundation depth of more than 3 m were smaller than the estimations of the fragility function.

According to the relationship between the damage ratio of buildings and the estimated tsunami inundation depth, the damage ratios associated with the inundation depth of less than 3 m coincided with those at Banda Aceh after the 2004 Sumatra–Andaman earthquake. However, the damage ratios decreased at inundation depths greater than 3 m. In order to arrive at more definite conclusions, it is essential to improve the accuracy of numerical simulation by employing a finer digital-elevation
