SHAKE TABLE TESTS ON PLASTERBOARD CONTINUOUS CEILINGS

G. Magliulo, V. Pentangelo, V. Capozzi, C. Petrone, G. Manfredi
University of Naples Federico II, Department of Structural Engineering, Naples, Italy

Keywords: continuous plasterboard ceiling, full scale shaking table test, seismic performance, nonstructural components.

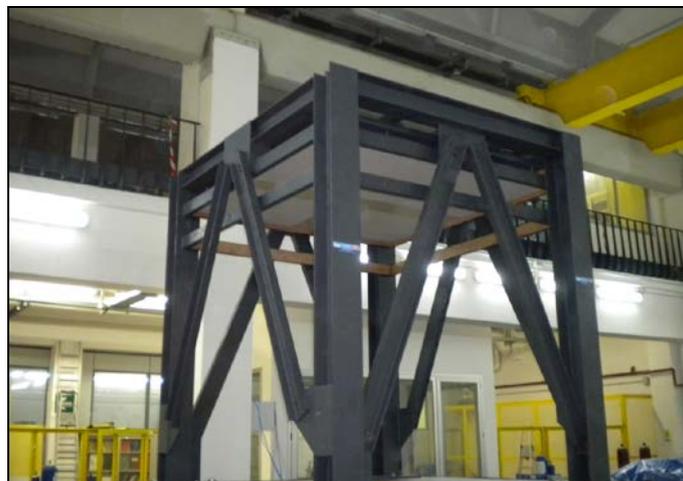
With the purpose of simulating the seismic effects on the ceilings, a steel test frame is properly designed and built (Fig. 2.2). The test frame is of S275 steel material with concentric V-bracings made of steel U-section (UPN160). The very stiff test frame is required in order to control the acceleration on the specimen and to avoid shake table – test frame – ceiling system double-resonance issues.

Two U-section profiles (UPN100) are welded around the perimeter of the test frame, at a distance of 20 cm and 50 cm from the roof; a 40 mm x 100 mm timber ledger is inserted in the U-section profile in order to easily laterally restrain the ceiling system. Indeed, the ceiling system plasterboards are connected along the perimeter of the frame to the timber ledger. Consequently, the light mass and the large stiffness of the timber-channel profiles system represent the typical boundary conditions of a ceiling on structural elements. The total weight of the test frame is equal to 19.2 kN.

Figure 2.2. Test frame installed on the shake table
