RESILIENT CITIES - AN EFFECTIVE WAY TO REDUCE DISASTERS

Julio Kuroiwa

National University of Engineering. UNI. Lima, Peru

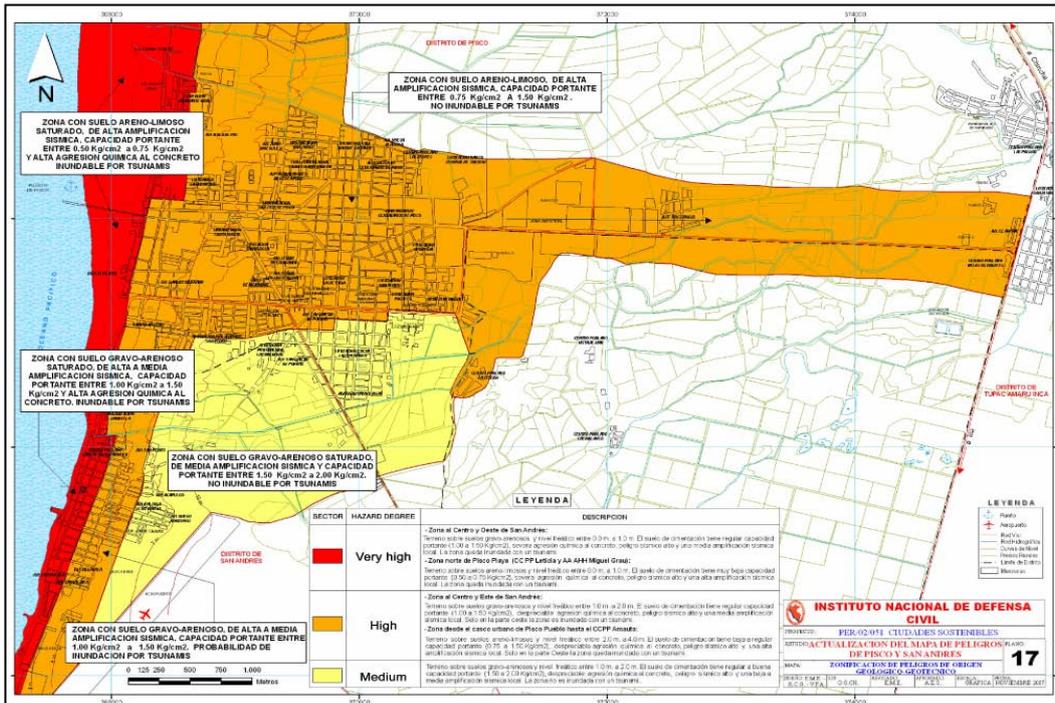
Fig. 1. Final Hazard map of Pisco. Results of compatibilization of the CISMID UNI and SPC INDECI/UNDP hazard maps. Reported to the Peru Ministry of Housing, Construction and Sanitation and to the Municipality of Pisco, in December 2011

In the validated map of Pisco (see Fig. 1), it was found that in general the boundaries between the very high, high and medium hazard sectors were accurate. Few correction were made, but in the validated map the limits between sectors were made along the axes of avenues and streets, so as not to cut properties, because of the legal implications of the municipal ordinance approving the hazard map and land-use plan.

At the request of the Ministry of Housing Construction and Sanitation, in November/December 2011, the author compatibilized both hazard maps. Some changes were necessary, for example in downtown Pisco, there are two relatively small spots with very high hazard not identified by the SCP INDECI/UNDP map, but clearly indicated in the CISMID report, and this contribution was included in the final Pisco hazard map.

The sector northwest from downtown Pisco had been considered in the CISMID FIC/UNI map as low/medium hazard; however, in the final version, it was considered with high hazard, because the sewage treatment plant is located there, which moistens the area. The area is also contaminated by bad smell from the sewage and the presence of mosquitoes and sea birds that increase the contamination, so it was graded as high hazard. In the Pisco Municipality land-use plan, this sector is designated as recreational green areas, which was accepted by all the stakeholders.

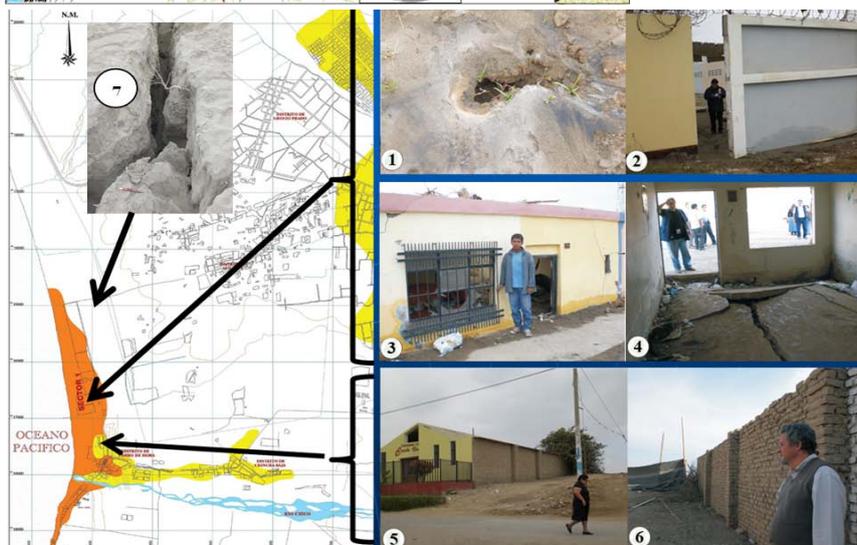
Fig. 3. MICROZONATION EFFECTS IN TAMBO DE MORA

- 1). Volcano of soil liquefaction. 2). Lateral spread. A “door was opened”. 3). Settlement of 0.80m 1.00m.
- 4). Settlement of bearing walls and broken concrete floor. 5). Undamaged adobe church and 6). adobe fence, only 200 m from the Tambo de Mora main square (Plaza de Armas) where generalized soil liquefaction occurred. 7). Large and abundant cracks were opened north of Tambo de Mora, where also a 3 km long and 0.6 km wide block was displaced a few meters toward the ocean.

In the case of Tambo de Mora (see Fig. 2), the microzonation effect was very clear. General liquefaction occurred there in the loose water-saturated fine sand. There, rows of brick houses settled as much as 0.90 m, and reinforced concrete tilted and sunk a few decimeters. At the Tambo de Mora, Chinchá, Provincial Jail, some of buildings sunk over 0.50 m and fences moved along the wall axis about a meter and forward, some 0.70 m, opening a “new door” from the original one inch (1”) construction joint.

Two and a half blocks from the Tambo de Mora main square (Plaza de Armas) an Evangelical church built with 4.20 m high and long adobe walls, with no reinforcement, nor any confinement at their top edge, did not suffer any damage. Something similar happened with a 3.80 m high adobe fence. The church and the fence were constructed on a hard, dry soil, resulting from a cut made to a small elevation. See Fig. 3
