Seismic Responses of Masonry Structures Strengthened with FRP Laminates: a Shaking-table Study

School of Civil Engineering, Wuhan University, China

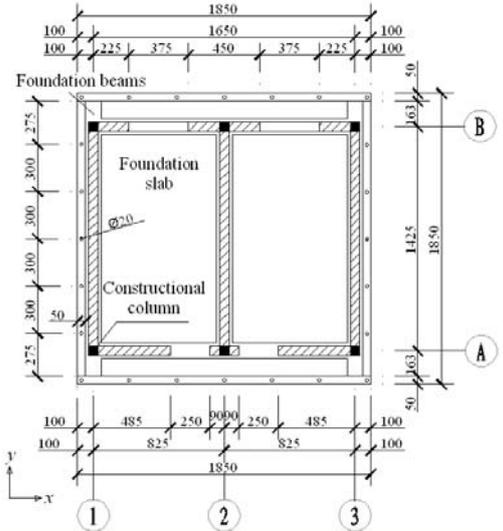
Figure 2.1. Typical configuration of the models (Unit: mm)

Two test models strengthened with CFRP and BFRP laminates respectively were constructed, which was denoted as M1 and M2. The dimensions of the models were 1.850m × 1.425m × 1.500m (length × depth × height). As shown in the Figure 2.1, the walls located at the A-axis and the B-axis had door openings of 250mm × 525mm (width × height) and window openings of 375mm × 455mm (width × height) respectively. The walls were constructed on reinforced concrete foundation beams which were designed for convenience of lifting model. The angle irons were laid around the perimeter of foundation slab to anchor the test models onto the shaking table. The constructional columns with the section size of 60mm × 60mm were deployed at the intersection of the walls and the ring beams with the section size of 60mm × 60mm were located at every storey level. Slabs, constructional columns and ring beams were made by pisolite stone concrete and the steel reinforcements were represented by three types of galvanized iron wires whose areas were determined according to the laws of similitude. During the construction process, masonry walls were built firstly and then the constructional columns were constructed. The typical configuration and the field photo of one model are shown in Figure 2.1 and Figure 2.2 respectively. The measured mechanical properties of the materials used in the models are listed in Table 2.2.

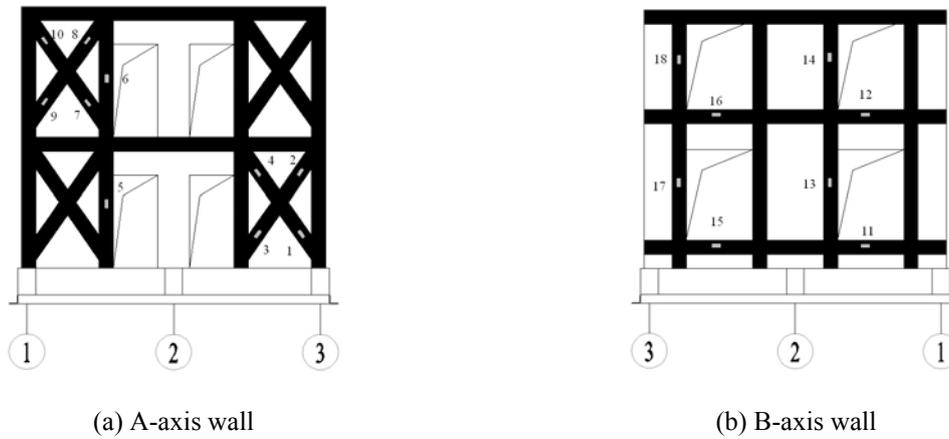
Figure 2.3. Reinforcement scheme

The test models were reinforced along the x direction and therefore the FRP laminates with one layer were pasted outside the A-axis and B-axis walls, as seen in Figure 2.3, where the white rectangular blocks on FRP laminates represented strain gauges. The two models had the same layout of FRP laminates but with different FRP materials. The measured tensile strength and elastic modulus of CFRP laminates were 4363MPa and 241GPa, while BFRP laminates had the tensile strength of 1878MPa and the elastic modulus of 92GPa.

A total of 24 strain gauges were set on each model, among which 18 strain gauges were placed on the FRP laminates (see Figure 2.3 as mentioned above) and others were located on the inner side of walls (see Figure 2.4). As shown in Figure 2.5, five acceleration sensors and five displacement sensors were instrumented at the 1-axis wall and 3-axis wall respectively.

Most previous studies show that for the masonry walls strengthened with FRP laminates, the mechanic behavior of FRP laminates can be equivalent as the tie or strut in the truss model while the former plays the main role. In this section, the strain responses of three strain gauges were analyzed to investigate the mechanical behavior of the FRP laminates, among which point 8 and 11 strain gauges were arranged on FRP laminates (see Figure 2.3.) while point 24 strain gauge was located on the inner side of B-axis wall (see Figure 2.4(b)).

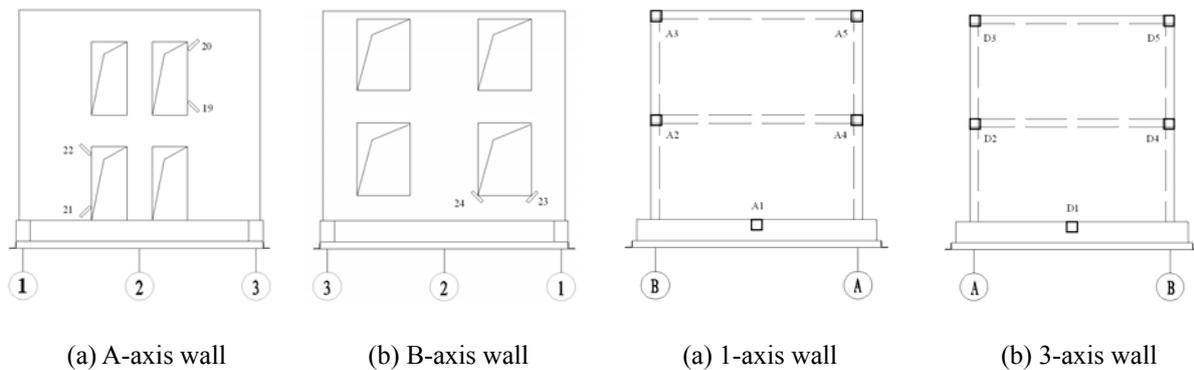
Figure 2.4. Arrangement of strain gauges on the inner side of walls

Figure 2.5. Arrangement of sensors ('A' and 'D' represent acceleration sensors and displacement sensors respectively)

For each loading level, the Acceleration Dynamic Magnifications Factors (ADMF) at each storey level of the two models were computed. In this paper, the ADMF was defined as the ratio of the maximum acceleration response recorded at the storey level to the one at the base acceleration in the x direction. The responses at the storey level were obtained by averaging the recorded responses from the two acceleration sensors mounted the storey, as seen in Figure 2.5(a).

As seen in Fig. 2.5(b), five displacement sensors were instrumented to record the absolute displacement at the story level of each model, among which D1, D2 and D3 were used to obtain the displacement of A-axis wall. The curves of relative displacement along the height for the two models under EL Centro are shown in Fig. 4.6. It could be seen that compared to the M2 model, with the loading level increasing, the increase of the relative displacement of the M1 model was much more obvious. The maximum relative displacements of the two models are 1.47mm and 1.22mm respectively. It could be also noted that during the loading process, the lateral displacement curves of the two models are both shearing type from beginning to end.

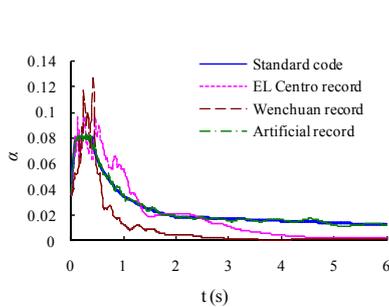
Figure 3.1. Acceleration response spectra

Base excitations were applied to each test model only in the x direction. Three earthquake records were selected including EL Centro record (1940, 180 components), Wenchuan record (2008, EW component) and Artificial record. As seen in Figure 3.1, the acceleration response spectra of the selected records matched well with the target spectrum pertaining to the frequent earthquake of intensity 7 according to the Chinese seismic design code (2010). Considering the requirements of similitude, the acceleration histories were scaled to be 4 times in acceleration axis and 25 percents in

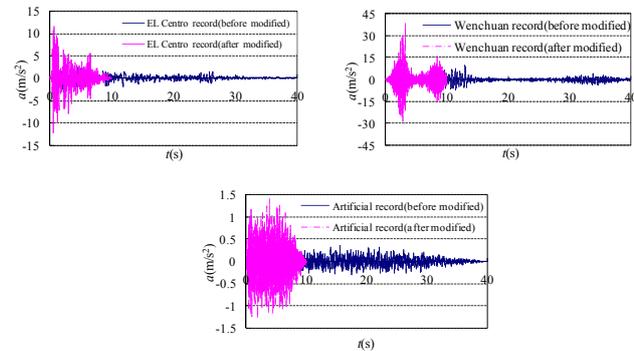
Figure 3.2. Base acceleration histories

time axis, as shown in Figure 3.2.

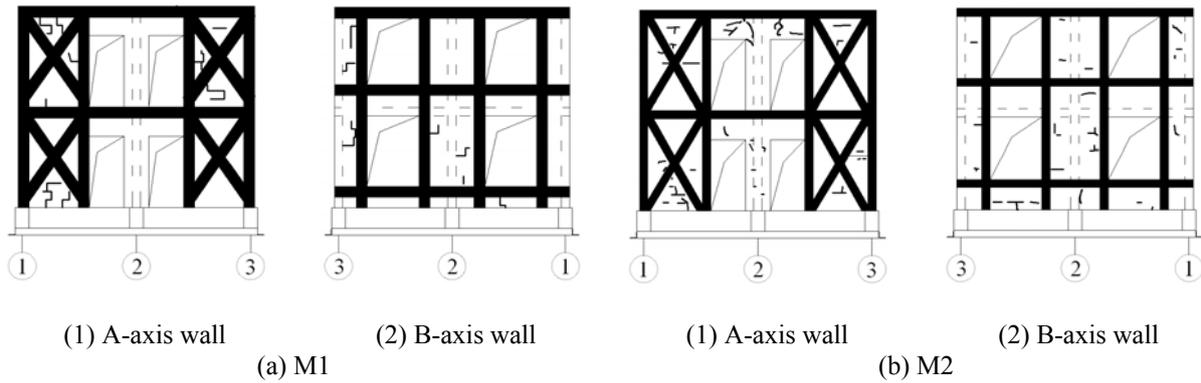
Figure 4.1. Crack patterns of the test models

After the seismic excitations, a number of cracks were observed on both models, as seen in Figure 4.1. It can be noticed as follows: (1) there are no cracks across brick, concrete and FRP laminates, meanwhile the bonding between FRP laminates and blocks did not fail; (2) the shear cracks appearing in x direction were distributed near FRP laminates; (3) the flexural cracks emerged in the y direction

for both models. A continuous horizontal crack was observed on the M2 model, which was not found on the M1 model.

During the first three loading levels, no cracking was observed on both of the models. The natural frequency of the M1 model remained nearly constant before the loading level corresponding to the frequent earthquake of intensity 7 with the peak acceleration of 0.15g, indicating that the M1 model worked in linear elastic condition. After the fourth loading level with the peak acceleration of 0.3g, little cracks were observed. Some vertical cracks also emerged to the left of door openings at the A-axis wall and the left of window openings at the B-axis wall. After the model was subjected to the design earthquake of intensity 7 with the peak acceleration of 0.4g, the existing cracks near the window openings at the B-axis wall extended and appeared to be stepped shape. At this time, its natural frequency dropped about 3%. Subsequently, with loading level increasing, existing cracks developed further along mortar joints and finally extended to foundation beams and ring beams. Under the loading level corresponding to the rare earthquake of intensity 7 with the peak acceleration of 0.9g, the cracks developed rapidly. When the peak acceleration went up to 1.3g, a step-shaped shear crack appeared in the y direction abruptly accompanied with horrible rupture sound. At last, the natural frequency of the M1 model decreased by about 26 per cent compared to the initial condition.

The M2 model remained elastic before the loading level pertaining to the frequency earthquake of intensity 7. When the peak acceleration increased to 0.3g, the horizontal cracks appeared near the left side of X-shaped BFRP laminates, the door openings at the A-axis wall and the window openings at the B-axis wall. A 50mm long horizontal crack emerged at the bottom of the 3-axis wall, and some step-shaped shear cracking appeared at the central region of the 1-axis wall. Under the loading level corresponding to the design earthquake of intensity 7 with the peak acceleration of 0.4g, some new cracks were observed near the left window openings of the B-axis wall and the bottom of the 3-axis wall. At this time the natural frequency decreased by about 5%. After the loading level corresponding to the rare earthquake of intensity 7 with the peak acceleration of 0.9g, more cracks emerged near BFRP laminates at the A-axis and the B-axis walls, the existing horizontal cracks in the y direction walls extended, and the natural frequency of the M2 model reduced about 14%. When the value of peak acceleration went up to 1.3g, the cracks developed more rapidly and the horizontal continuous crack at the 1-axis and 3-axis walls appeared. At ultimate, the natural frequency decreased more than 28 per cent.

To investigate the torsion of the models, the displacement ratio was defined as the ratio of displacement at the two sides of models. According to the definition, the less torsion the model experienced, the value of displacement ratio is closer to 1. Figure 4.7 shows the displacement ratios of the two models under EL Centro record, from which it could be seen that torsion existed in the test models during the whole loading process. In the initial loading phase, the torsion occurred to the same degree in the two models. With the loading level increasing, the torsion effected on the M1 model changed little; however, for the M2 model, the torsion increased dramatically especially for the first storey. Overall, compared to the M2 model, the M1 model experienced less torsion, which can be evidenced by its displacement ratio closer to 1. Torsion mainly resulted from the following three aspects: (1) the geometry of the two models were unsymmetrical with bigger openings at the B-axis wall, leading to the comparatively lower stiffness of the B-axis wall; (2) the reinforcement scheme for the B-axis wall was different from that for the A-axis wall, as seen in Fig. 4.1; (3) the FRP laminate area of the A-axis wall was about 1.5 times that of the B-axis wall.

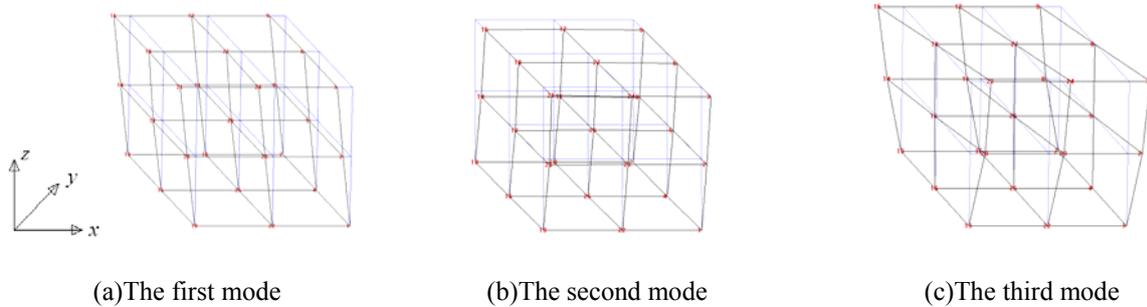
Figure 4.2. The first three mode shapes

During the shaking table tests, dynamic characteristics of both models were also obtained. Before the shaking table test, modal tests were performed using the Hammer Method and the White Noise Method respectively, showing that: (1) using the Hammer Method, the first three model shapes for the M1 and M2 models were the same (see Figure 4.2), in which the first two modes translated in the x and y direction respectively and the third mode rotated along the z axis; the fundamental frequencies and the corresponding damping ratios of the two models were 34.3Hz (2.97%) and 33.5Hz (1.86%) respectively; (2) using the White Noise method, the fundamental frequencies and the corresponding

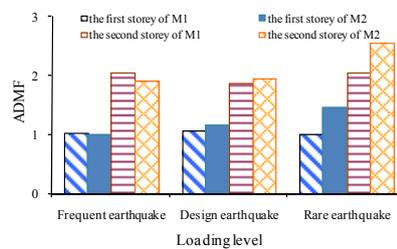
Figure 4.4. ADMF under Wenchuan earthquake record

The variation of ADMFs of the two models under Wenchuan record are illustrated in Fig. 4.4, showing that: (1) under the same loading level, the ADMF of the second storey level was about two times that of the first one; (2) during the lower loading levels, the ADMFs of M1 were relatively higher than that of M2; however, with the loading level increasing, the ADMFs of the M1 model changed little while an obvious increase of ADMFs was observed for the M2 model. Fig. 4.5 shows the ADMFs of two models subjected to the loading level corresponding to the rare earthquake of intensity 7, it can be seen that a larger disparity existed between the ADMFs under different earthquake records for the M2 model compared to the M1 model.
