Seismic Vulnerability Assessment of Existing Public and Private Buildings in Kathmandu

National Society for Earthquake Technology-Nepal (NSET)

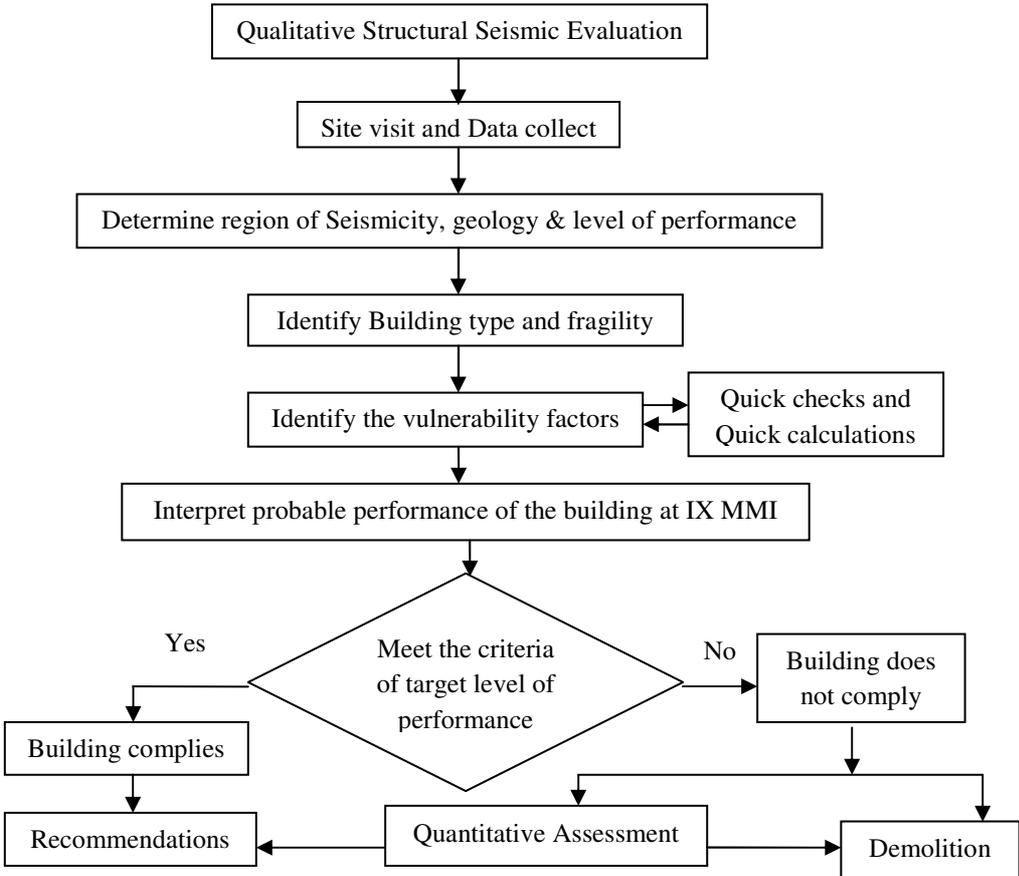
Figure 2.1. Qualitative Seismic evaluation process

The process followed in the qualitative assessment is shown in the Fig. 2.1.

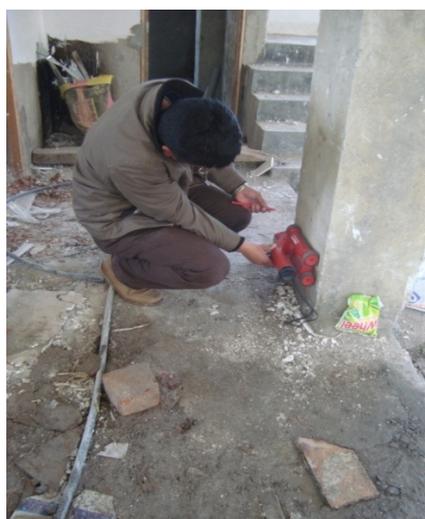
Figure 2.1.1. Use of Rebar Detector for Verification of Reinforcement Details

Architectural and structural drawings were collected from the house owners where possible. In many cases, only the architectural drawings were available as most of the buildings were non-engineered, hence no structural drawings and in many cases, a limited capability for detail assessment. The data was verified from site visits. Interviews with the building owner and designer were conducted wherever possible. Structural drawings were verified through rebar detection tests using bar scanners at the site. Additional missing data and other data such as the condition of the building and the site, building typology, terrain type, pounding effects etc., were also collected.

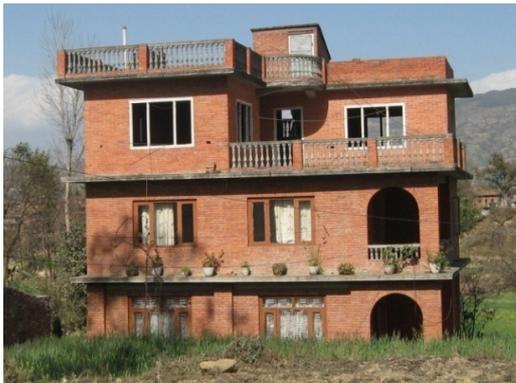
Figure 2.2.1. Load bearing masonry Building (Brick in Cement)

The buildings assessed were of three major types, namely unreinforced load bearing masonry (brick in cement), non engineered reinforced concrete moment resisting frame buildings with masonry infill, and engineered reinforced concrete moment resisting frame buildings with masonry infill, as shown in fig. 2.2.1, 2.2.2, 2.2.3

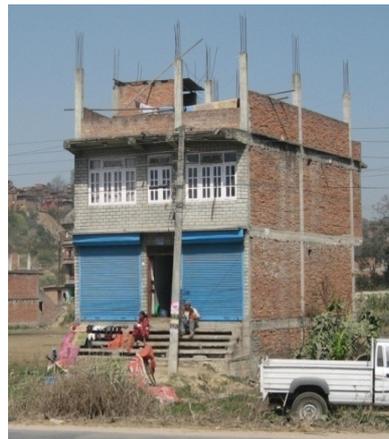
Figure 2.2.2. Non Engineered Reinforced Concrete Moment Resisting Frame Building

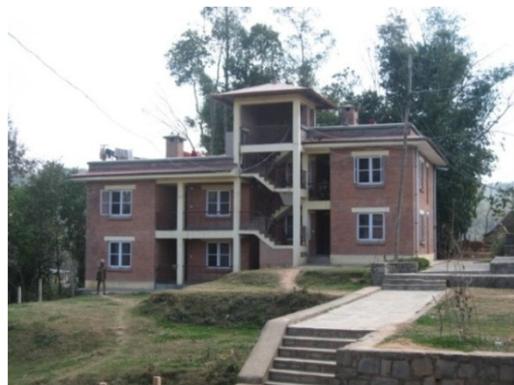
Fig 2.2.3. Engineered Reinforced Concrete Moment Resisting Frame Building

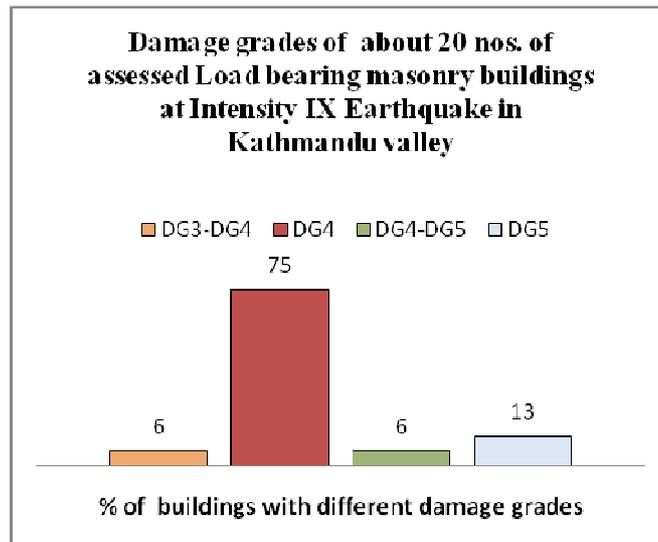
Figure 3.4.1. Damage grades of assessed unreinforced masonry buildings in Kathmandu valley

The expected damage levels in masonry buildings and RC frame moment resisting buildings is shown in fig. 3.4.1 and fig. 3.4.2. respectively.

The possible damage grade at intensity IX earthquake for almost all of the masonry buildings, about 30% of engineered RC moment resisting frame buildings, and about 80% of the non-engineered moment resisting frame buildings assessed in Kathmandu valley, is greater than DG3.

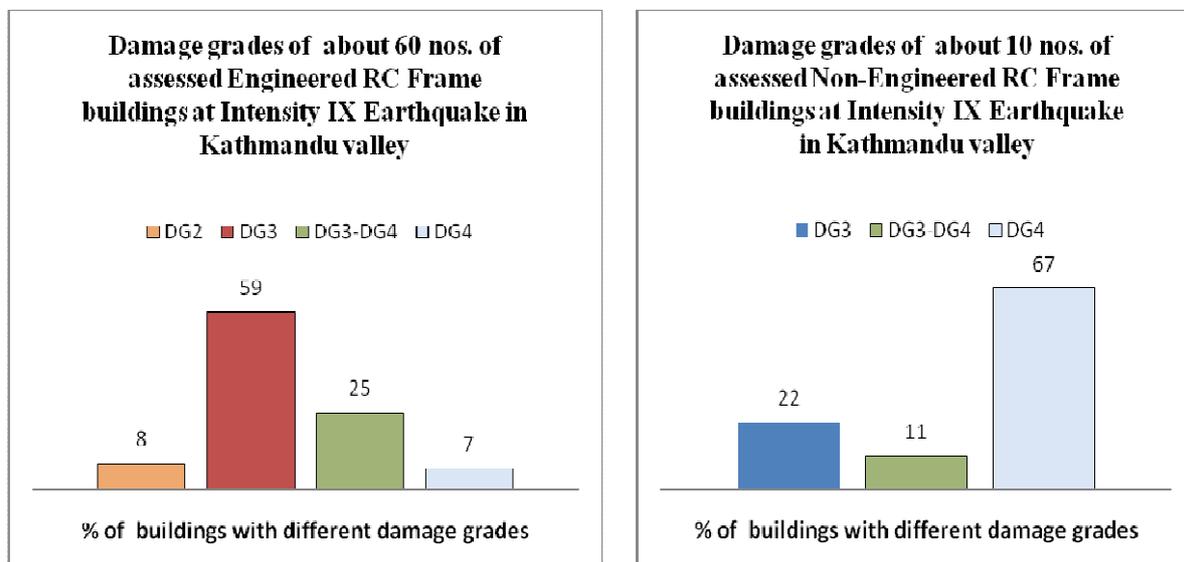
Figure 3.4.2. Damage grades of assessed RC Frame buildings in Kathmandu valley
