Experimental study on seismic behavior of an irregular high-rise building

Tian Chunyu, Liu Junjin, ZhangHong, Cao Jinzhe

China Academy of Building Research, Beijing

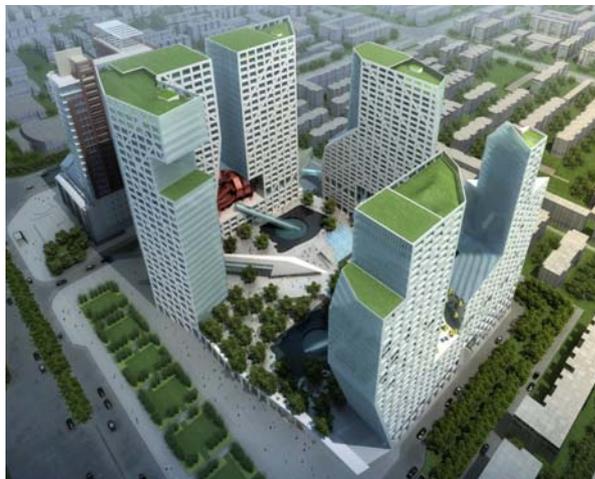
Figure 2.1. Chengdu Raffle Plaza

The Chengdu Raffle Plaza is a high-rise office building, including five towers, as shown in Fig.2.1. Steven Holl Architect was invited to design it. Among these towers, T4 tower with height of 112.4m was designed to have very irregular plan and elevation due to requirements of sunshine duration, ventilation and other reasons, as shown in figure 2.2, which created a challenge for structural engineers to realize the design. There was a big entrance at south elevation and many columns are incontinuous and transferred by beams and braces, as shown in Fig.2.3. The building plan changes form first floor of 'L' shape with dimension of 36mX70m to triangle shape with dimension of 16mX15m by three abrupt reduction of plan, as show in Fig.2.4. Previous seismic hazards and study results both show that this kind of structure was easy to be damaged during earthquake. A reinforced concrete core wall-composite braced frame hybrid structure system was employed.

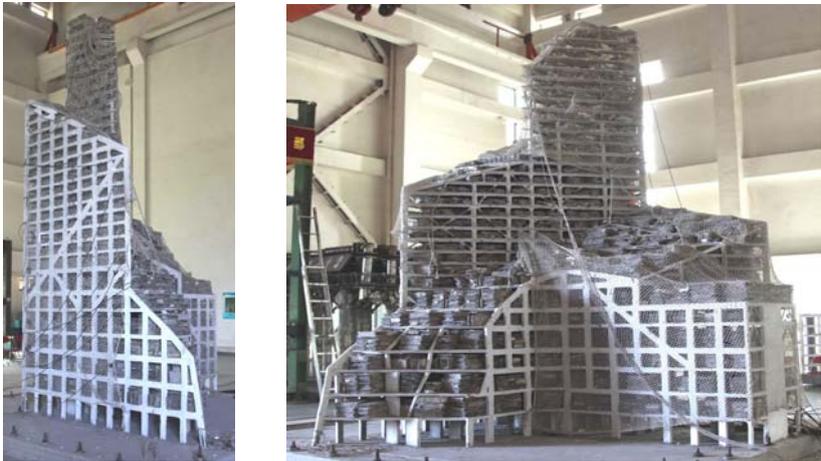
Figure 3.1. Test Model

The construction procedure of test model is similar with real structure. The brass members were installed firstly, secondly the reinforcement in SRC and RC members were installed, and then the floor slab and RC members were cast in site. During construction polyfoam was taken as mould of concrete members. The finished test model is shown in Figure.3.1.

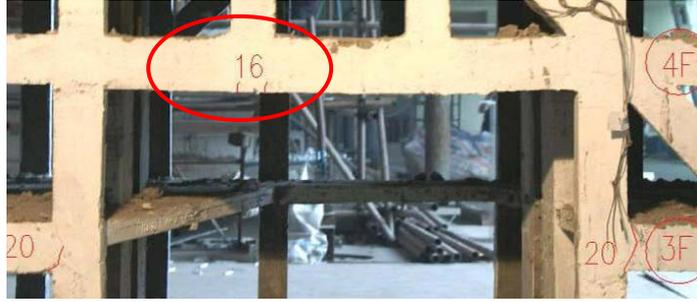
Figure 5.3 Cracks on transfer beam

For large earthquake of intensity 7, existing cracks were extended. Many cracks appeared at the internal corner joint of 7th, 15th and 23rd story where the plan was reduced (figure 5.1). Tension cracks were found on some braces (figure.5.2). The transfer beam and column at entrance of south facade have slight cracks (figure.5.3). An obvious damage was observed at the corner column at 11th story, where a brace was connected to this column (figure.5.4). The littler tower above 23rd story shakes obviously.
