A Low Cost Retrofit Scheme for Masonry-Infilled Non-Ductile Reinforced Concrete Frames

P. Lukkunaprasit & J. Srechai

Center of Excellence in Earthquake Engineering and Vibration, Chulalongkorn University, Bangkok, Thailand

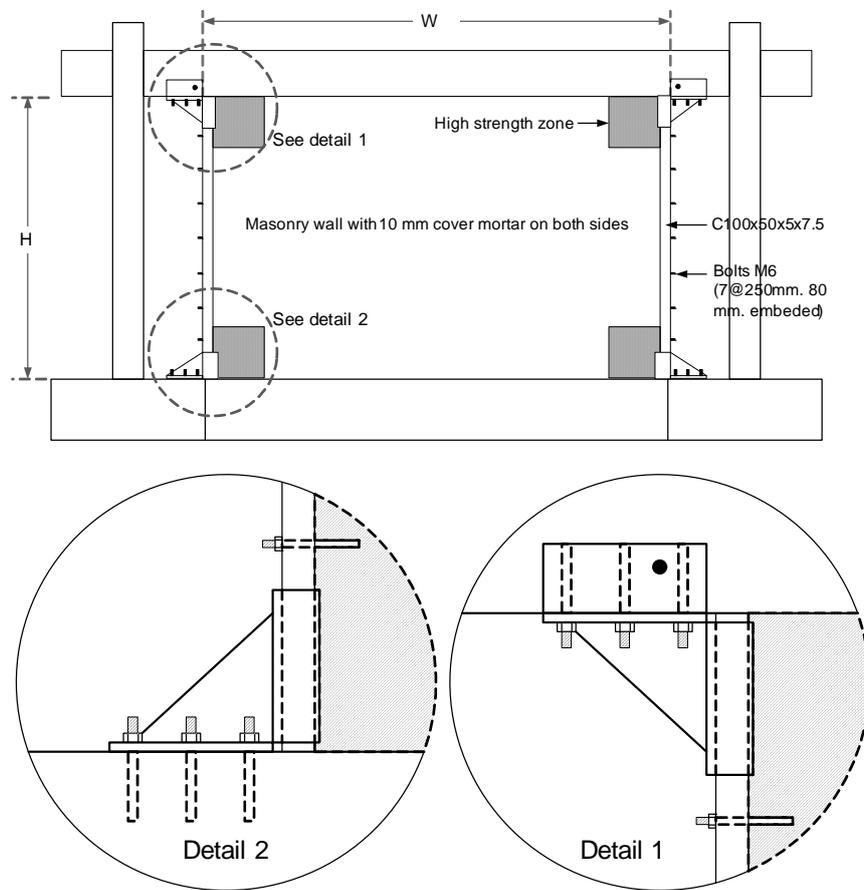
Figure 1. Retrofit scheme of URM infilled RC frames

In order to be able to effectively utilize the masonry walls for seismic resistance, one has to address and minimize the following major problems: shear failure of the (non-ductile) RC columns and beam-column joints; crushing of the corners of the infill and sliding of horizontal bed joints in the infill, including the masonry-beam interfaces. Guided by failure mechanisms observed in the literature, the following measures are adopted for resolving weaknesses in non-ductile infilled URM-RC frames. The retrofit scheme separates the URM panel from the vertical columns by a gap so that the strut force in the masonry panel cannot be transferred directly to them. Steel brackets are provided to transfer the interactive horizontal forces between the RC frame and the masonry panel. The corners of the infill are reinforced with wire meshes and high strength mortar. Furthermore, small vertical steel members are anchored to the vertical boundaries of masonry infill to prevent sliding joint failure of the masonry panel. The proposed scheme is depicted in Fig. 1.

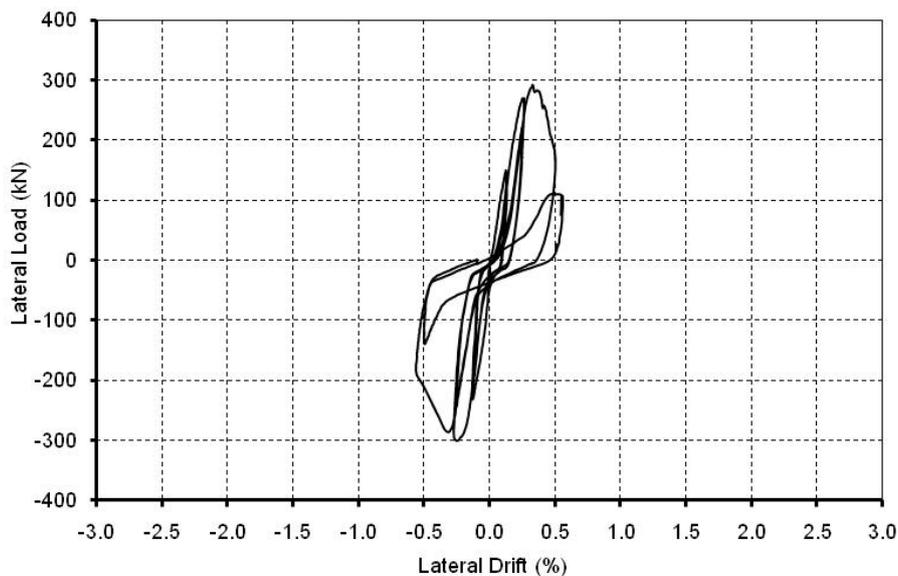
**Figure 2.** Hysteretic loop of specimen MIRCF01

Minute horizontal cracks occurred along the wall-beam and wall-footing interfaces of the control specimen MIRCF01 at 0.125% drift ratio. Impending corner crushing was observed at one corner at 0.25% drift. This frame assembly attained an average peak load of 296 kN at 0.25% drift, after which the capacity suddenly dropped to less than 40% at 0.5% drift (see Fig.2) with the formation of damaging shear cracks in RC columns and beam-column joints and corner crushing of the masonry infill as depicted clearly in Fig. 3. Note that the URM panel was essentially undamaged except for the crushed corners. In fact, the URM panel of this specimen was retained (with part of the panel adjacent to the columns removed) in the retrofitted specimen MIRCF02.

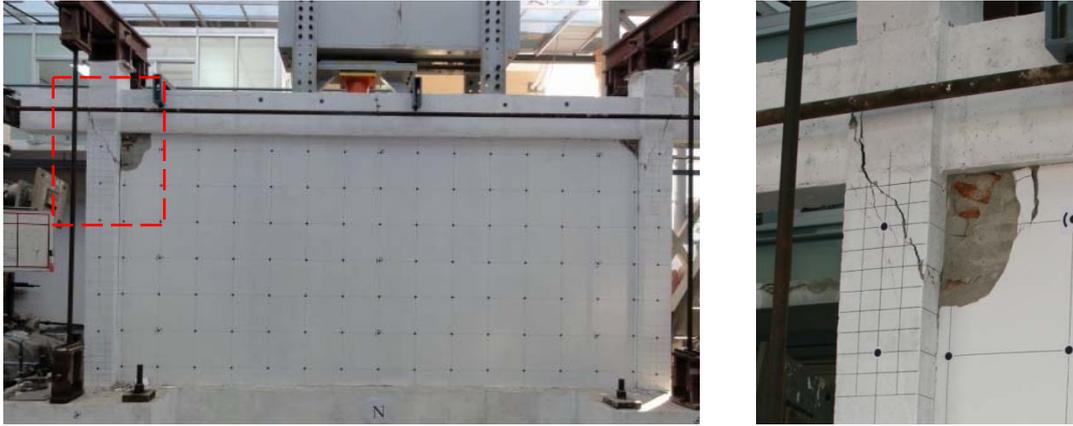
Figure 3. Un-reinforced masonry infilled non-ductile (MIRCFO1) with column shear failure and infill panel corner crushing at 0.50% drift

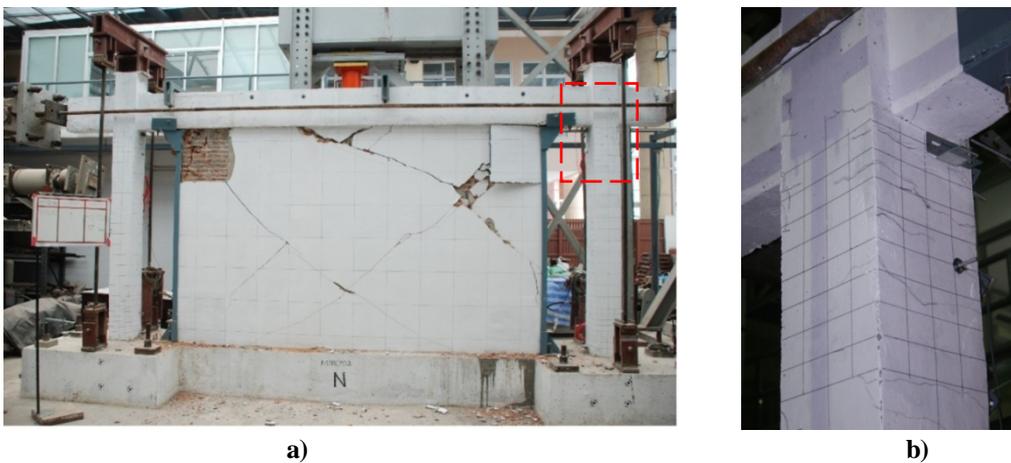
Figure 4. a) Retrofitted masonry-infilled RC frame (MIRCFO2) with the innovative scheme at 2% drift;
b) damage condition in the column

Specimen MIRCFO2, with 10% of the URM panel adjacent to the columns removed reveals a remarkable improvement in performance over the original system. At 0.125% drift, hairline diagonal cracks started to develop in the panel. The compression strut mechanism could be seen clearly at about 0.50% drift. Splitting of the boundary between the strengthened corner and the rest of the panel was observed at 1% drift. This frame assembly attained an average peak load of around 246 kN at 1.25% drift. Corner crushing was severe at 1.75% drift with the wire mesh reinforced plaster spalled off (see Fig. 4). It is interesting to note that removal of 20% of the wall slightly reduces the peak horizontal load capacity by about 17% compared with the original specimen. The drift capacity of 1.5% is achieved at a sustainable lateral load of 80% of the peak capacity with subsequent gradual drop in load capacity (see Fig. 5). The test was terminated at 2.0% story drift for safety reason since significant out-of-plane deformation was observed in the URM panel. Although severe damage occurred in the URM panel at impending failure, mainly flexural-cracks developed in the RC columns without threatening shear cracks or splitting of concrete cover as evident in Fig. 4b.

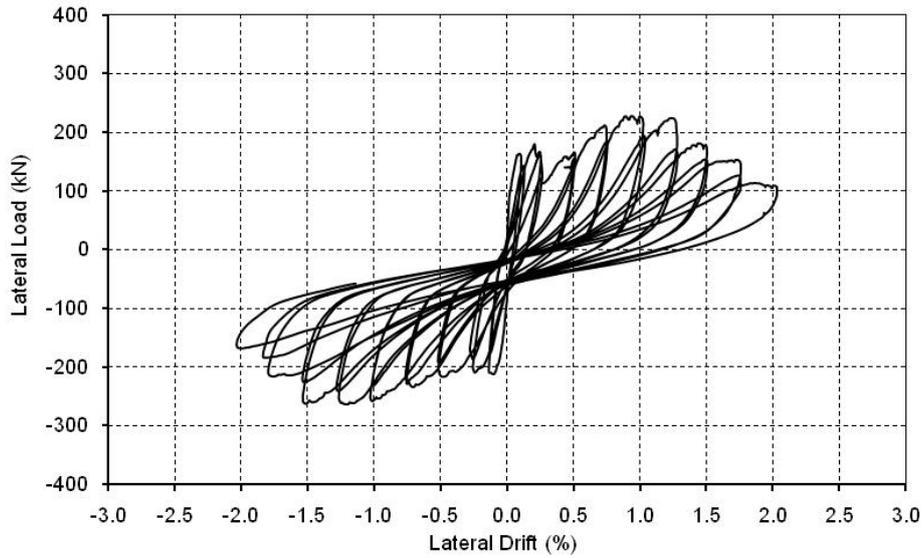
Figure 5. Hysteretic loop of specimen MIRCF02

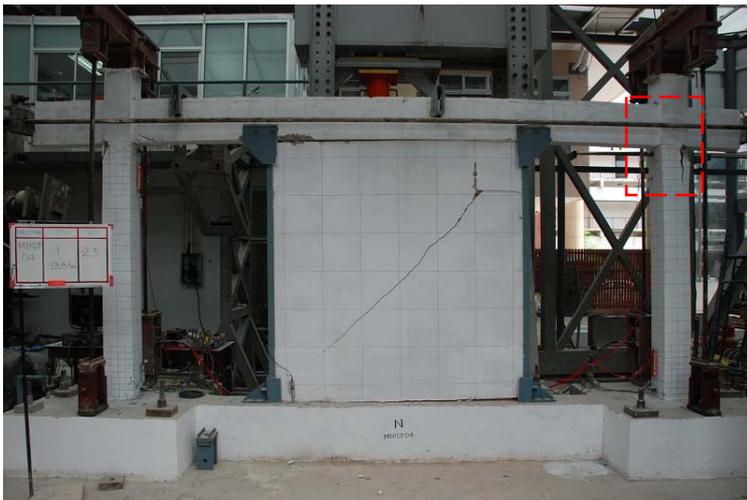
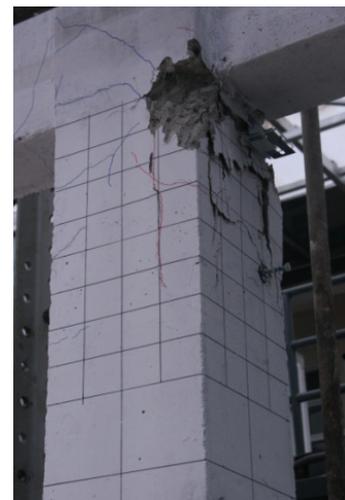
Figure 6. a) Retrofitted masonry-infilled RC frame (MIRCF04) at 2.5% drift;
b) damage condition near the beam-column joint

For specimen MIRCF04 with 25% of the URM panel adjacent to the columns removed resulting in wall aspect ratio of 1.0 (Fig. 6), more flexural and shear cracks developed in RC columns and less diagonal cracks in the masonry infill compared with MIRCF02. The specimen could sustain a drift of 1.75% at 20% drop in lateral load capacity (see Fig. 7). However, significant rocking occurred. At a drift of 2.5%, severe splitting of concrete developed near the beam-column joint, and longitudinal steel bars in the columns buckled. The gap widening at the base of the wall due to rocking was as large as 30 mm.

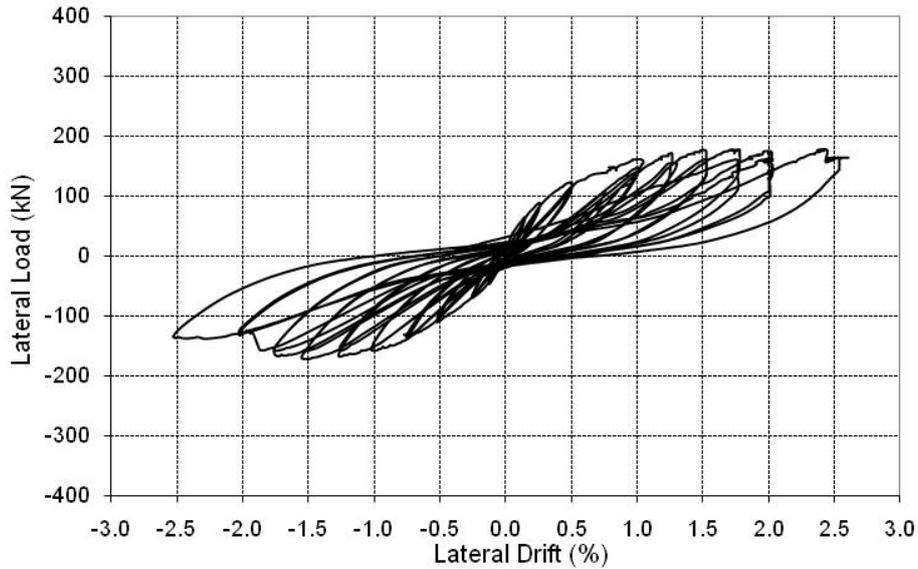
Figure 7. Hysteretic loop of specimen MIRCF04

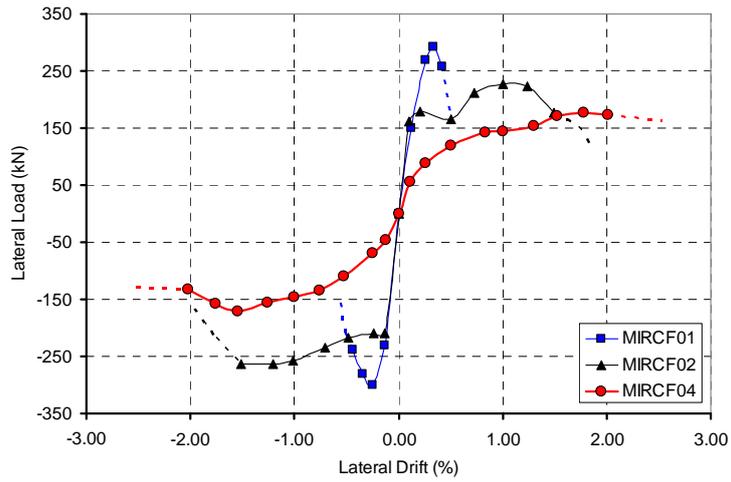
Figure 8. Envelopes of the hysteretic curves

The load displacement envelope curves, the secant stiffness versus drift ratio, and the energy dissipation with increasing loading cycles are depicted in Fig. 8-10, respectively. With reduction in the URM panel cross-sectional area, the peak lateral load decreases approximately in proportion to the area reduction ratio. Interestingly, the secant stiffness of the infilled URM - RC frame assembly MIRCF02 at 0.125% drift is slightly more than 90% of the solid specimen MIRCF01 even though 20% of the URM wall area is removed. The reason is that the former is less damaged at this drift level. However, the secant stiffness of MIRCF04 is reduced significantly, being less than 1/3 of the un-retrofitted specimen. The energy dissipation capacity of MIRCF04 is also much inferior to that of MIRCF02.

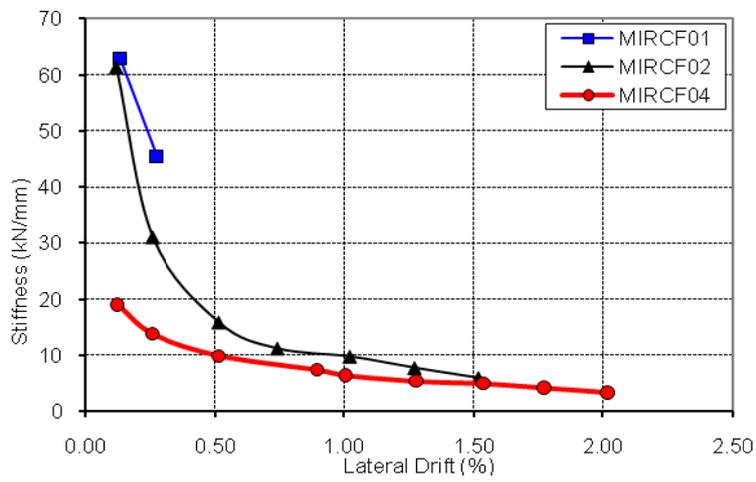
Figure 9. Secant stiffness reduction with lateral drifts

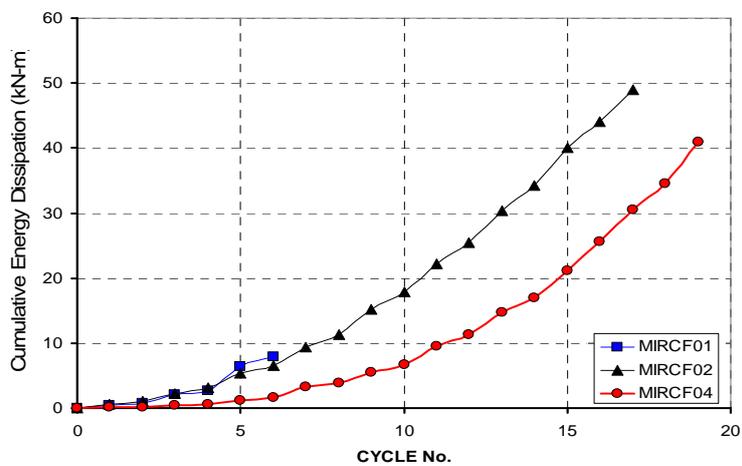
Figure 10. Cumulative energy dissipation with loading cycles
