In-situ test for the shear strength evaluation of masonry: the case of a building hit by L'Aquila earthquake (Italy)

SUMMARY:

Keywords: in-situ shear test, masonry, in-plane behaviour, strength parameters

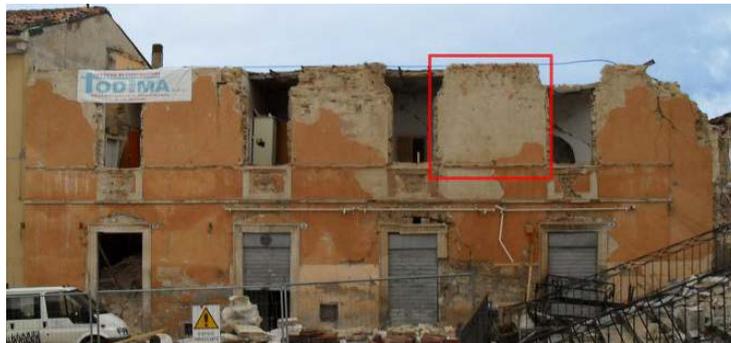
Figure 1.1 View of the selected building and identification of masonry panel subjected to in-plane shear test.

To this aim, a building in the historical centre of L'Aquila, which has to be demolished except for the ground floor, was chosen as able to execute the in-situ destructive test (Fig. 1.1). This choice has been determined by considering different aspects like as: safety of workers; accessibility; representativeness of masonry for typical historical buildings in the Abruzzo region. Different panels have been selected to perform tests addressed to analyse both the in-plane and out-of-plane response of masonry. This paper focuses only on the in-plane mechanical characterization of masonry; the results of the out-of-plane tests are described in Borri et al. (2012).

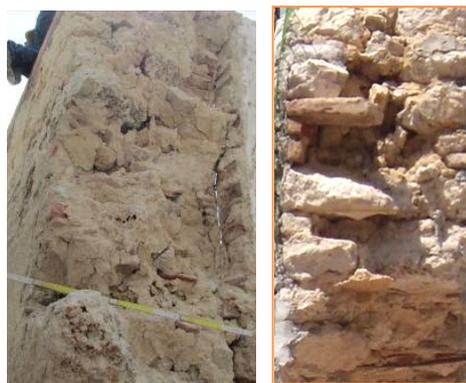
Figure 1.2 Masonry cross-sections in the examined building.

In particular, a panel has been identified to perform an in-situ shear test. It is characterized by a rubble masonry, built with calcareous stones (medium size and rounded) and air lime mortar (mixed with a significant earthy component). The mortar joints are quite thick. The cross section is composed by two leaves plus some smaller stones and mortar infill, without a inner core. The two external leaves are not connected through systematic stone headers (named *diatoni* in Italian), which act as transversal shear keys; however, the random presence of some stones a little bit bigger than others seems to provide a not so negligible cross section connection. These characteristic are quite common in masonry types of Abruzzo Region; Fig. 1.2 shows two cross-sections of the examined building.

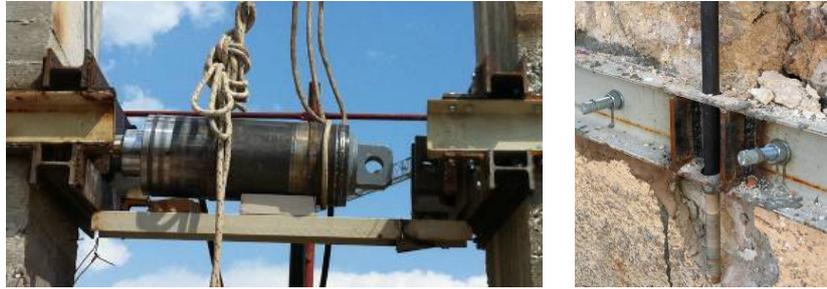
Figure 2.2 On the left, system of the actuator's connection; on the right, connection of the steel pre-stressed bars to the UPN steel profile.

- an horizontal actuator of 500 kN, in order to apply the alternated loading conditions to the panel which is free to roll on the top. A specific system made of HE steel beams has ensured the actuator’s connection to the panel while the loads have been applied to the sample through a steel beam (see Fig. 2.2);
