## INVESTIGATION OF LIQUEFIED SITE OF CHIGU, TAINAN, TAIWAN

### SUMMARY

The purpose of this paper is to present the geotechnical investigation results of a case of liquefaction site during earthquake. The site is located at Chigu, Tainan, Taiwan. The earthquake is scaled as Richter Magnitude of 5.9 and occurred on March 12, 1991. Many areas of free field were liquefied but caused no much damage during the earthquake. However, a serious damage happen at harbor structure induced by liquefaction. The paper presents the case of this earthquake with the view point of geotechnical engineering. The main focus in this paper is on the reasons of why the soil liquefied during this earthquake. A total of five boreholes were drilled to investigate the soil properties of the liquefied area. Both the dynamic triaxial test and resonant column test were performed with undisturbed samples in the laboratory while the in-situ seismic downhole tests were performed in the field. The soil profiles show that both SPT-N value and shear wave velocity is low at shallow depth. The ground water level is high (less then 0.5 m below ground surface) in the coastal area. The results of liquefaction potential an

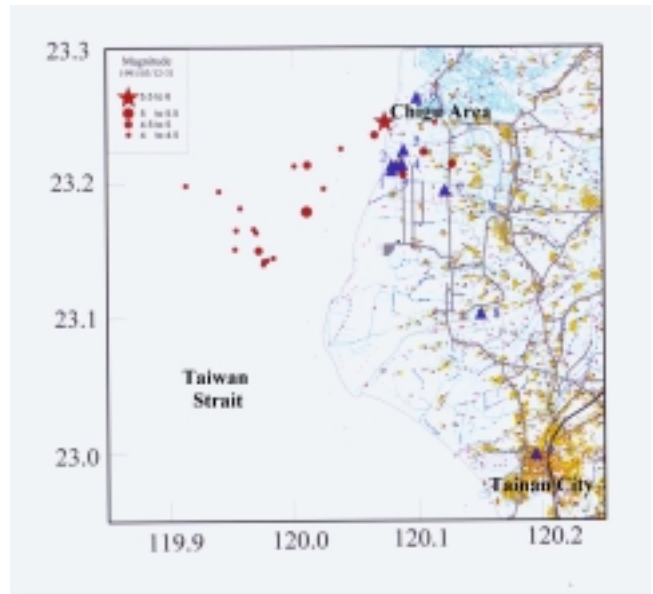
**Fig. 2 Seismic intensities in the Chigu area**

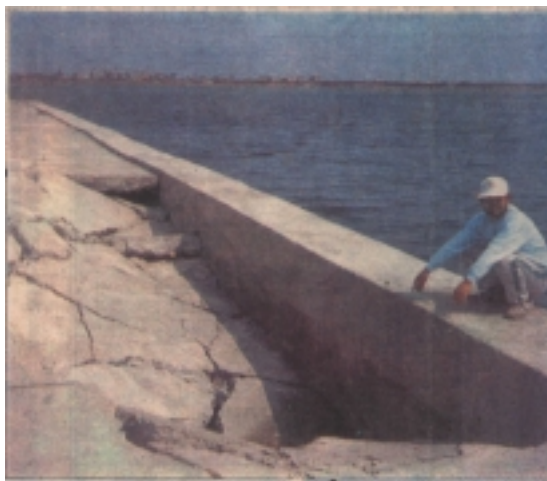
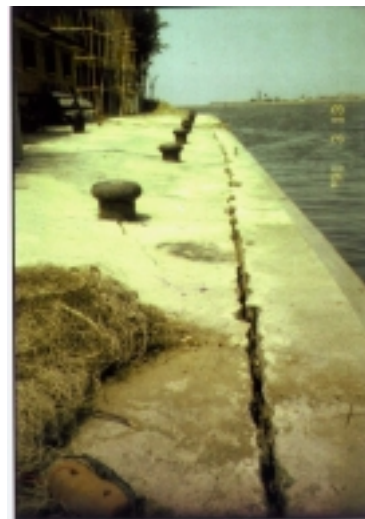
There are two fishing harbours in the Chigu area. They are Masago harbour and Chinshan harbour. The earthquake caused considerable damage to the existing two harbours. Part of ground surface of levee area was collapsed due to underground soil liquefied. As shown in Figure 4(a), soils flowed out during soil liquefaction such that the concrete slab collapse due to the loss of support of soils in the Chinshan harbour area. Also, as shown in Figure 4(b), the levee of Masago harbour was subjected to about 5 to 200 mm wide crackings with 20mm to 250mm settlements.

**Fig. 4 Damage in Masago harbour**

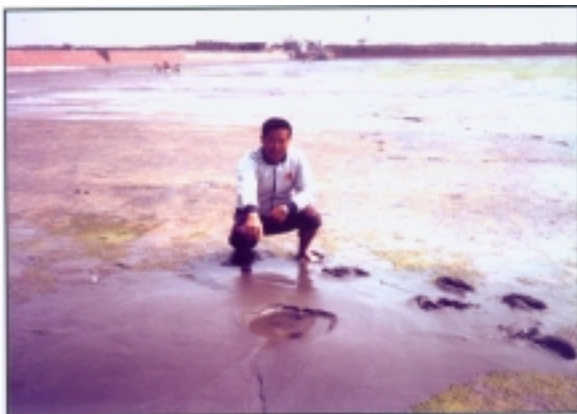
Sand boils was observed at a number of places in the Chigu area, especially in free field. As shown in Figure 3, the sand boils occurred in a big dried fishing pool. Actually, there are many sand boil holes in the same pool. Many sand boils holes were also observed under water in the salt field. The foundation soils of both fishing pool and salts field are involved very loose saturated sandy soils.

**Fig. 3 Sand boils in dried fishing pool road**

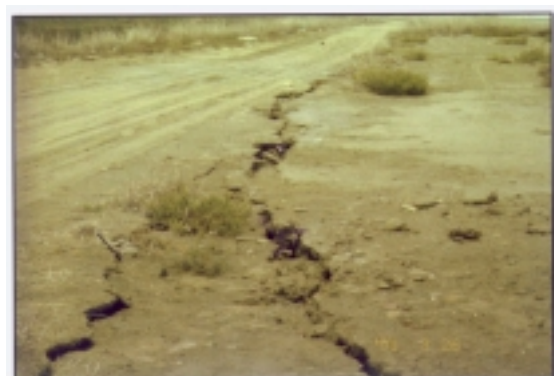
Many highway embankments in the Chigu area were seen with slope failure. The failure frequently occurred at junctions between bridge and road. The material used for the embankments is mostly alluvial sandy soils. The foundation soils are always saturated at the junction of bridge. The slope failure may mainly caused by soil liquefaction of foundation soils of the embankment during the earthquake. In addition to slope failure of embankments, some places of country roads were seriously damage with cracking due to differential settlements, as shown in Figure 5.

**Fig. 5 Cracks damage on country road**

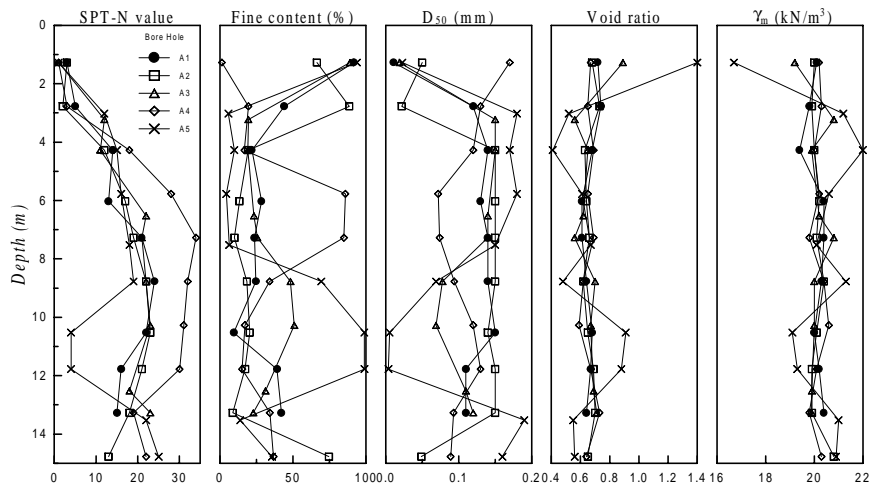
**Fig. 6(b) Soil properties of the five boreholes**

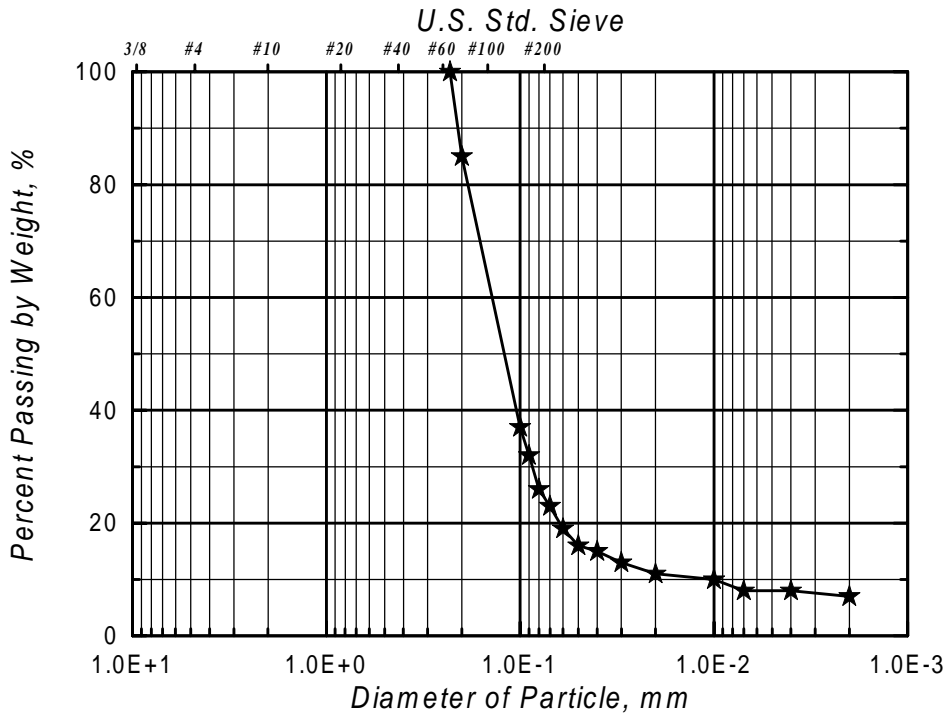
The specimen taken from split-spoon sampler is used to perform soil physical property tests. The results show that the soils with an average specific gravity of 2.69. The void ratio is ranged from 0.52 to 0.73. The moist unit weight is about  $19.7 \text{ kN/m}^3$ . The mean diameter ( $D_{50}$ ) is ranged from 0.11mm to 0.18mm. Fines contents of the soil are ranged from 20% to 40%. Most of sandy soils are contained a significant fine materials. The soil profiles for the five boreholes, which are named as A1 to A5, are shown in Figure 6. As shown in the profile, the soil deposits are mainly consists of the soil classifies as SM and ML, and with some relatively thin layers of containing a significant fine materials, clay (CL). The boring results show that the soil profile is mainly formed by gray silty sand (SM) and silty clay (ML) with a relatively thin layer of clayey soil (CL) at near the top of soil deposit. The ground water level is located less than 0.5 meter. The SPT-N value is varried from 16 to more than 30 counts at the depth greater than 10 meters. However, the SPT-N value is less than 5 counts for the depth less than 3.5 meters. The typical grain size distribution curve is shown in Figure 7.

**Fig. 7 Typical grain size distribution curve in Chigu soils**

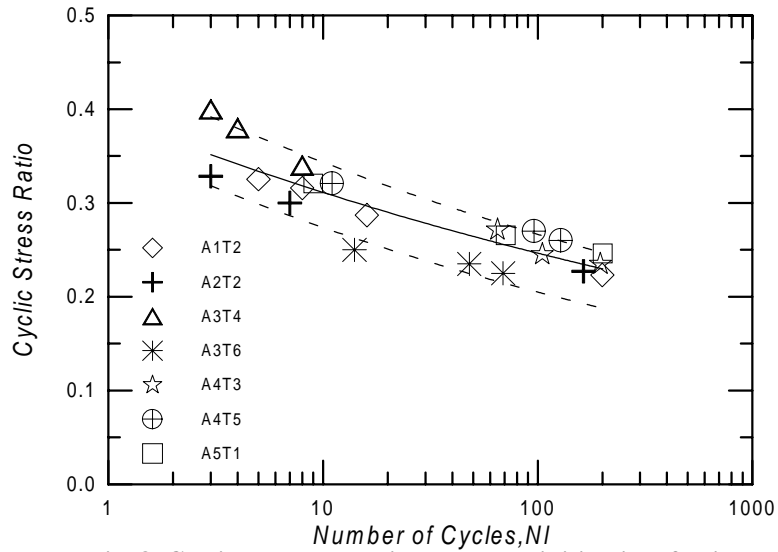
The results of cyclic triaxial undrained compression tests on specimens taken from five boreholes were stated in Figure 8. The test results show that the relationship of cyclic stress ratio via the numbers of cyclic cycles to cause initial liquefaction for each specimens. It is indicated that the increase of the numbers of cyclic cycles to cause the increase of the pore water pressure, if the pore water pressure rise up to the confining pressure indicating that the effective stress momentarily dropped to zero. Based on Seed [5], this constitutes the initial liquefaction.

**Fig. 8** Cyclic stresses required to cause initial liquefaction
