A STUDY ON EARTHQUAKE DAMAGES OF TIMBER HOUSING AND SIMULATION BY THE THREE DIMENSIONAL VIBRATION ANALYSIS

Katushiko KOHARA¹, Yoichiro OHKI² And Kenji MIYAZAWA³

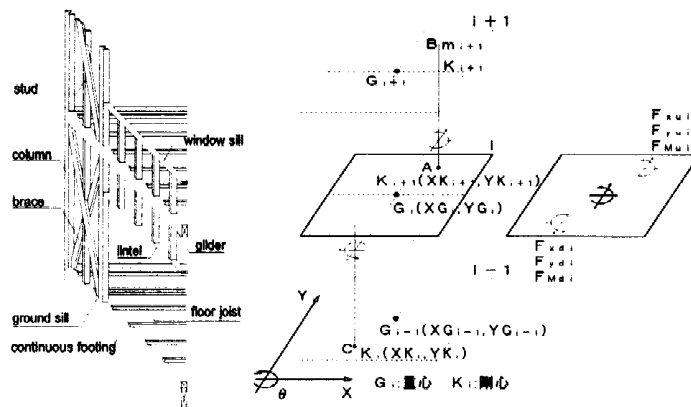
Fig.1 Japanese frame construction

Fig.1 shows ordinary Japanese wooden dwelling frame constructions. Wooden braces and wall constructed by wood lath, mortar exterior (mortar are excluded as structural element) and gypsum board are structural elements for horizontal forces. Recently, the siding are ordinarily used on exterior wall.

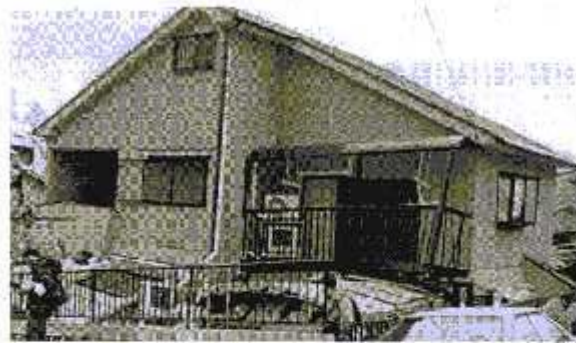
Photo.1 Collapsed 2 story house in Kobe

Grate many severe damaged houses were investigated. The two types of them were used in this study for to discover the cause of collapse. One of them was suffered from the 1995 Hyogo-Ken Nanbu Earthquake within two month after the complete building. The drawing was kept and damage was clearly recorded (see Photo.1). Another damaged house was built in 1957 (extension work in 1968). This house has the eccentricity factor of 0.35 and has insufficient wall length (left side in Fig.8). These two houses were conducted the response analysis by three dimensional linear analysis.

The collapsed wooden house (shown in Photo. 1) was suffered in Kobe⁽¹⁾, has floor plan of Fig.4 and the structural model for response analysis shows Photo.2. The model is quasi-three dimensional one shown in Fig.2. The natural periods and vibration modes are shown in Fig.5. The blank circle is the center of gravity and the black circle is the center of rigidity of each story. Results of response analysis with 3-dimensional input seismic wave recorded in Kobe are shown in Fig.6. Fig.7 shows the orbits of four corner points on the roof. Photo.2 is one scene of televised computer graphics on Japan Broadcasting Corporation, is at maximum response displacement and is shown with magnification of five times.

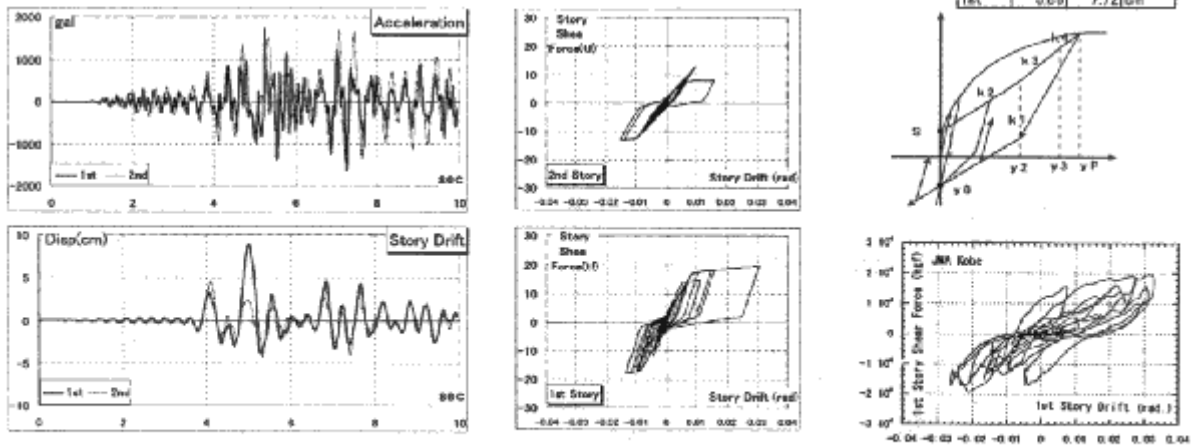
Fig.19 Results of degrading tri-linear model (Kobe N-S for input in E-W direction of the specimen)

2nd Story			
k1	7020	k2	4000
k3	300	Y1	0.5
Y2	1.5	Y3	1.725
Weight	9.2t		
1st Story			
k1	12270	k2	7000
k3	800	Y1	0.5
Y2	1.5	Y3	1.725
Weight	9.1t		
Natural Period			
Primary	0.354 sec		
Secondary	0.146 sec

Analysis	Experiment
Maximum Story Shear Force		
2nd	13.18	15t
1st	19.53	20t
Maximum Story Drift		
2nd	4.63	3.54 cm
1st	8.88	7.72 cm

- 4) Degrading tri-linear model could fairly simulate the story shear force - story drift relationship of shaking table test.
- 5) To grasp the properties of each stress - displacement relationship of elements and parts, three dimensional model with each element of degrading tri-linear are desired.

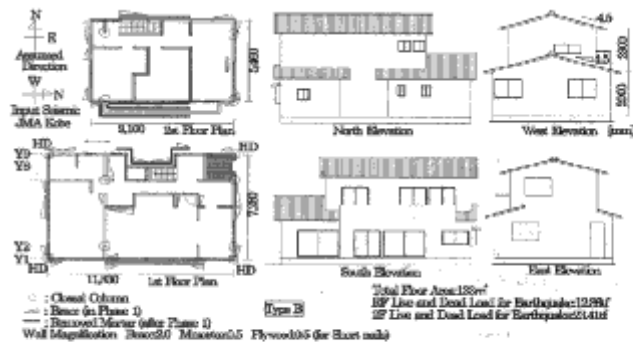
Fig.21 Floor plan of type B for shaking table test

The type B of Fig.21 and Photo.7 is one of six full scale 2 story wooden houses that shaking table tests were executed in 1995⁽²⁻⁴⁾. The total floor area of type B is about 133 m². The external facing is a mortar finishing. After the first Phase test, mortar and plaster board was removed (Phase 2) as Fig.21. Three components of JMA Kobe 1995 wave were inputted to the shaking table as Fig.21, but in response analysis, only one component of N-S was inputted in the longitudinal direction. Fig.23 shows the results of experiments and analysis. For the results of brace, results of experiment of the Phase 2 is added. The response acceleration and story drift of the analysis are close value of the experiment, though the axial force of brace and column are not close values. The share of story shearing force by braces was 7 % in experiment of Phase 1 and 12 % in Phase 2. The share of story shear by non-structural elements was extremely large. Therefore, investigation on non-structural elements is very important.

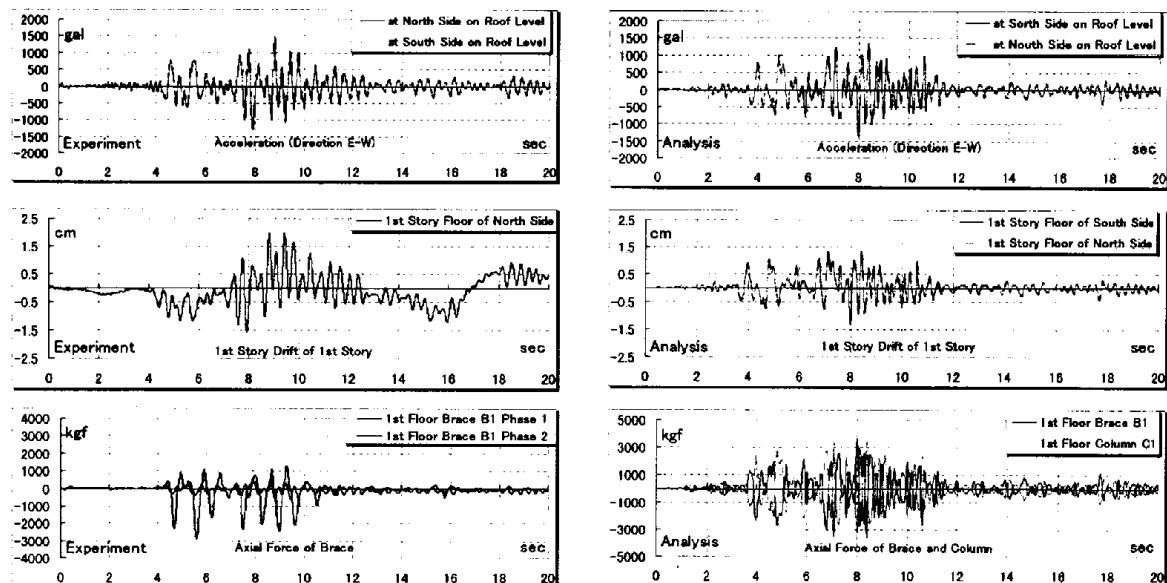
Fig.23 Results of response analysis and shaking table test (acceleration, story drift, axial force)

unit	south side		northside		
		analysis	experiment	analysis	experiment	
acceleration	max	gal	1393	1513	1029	1075
	min	gal	-1351	-1308	-993	-1083
story drift	max	cm	1.34	3.40	0.99	1.38
	min	cm	-1.32	-2.02	-1.03	-2.41
axial force			brace B1		column C1	
	max	kgf	3589	419	3678	341
	min	kgf	-3628	-717	-3748	-554
