# Recovering strong ground motion from performances of simple structures

## A contribution to microzonation

Carlos S.Oliveira

National Laboratory for Civil Engineering, LNEC, Lisbon, Portugal

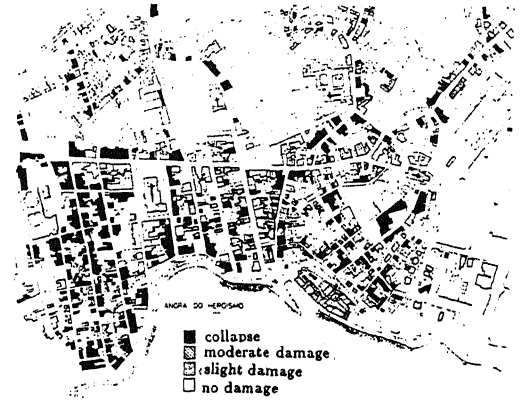
Figure 4 - Distribution of damage in Angra do Heroísmo (after Carta de Danos, 1992).

Another piece of great information, certainly when analysing microzoning of a town, is the damage distribution in the town of Angra do Heroísmo, Fig. 4. This damage was assessed building by building (Carta de Danos, 1992), classifying the damage into 4 categories: no damage; slight damage; moderate damage; collapse. An observation of this map, indicates clearly that there are zones more strongly shaken, independently of the type of construction at stake, streets with heavier damage or even facades more prone to the shaking. This would certainly depend on the direction of more intense motion and on how buildings organized in blocks resist to that motion.

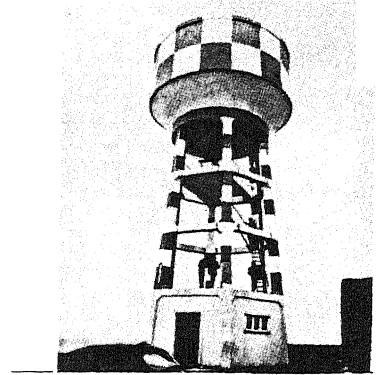
Figure 8 - General view of the elevated water tower in Lajes.

The Elevated water tower in Lajes, Fig. 8, is a Hintz structure with a  $250 \text{ m}^3$  tank. At the time of the earthquake the tank was approximately at 50% full capacity. It suffered damage in the beams showing narrow cracks and spalling slight of the finishing mortar, and no damage in the columns. Dynamic analysis performed in this structure, considering the effect of water sloshing has led to an upper  $PGA_{max} = 30 \text{ cm/s}^2$  and a lower bound  $PGA_{min} = 15 \text{ cm/s}^2$ . These values correspond to the limit states of damage in the columns and beams, respectively.

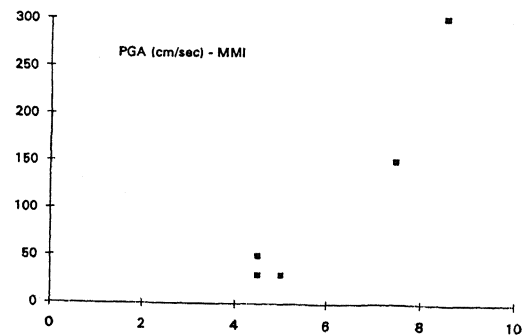
Figure 10 - Correlation between MMI and estimated PGA.

- Upper and lower bounds are quite stable.
- Values obtained agree in general with Mercalli Modified intensity assignments.
- In Angra do Heroísmo at 2 sites separated by approximately 2 km, (Monte Brasil and Hospital) the variation in PGA is 1:5. These values, which are in accordance with descriptions by witnesses, show that there are great differences in ground motion intensities probably due to soil and topographic characteristics. Further study at these sites should clarify these observations.
- In Praia da Vitória, the two sites under analysis (signal-house and elevated water tank) led to the same PGA bounds.
- In Topo the acceleration was by far the largest observed in this study.
- Correlation of PGA with assigned intensities, shown in Fig. 10, is quite good.
