ANALYSIS OF DAMAGE OF STEEL REINFORCED CONCRETE BUILDING FRAMES BY 1995 HYOGOKEN-NANBU EARTHQUAKE

SUMMARY

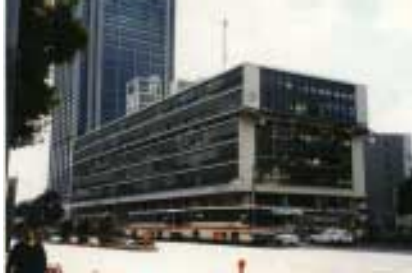
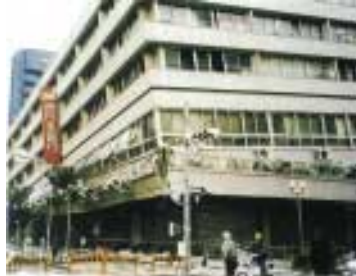
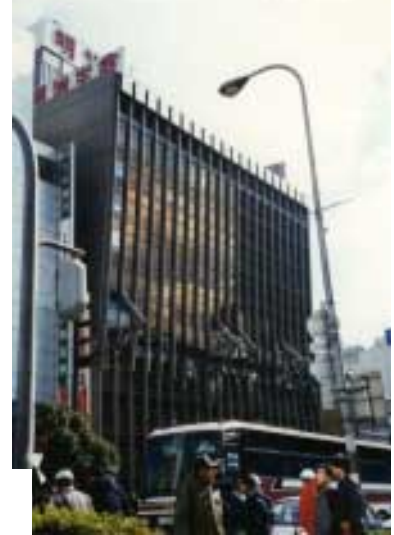
Thirty-two of SRC uildings collapsed by the story failure. All of them were constructed before 1972 and composed of the open web type SRC. Twenty-seven buildings collapsed by the story failure at an upper floor level (see Photo. 1) and five buildings collapsed at the first story. At the failure story, SRC columns collapsed brittly in shear (see Photo. 2) and concrete in RC shear walls crushed to out of plane. Collapse by the story failure at an upper floor level was characterized of the damage caused by this earthquake. Several factors potentially responsible for these failures can be considered as follows:

(a) Photo 1 Collapse Buildings with Story Failure at an Upper Floor Level b)

- (a) The design earthquake force distribution over the height used in the old design codes is different from the one used now, and the proportion of design story shear force is smaller at the mid-stories in the old codes. Then the ultimate strength of the collapsed story was insufficient to sustain the lateral load induced by the earthquake. And also the ductility of the columns and the shear walls was insufficient.
- (b) Damage concentrated at the collapsed story where the lateral strength and/or stiffness changes abruptly between adjacent stories. And eccentricities of stiffness and mass caused torsional failure.
- (c) Large vertical accelerations generated large compressive and tensile axial forces in the columns, causing reductions in ductility and shear strength, respectively.

(d) Joint of encased steel was located in the collapsed stories and the columns collapsed brittly in shear at this story.

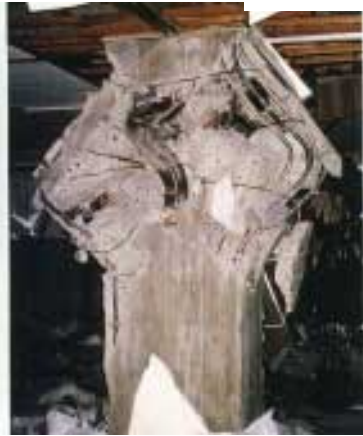
Photo 2 Collapsed Column in Shear

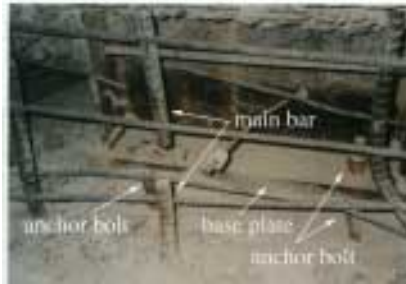
Photo 3 Fracturing of Anchor Bolt at Column Base (after chipping concrete)

(a) About 40 buildings were damaged at the column base. There were many buildings in which the steel base plate was anchored at the ground floor level using a detail known as “non-embedment type steel base”. Severe damage was observed in buildings that used this base plate detail. Concrete crushed at the

column base and anchor bolts were pulled out (see Photo. 3) .

Reasons for the damage from (a) to (d) were considered to be the large compressive and tensile axial forces in the columns generated by the large vertical accelerations of this earthquake and the existence of multi-story shear walls. A large number of columns or beams with flexural cracks, shear cracks, and shear bond cracks were observed, but severe damage has not been reported.

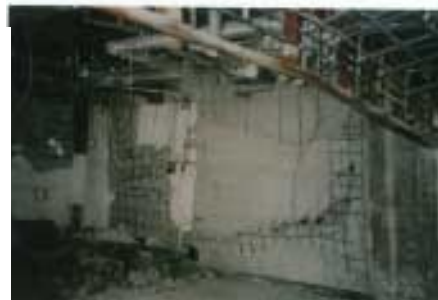
Photo 6 Damage of RC Shear Wall

- (b) About 10 buildings were damaged of fracturing of encased steel flange plate (see Photo. 4).
- (c) About 10 buildings were damaged of fracturing of steel splice plate at the joints of columns or beams (see Photo. 5).
- (d) About 10 buildings were damaged at beam-column connections where diagonal shear cracks and spalling of cover concrete were observed (see Photo. 6), but severe damage at beam-column connections has not been reported.
- (e) About 40 buildings were damaged of the shear RC walls in shear; the surrounding SRC frame was strong enough to carry the forces delivered from the concrete diagonal struts, so sliding failure of the wall took place with crushing of the concrete strut to out of plane (see Photo. 7).

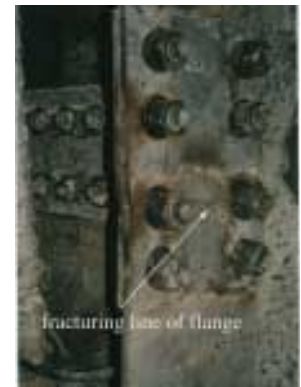
Photo 7 Fracturing of Splice Plate at Column Joint (after chipping concrete)

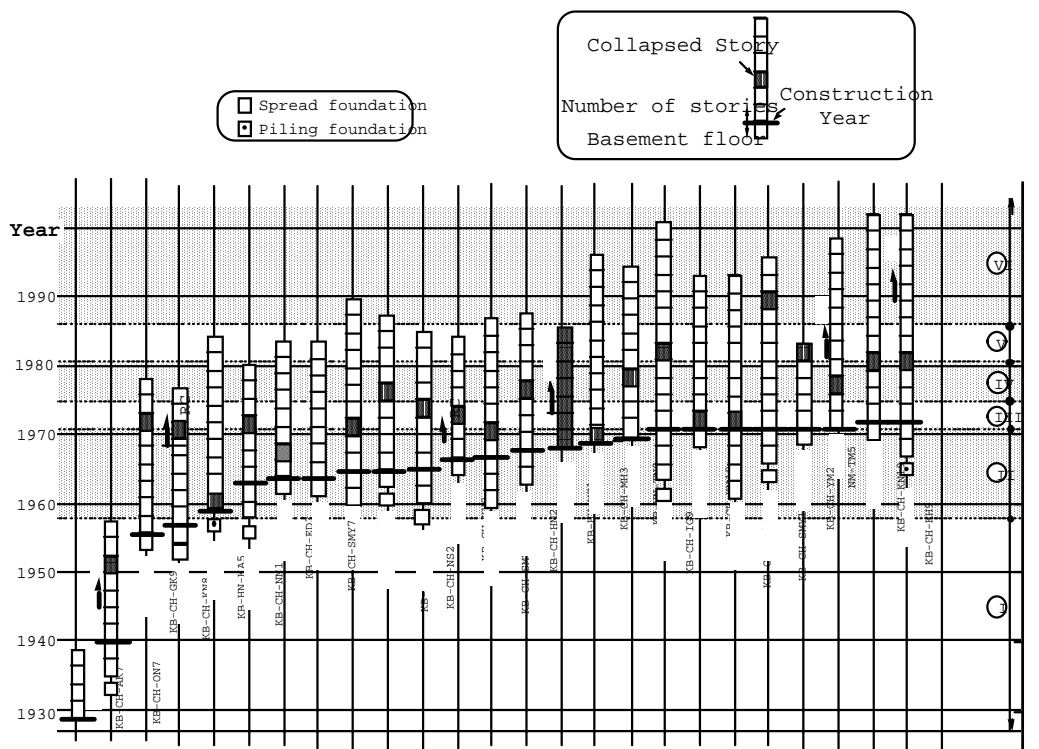
Fig. 9 Building Story and Construction Years of Collapsed Buildings

Figure 8 shows the distribution of damage classified by building story and construction years. From these figures, it was clear that almost all of the buildings collapsed or sustained severe damage had over seven to twelve stories, and the buildings under six stories tended to be able to avoid severe damage, regardless of construction years of buildings. The buildings over fifteen stories did not sustain severer damage. Figure 9 shows the building story and construction years of collapsed buildings.
