SEISMIC PERFORMANCE OF FLAT-SLAB SHEAR REINFORCEMENT

Ian N ROBERTSON¹, Tadashi KAWAI², James LEE³ And Brian ENOMOTO⁴

The intent of this research program was to study the response of slab-column connections containing various types of shear reinforcement when subjected to combined gravity and cyclic lateral loading. The four test specimens were a half-scale representation of interior slab-column connections in a prototype flat plate building. All test specimens were identical except for the type of shear reinforcement used in the slab. The control specimen had no shear reinforcement, while the other specimens had closed hoop stirrups (open hoop with closure clip), single leg stirrups, and headed studs as shear reinforcement.

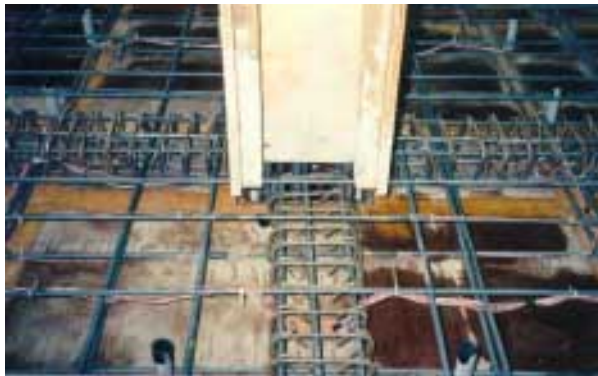
Figure 3: Closed hoop stirrups – Spec. 2CS

The slab reinforcement in specimens 2CS and 4HS is shown in Figures 3 and 4 respectively.

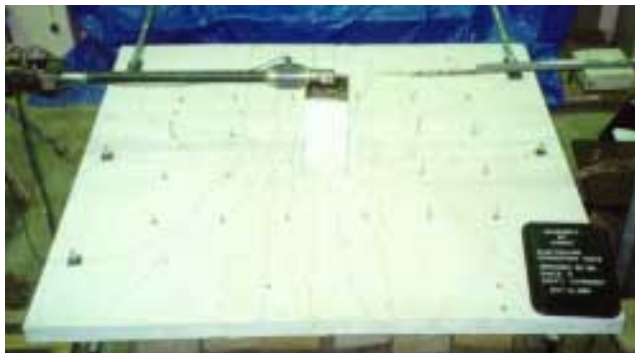
Figure 7: Typical cracking at 1.5% drift.

During the application of gravity load on the slabs, flexural cracks developed at the face of the column in all specimens. With the application of lateral load, additional flexural cracks formed across the entire width of the slab. In addition, diagonal torsional cracks appeared adjacent to the side faces of the column. The typical crack pattern at 1.5 percent drift for all specimens is shown in Figure 7. During the 3.5 percent drift cycle for specimen 1C, a punching shear crack formed without warning. Figure 8 shows the projection of the shear crack on the top surface of the slab. None of the specimens with slab shear reinforcement experienced shear failure even at drift levels of 8 percent (Figs. 9 and 10).

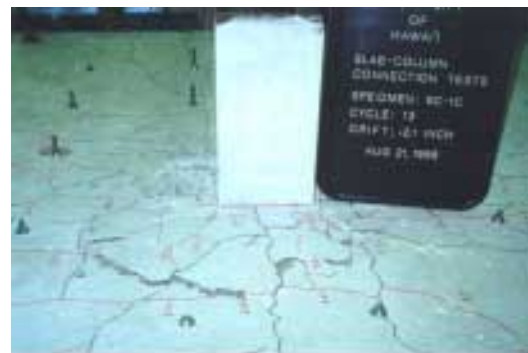
Figure 8: Punching shear failure, 1C.

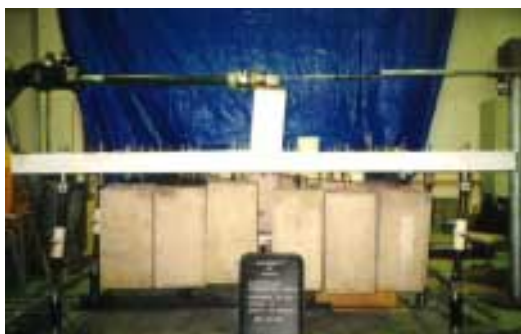
Figure 9: Specimen 2CS at 8% drift.

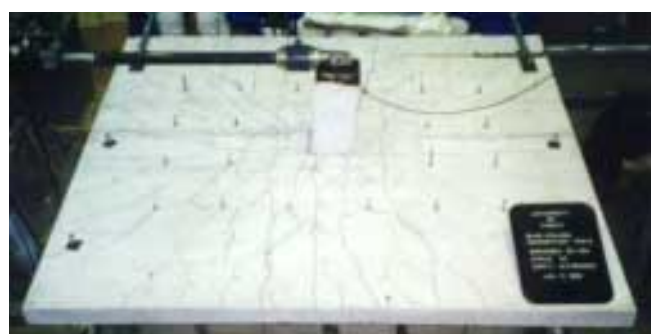
Figure 10: Specimen 4HS at 8% drift.

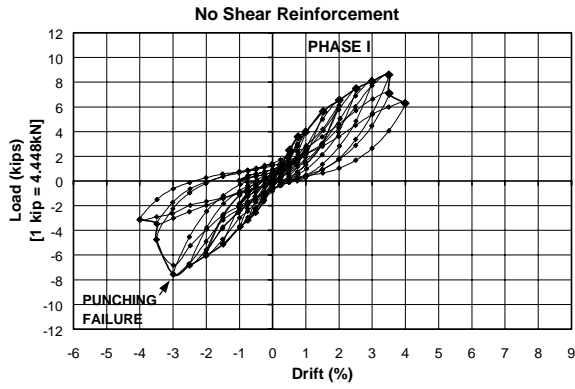
Figure 11: Specimen 1C, load vs drift.

The load-drift hysteresis loops for each of the four tests are shown in Figures 11 to 14. The maximum lateral load sustained during each cycle is highlighted as part of a load-drift envelope superimposed on the hysteresis plots. These envelopes are then plotted for all four specimens in Figure 15 for easier comparison.

The punching shear failure of specimen 1C is indicated in Figure 11 by the sudden drop in lateral load capacity during the 3.5 percent drift cycle in both positive and negative directions. All specimens with slab shear reinforcement were able to resist punching shear failure and sustain lateral drifts as high as 8 percent with less than 15 percent decrease in peak lateral load capacity.

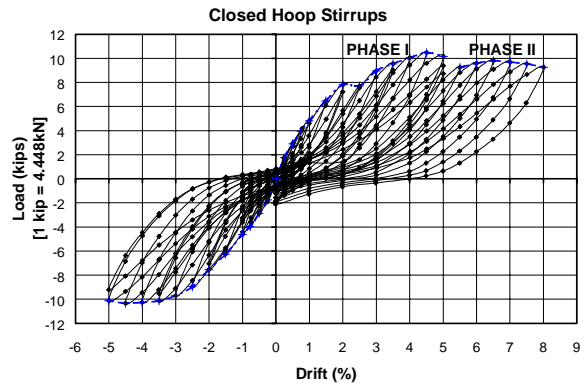
Figure 12: Specimen 2CS, load vs drift.

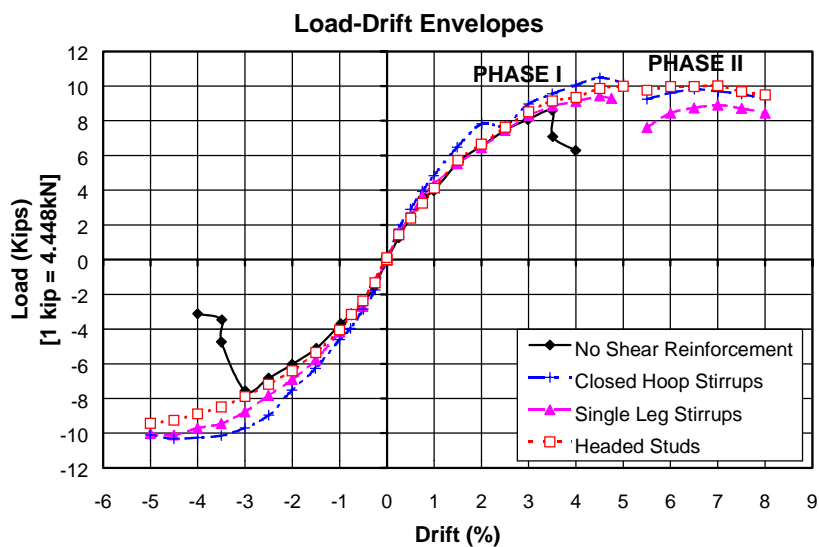
Figure 15: Load vs drift envelopes for all specimens.
