## REHABILITATION OF REINFORCED CONCRETE BEAM-COLUMN JOINTS

A. GHOBARAH, T.S. AZIZ and A. BIDDAH

Department of Civil Engineering, McMaster University, Hamilton, Ontario, Canada.

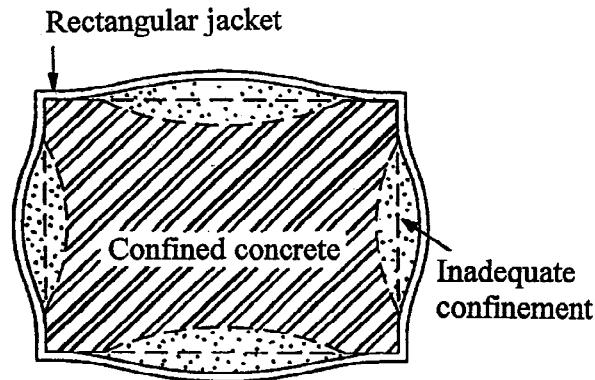
Fig. 2. Rectangular section confined by a flat rectangular tube (Priestly *et al.*, 1994)

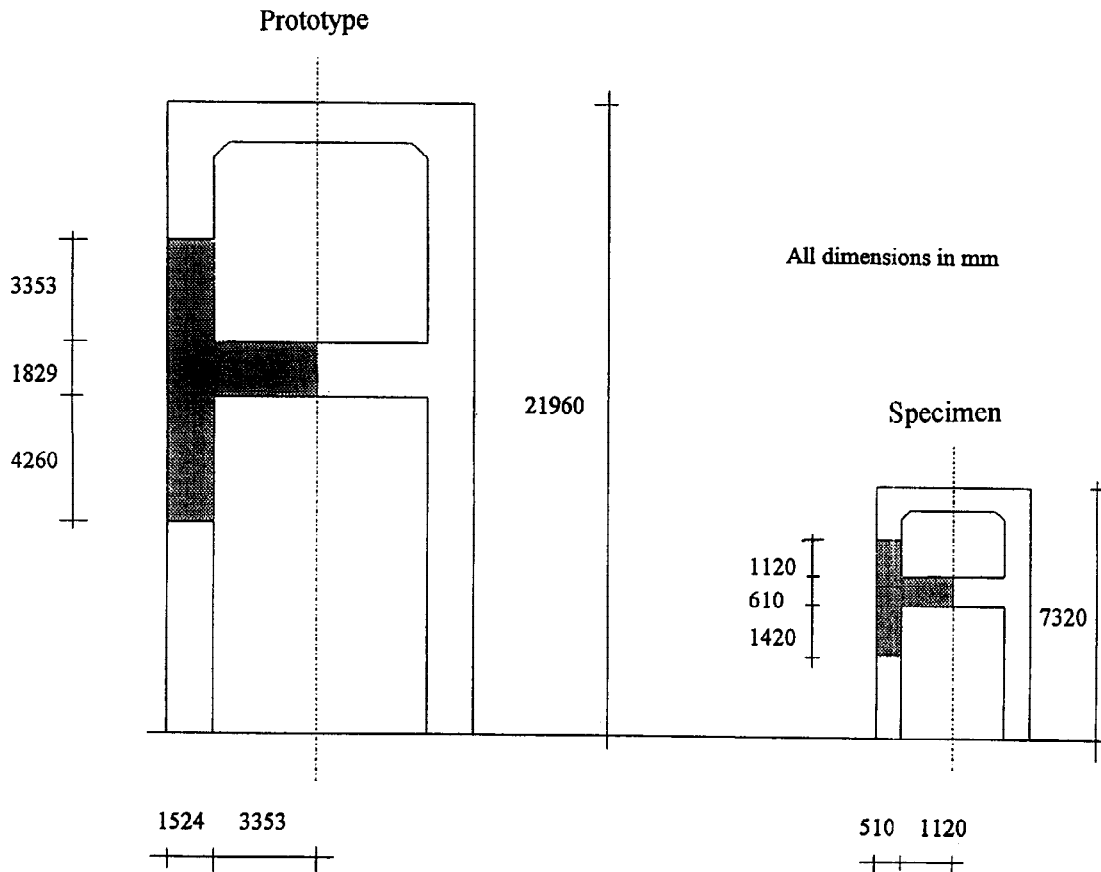
Fig. 3. Dimensions of the frame and one-third scale specimen.

The first floor exterior column connection of an existing frame structure, shown in fig. 3, was tested. The structure was designed and constructed in 1969 before current seismic codes were applicable. Because of laboratory space and equipment limitations, a one third scale test specimen was selected as shown in fig. 3. The criteria used in the modelling of specimens was discussed elsewhere (Biddah *et al.*, 1995). The test results described represent the first four specimens of an ongoing research program to determine the seismic capacity of existing frame structures and a suitable rehabilitation scheme for these structures. The four specimens have the same concrete dimensions. Each specimen consists of a beam 1.27 meters long, framing into a column 3.45 meters high at a distance of 1.27 meters from the top. The beam and column ends of the specimens are assumed to correspond to the approximate location of the inflection points of the prototype frame. The only difference between the specimens is the transverse reinforcement in the beam, column and joint. The first, third and fourth specimens, J1, J3 and J4, were detailed to represent the steel of the existing reinforced concrete frame. The second specimen, J2, was detailed according to the current Canadian seismic design code, (1994). The different reinforcement details of the specimens are shown in fig. 4. In the existing frame, the ties inside the joint and also in the column are about 16% of the steel recommended by the current Canadian seismic design code. Specimens J3 and J4 were encased by a corrugated steel jacket on the beam and column and on the column only, respectively, to enhance their seismic behaviour. The corrugated steel jacket was taken as 2.8 mm thick with a grouted gap of 25 mm thickness. Steel angles were attached to the beam at the column face to resist the outward confining pressure from the concrete in the joint part. Due to the insufficient shear reinforcement in the beam, a corrugated steel jacket was also used on the beam for specimen J3 as shown in fig. 1 with 20 mm gap from the critical section, (approximately representing the recommended 50 mm gap for full-scale connection). The purpose of the gap is to avoid unnecessary flexural strength enhancement which may upset the relative strength ratio of the connected beam and column.

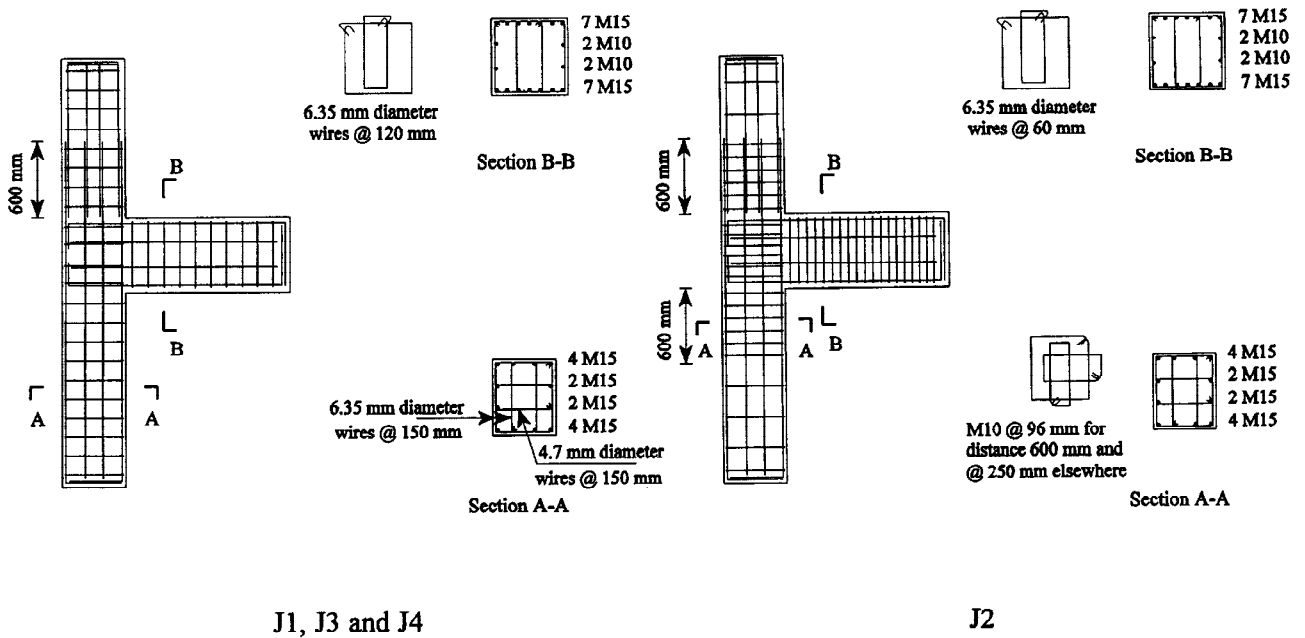
Fig. 4. Reinforcement details.

Concrete in the existing structure was assumed to have a compressive strength of 21 MPa. The compressive strength of concrete cylinders at the day of testing was 23 MPa. Grade 400 reinforcing steel was used as the principal steel in all the specimens and as ties in specimen J2 with measured yield strength of 440 MPa. Smooth wire size rods were used for the ties in specimens J1, J3 and J4. The ratio of the factored resistance moment of the columns to the nominal resistance moment of the beam is 1.55 which is higher than the 1.1 ratio specified by the current Canadian code.

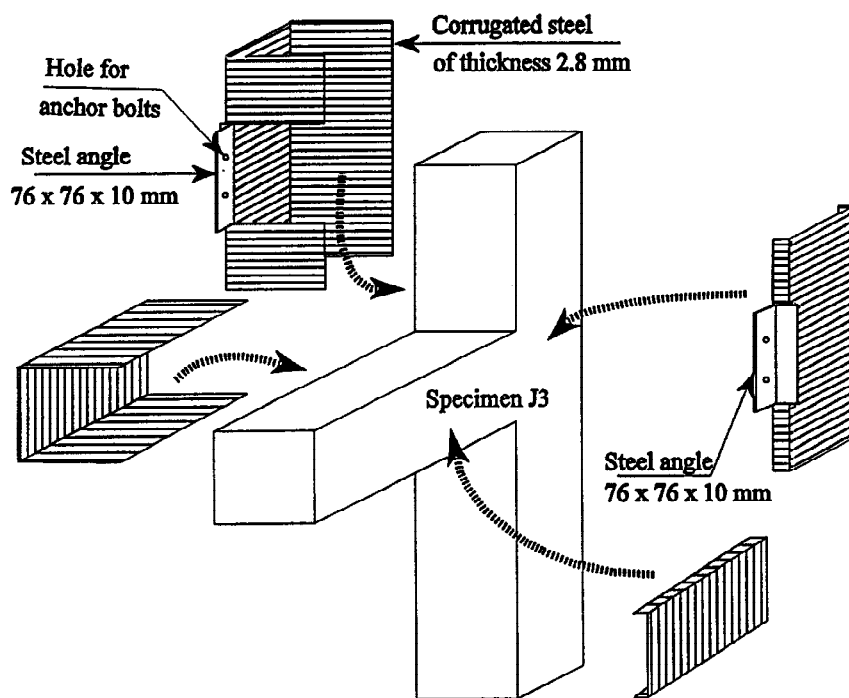
Fig. 5. Assembling of beam and column jackets.

It is proposed to build up the corrugated steel jackets for the column and beam from premanufactured "U" shape sections to be welded at the site as shown in fig. 5. However, for the joint jacket, two steel angles are proposed to resist the lateral pressure. these two angles are anchored to the concrete by expansion anchor bolts.

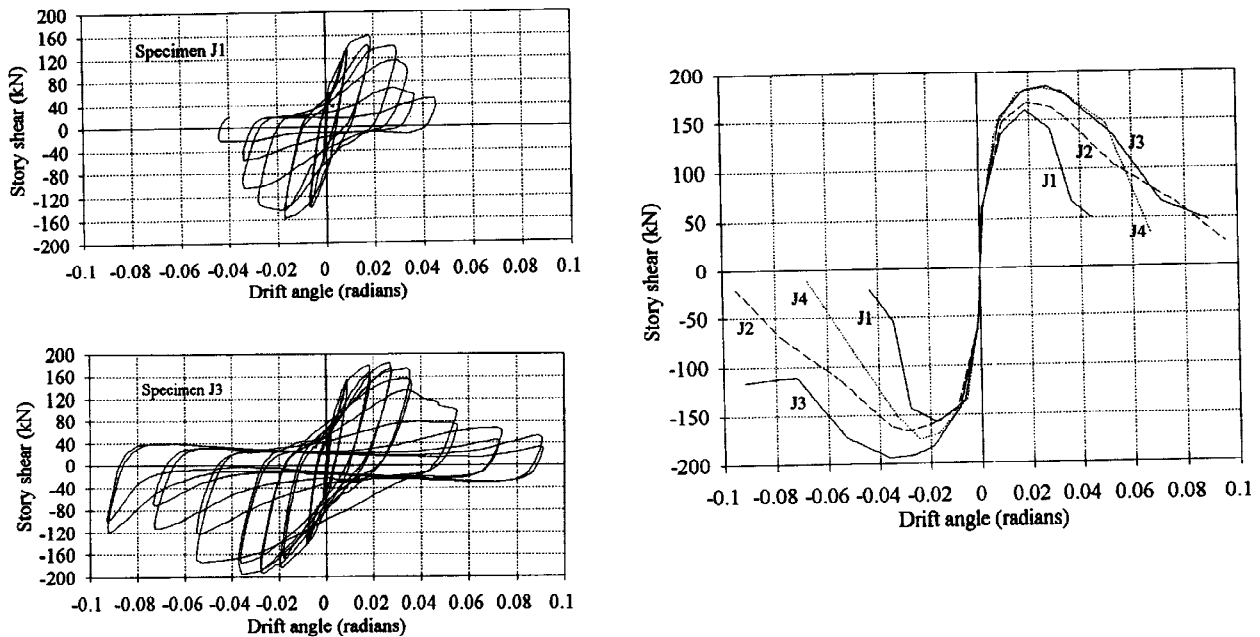
Fig. 8. Story shear-drift angle curves and envelope for the specimens.

**Hysteretic Behaviour.** The overall behaviour of the specimens is shown using story shear-drift angle relationships. Drift angle,  $R$ , is defined as the beam tip displacement divided by the beam length. Story shear,  $V$ , is computed from the beam tip load,  $F$ , considering the  $P-\Delta$  effect that may occur during an actual earthquake. The envelope of the story shear - drift angle for each specimen is shown in fig. 8. From the figure, jacketing of the frame elements was shown to improve the seismic behaviour of the existing structure as illustrated by the behaviour of specimens J3 and J4.

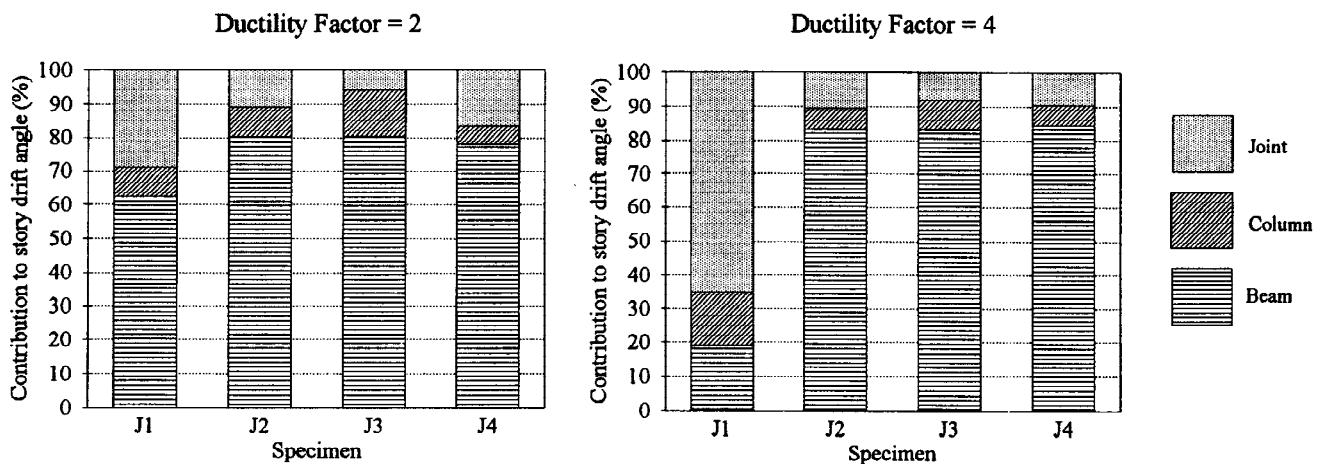
Fig. 9. Comparison between member contribution to drift angle.

**Member Contribution to Drift Angle.** Member contributions to drift angle for all specimens are outlined in fig. 9. Results are presented for the first negative cycle to given ductility level, i.e. ductility factors of 2 and 4. From this figure, it is clear that jacketing modified the behaviour of the existing structure so that all rehabilitated specimens behaved as "strong column - weak beam" systems, in which beam contributions were the largest throughout the test. Comparing the differences between the specimens, the joint contribution of J1 increased remarkably with story drift and had already exceeded 50% of the total drift by the time 1% story drift was achieved. On the other hand, the joint component of Specimens J2 and J3 were approximately less than 25% and 30%, respectively. There were approximately no difference in the joint component between J3 with jacket on column and beam and J4 with jacket on column only.

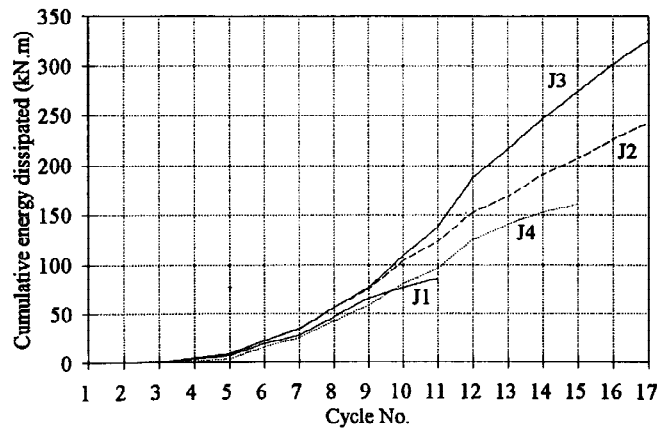
Fig. 10. Comparison of cumulative energy dissipated by the specimens.

**Dissipated Energy.** The energy dissipated during a loading cycle was computed as the area enclosed within the load-displacement curve. The cumulative energy dissipated was then calculated by summing the energies dissipated in consecutive loops throughout the test. The cumulative energy dissipation values are plotted in fig. 10 with the cycle number. The figure illustrates that specimens J2 and J3 exhibited considerably higher values for cumulative energy dissipation as compared to specimen J1. The cumulative energy dissipation values of specimen J4 are less than that of J2 and J3 due to the insufficient transverse reinforcement in the beam.
