REHABILITATION OF BUILDINGS AFTER THE 1985 MEXICO CITY EARTHQUAKE

J. IGLESIAS and J. AGUILAR

Departamento de Materiales, Universidad Autónoma Metropolitana
Av. San Pablo 180, Azcapotzalco, México 02200 D.F.

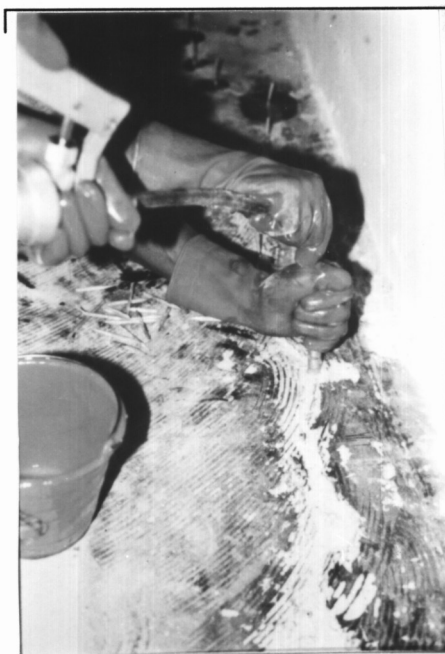
Figure 3. Crack injection of a damaged slab.

Very frequently, epoxy resins were injected in cracks of damaged elements. The equipment used grease guns for wide cracks (Fig. 3) and high pressure injection machines for slender ones.

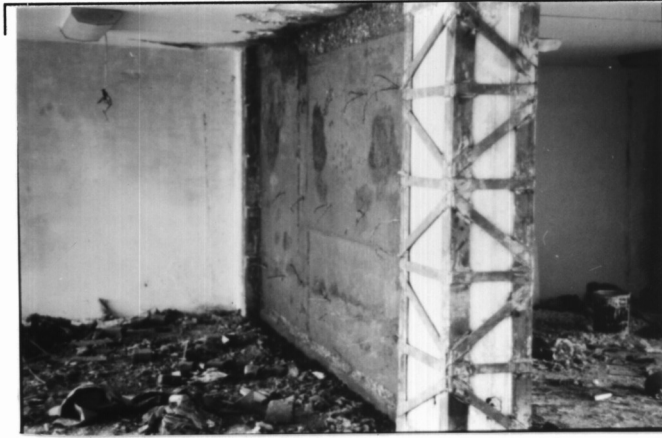
Figure 5. Jacketing of column with angles and straps.

Jacketing with steel angles and straps was a common system to strength columns (Fig. 5). External clamps or steel straps attached with epoxy resins were sometimes used for local strengthening of beams.

Reinforced concrete infilled walls with local strengthening of existing columns were also used in some cases (Fig. 5).

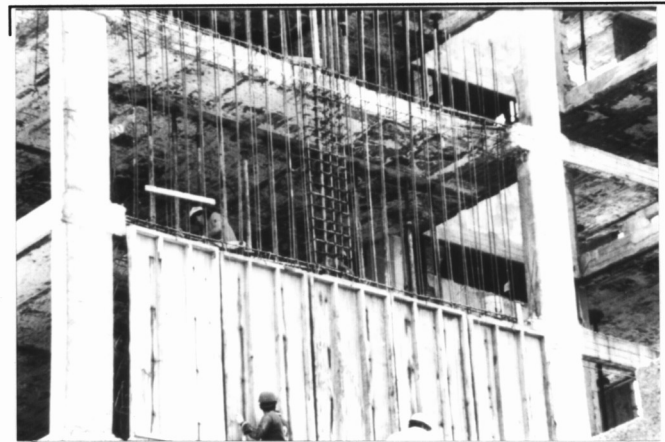
Figure 6. Reinforcement of new shear wall.

The addition of new reinforced concrete shear walls (Fig. 6) was the most common practice. Usually, the boundary elements were jacketed along the entire height of the wall.

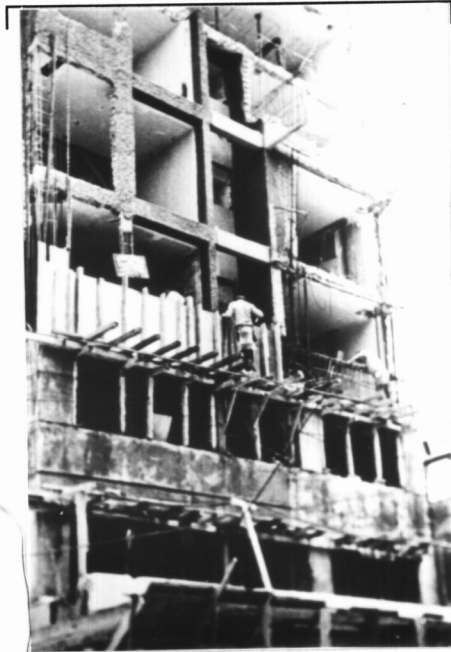
Figure 7. Addition of a reinforced concrete frame.

If the use of the building or the concentration of loads on the foundation limited the addition of concrete shear walls, the addition of concrete frames (Fig. 7) or steel bracing (Fig. 8) were the alternatives selected.

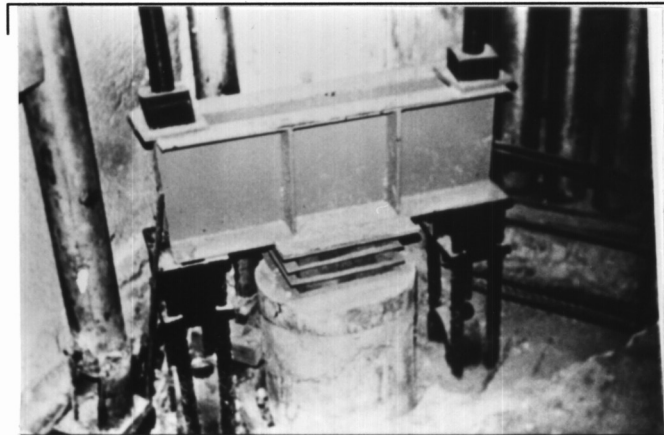
Figure 10. Control pile.

If the building had excessive non uniform settlement, the addition of new piles in combination with ballast and excavation was used to control the movement of the structure. In these cases control piles were also used (Fig. 10).
