AMBIENT VIBRATION STUDIES OF THREE SHORT-SPAN REINFORCED CONCRETE BRIDGES

C.E. VENTURA, W.D.L. FINN, P.R. WAGNER and A.J. FELBER

Department of Civil Engineering, University of British Columbia,
Vancouver, B.C., Canada, V6T 1Z4

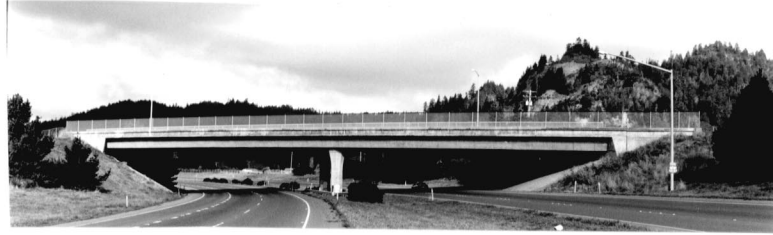
a) Painter Street Overpass

Fig. 1. General views of the short-span bridges tested in these studies.

The Painter Street Overpass (PSO) is a two-span, prestressed concrete box-girder bridge that was constructed in 1973 to cross over the four-lane US Highway 101 in Rio Dell (see Fig. 1a). Its construction is typical of the type of California bridges used to span multilane highways. The bridge is 15.85 m wide and 80.79 m long. The deck is a multi-cell box girder, 1.73 m thick and is supported on monolithic abutments at each end and two piers that divide the bridge into two spans of unequal length; one of the spans is 44.51 m long and the other is 36.28 m long. The abutments and piers are supported by concrete friction piles and are skewed at an angle of 38.9° . Longitudinal movement of the west abutment is allowed by means of a thermal expansion joint at the foundation level. The piers are about 7.32 m high and each is supported by 20 concrete friction piles. The east and west abutments are supported by 14 and 16 piles, respectively. The bridge was instrumented in 1977 as part of a collaborative effort between the California Strong Motion Instrumentation Program (CSMIP) and CALTRANS to record and study strong motion records from bridges in California. Twenty strong motion accelerometers were installed at the site (see Fig. 2a.).
