## **RETROFIT OF SLAB-COLUMN CONNECTIONS USING CFRP**

**Gaur P JOHNSON<sup>1</sup> and Ian N ROBERTSON<sup>2</sup>**

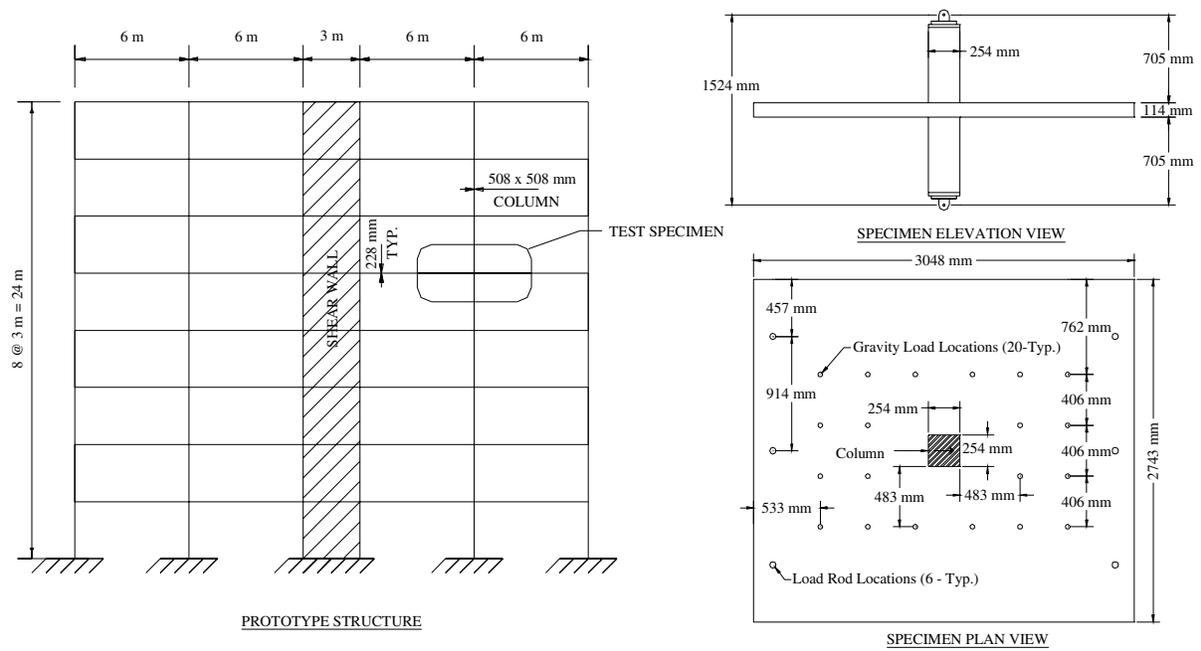
Each specimen represents a half-scale model of an interior flat-plate slab column connection (Figure 1). The gravity load applied during the test is equivalent to a loading on the full-scale structure of the total dead load plus 30 percent of the floor live load. This gravity loading results in an effective shear stress at the critical perimeter equal to 25 percent of the direct punching shear capacity of the concrete—defined by the ACI 318 Building Code [6].

**Figure 1-Prototype Building and Test Specimen.**

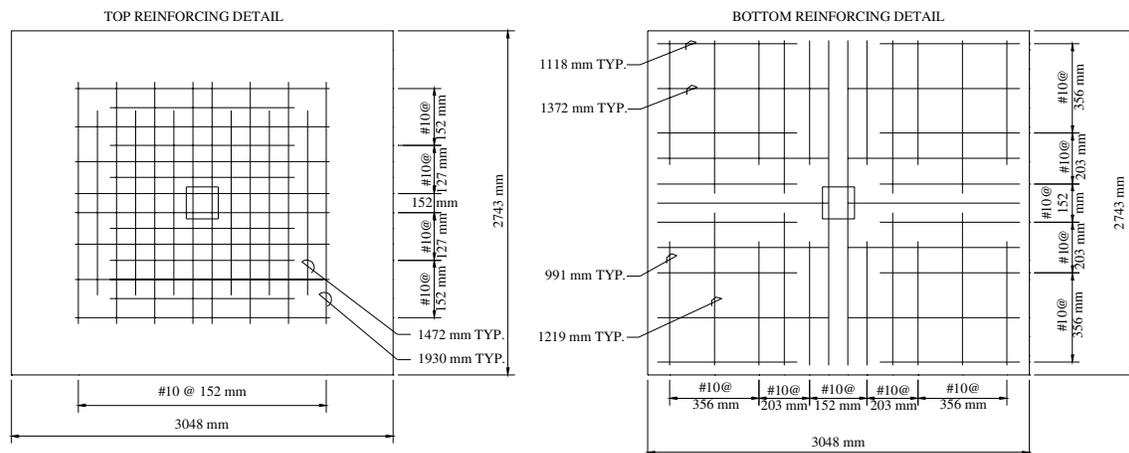
The specimens were designed using the ACI 318-63 Building Code which does not require continuous bottom reinforcement through column lines. No shear reinforcing was included since the concrete shear capacity was adequate for the code defined ultimate conditions. Two additional bottom reinforcing bars were added in the direction perpendicular to the direction of lateral loading to prevent total collapse of the specimens within the test frame. These added bars did not affect the behavior of the connection before punching failure. Figure 2 shows the steel reinforcing layout for all three specimens.

**Figure 2-Non-ductile Slab Reinforcing Details.**

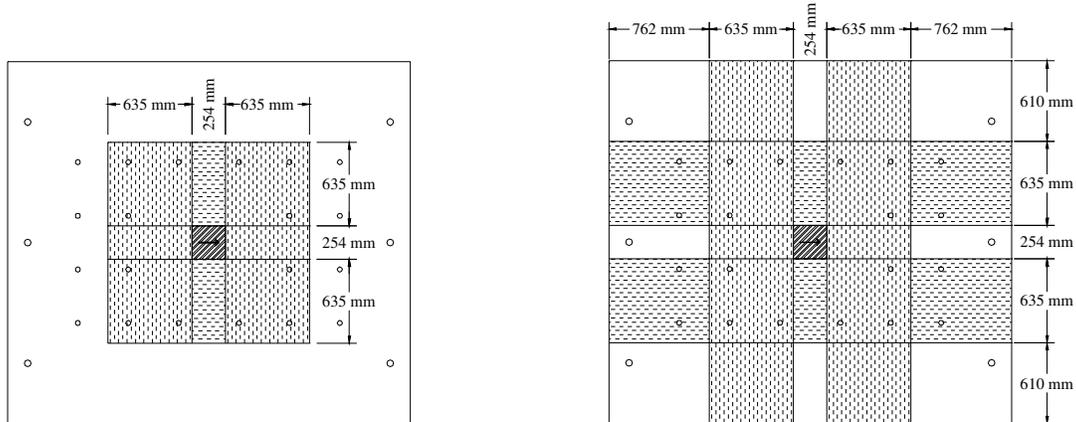
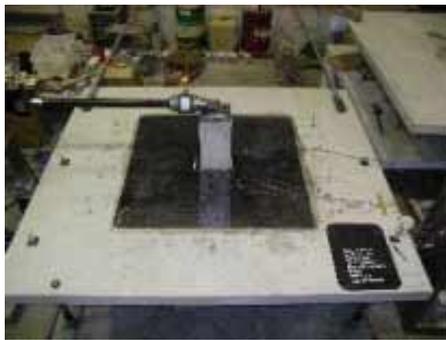
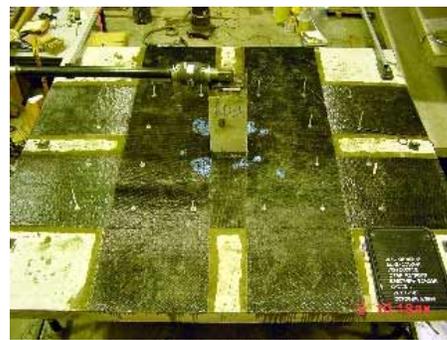
Three specimens were tested: a control specimen, ND1C, with no retrofit; a second specimen, ND2R, with 635 mm wide CFRP unidirectional fabric applied to the top of the slab directly adjacent to the column and discontinued at 635 mm from the face of the 254 mm square column (Figure 3a); the third specimen, ND3R, was retrofitted the same as ND2R but with no curtailment of the CFRP fabric (Figure 3b). During the retrofitting, the concrete surface was prepared by roughening with a needle gun to remove the surface cement paste in the area of the application of CFRP, SikaWrap Hex 103C. The prepared surface was equivalent to a concrete surface profile (CSP) between 3 and 4 on the ICRI CSP scale [7]. SikaDur Hex 300 was used as the impregnating epoxy and bonding agent.

a) Specimen ND2R

b) Specimen ND3R

Figure 3-Top View of CFRP Retrofit of Non-Ductile Slab-Column Connections.

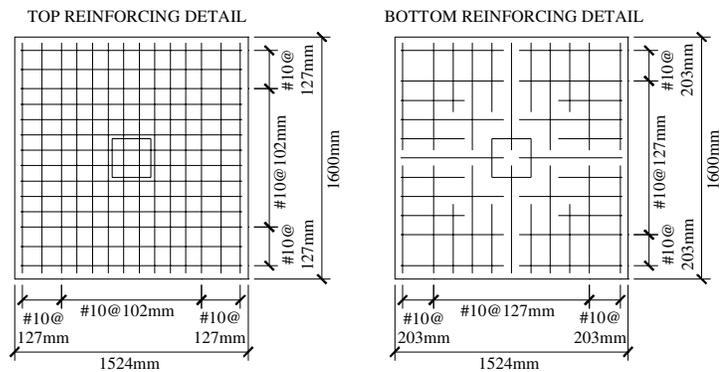
Figure 4-Specimen DPS1C & DPS2R slab reinforcing.

is shown in Figure 4.

Specimen DPS1C was the control specimen for the direct punching tests and contained only the reinforcing shown in Figure 4. Specimen DPS2R was retrofitted with 48-6.4mm diameter CFRP shear studs (Figure 5). These studs were installed in a configuration similar to shear stirrups—in eight rows of six studs. Each stud was installed as seen in Figure 4. Two rows of studs were placed starting at each column face at 140 mm apart (Figure 6). The stud spacing was 76 mm on center, with the first studs located 38 mm from the face of the column.

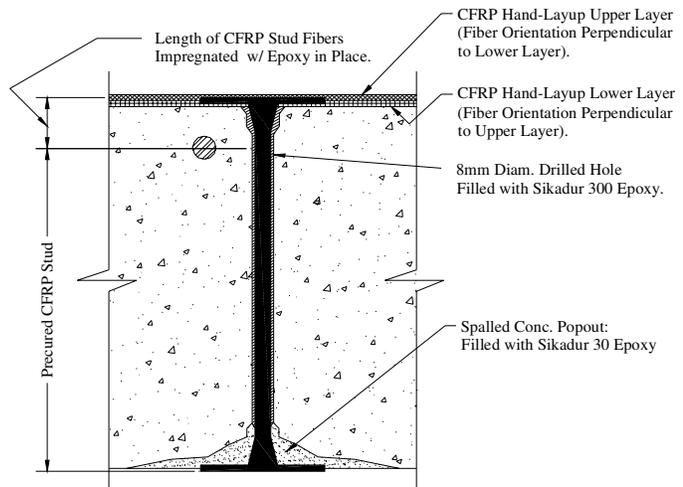
Figure 5-CFRP Stud Detail.

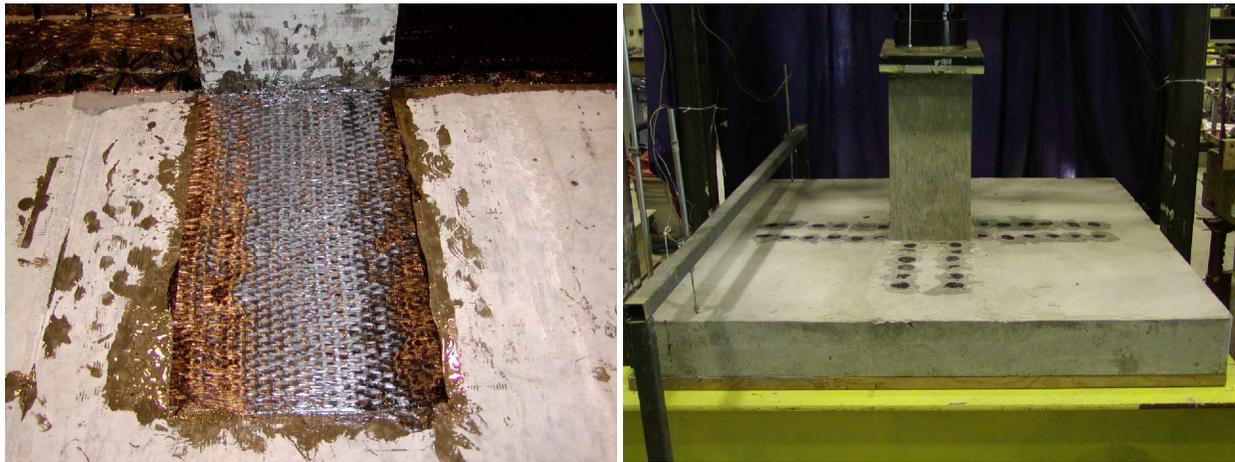
Figure 6-Specimen DPS2R: Top of Slab (left) and upside down in Direct Punching Test Frame (right).

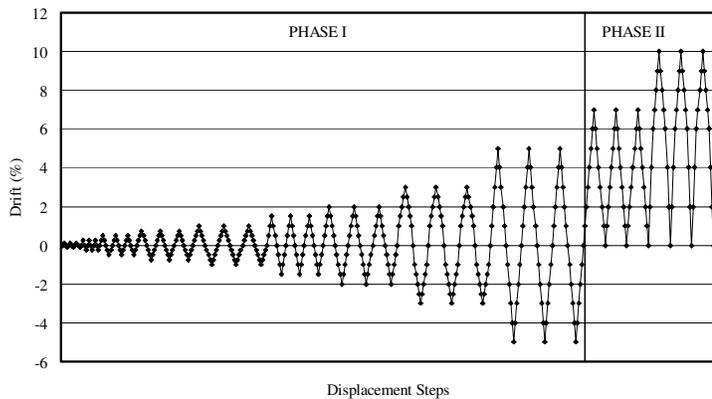
For the cyclic test specimens, the loading routine was performed in two phases: Phase I consisted of both positive and negative cycling at each drift level up to 5 percent (limitation of the actuator); Phase II consisted of cycling up to 10 percent drift, but only in the positive drift direction (Figure 7). This protocol gradually increases the drift level from +/- 0.1% to +/- 5% in Phase I and from +7% to +10% in Phase II. To evaluate the loss of strength and stiffness after repeated loading of the structure, each drift level cycle was repeated three times.

Figure 7-Lateral Displacement Routine.

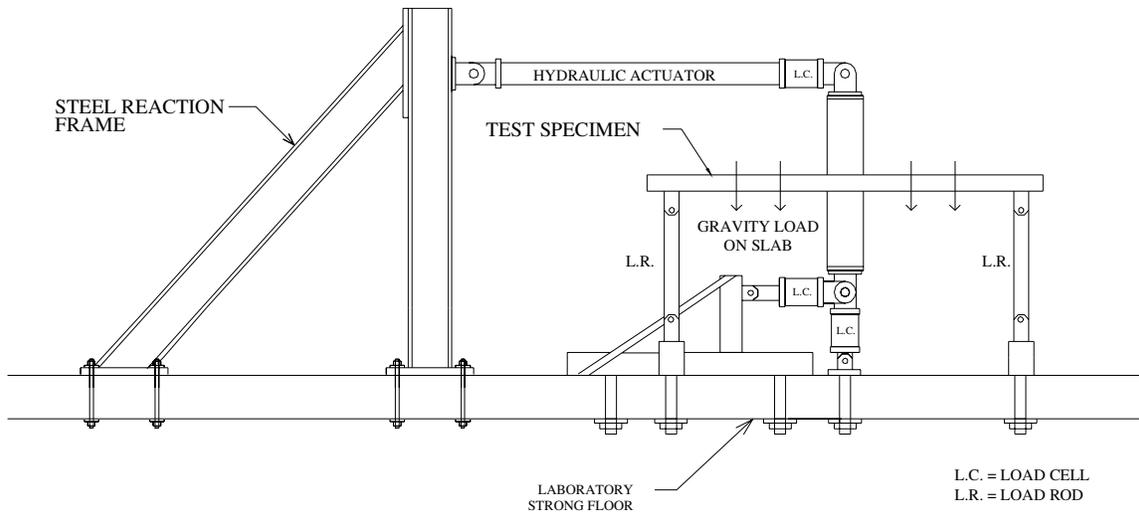
The laterally loaded specimens were tested as shown in Figure 8. A pin support, with two load cells to monitor column axial load and shear, was located at mid-height of the column below the slab. Three pin ended vertical load rods at each edge of the slab prevented vertical displacement of the slab, but allowed free lateral movement and rotation, thus simulating mid-span conditions in the direction of loading. The cyclic lateral displacement routine (Figure 7) was applied to a pin connection at the mid-height of the column above the slab via an actuator with an internal linear varying displacement transducer (LVDT) and an inline load cell.

**Figure 8-Lateral Test Frame Configuration.**

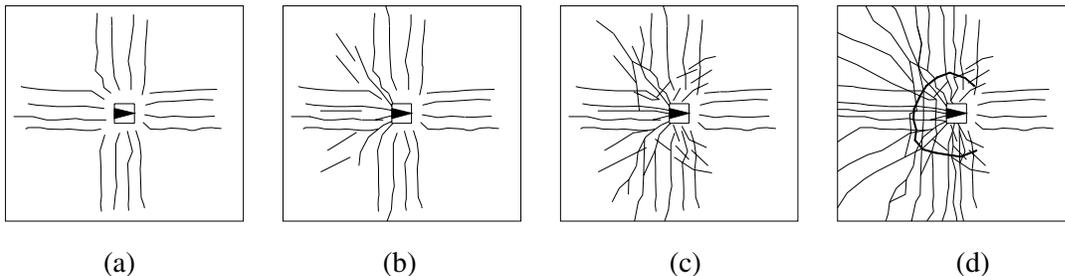
During the lateral testing of a reinforced concrete slab-column connection, the slab cracking around the connection follows a typical pattern and cracking order. Figure 9 shows this typical crack progression under cyclic lateral loading to increasing drift levels. First, the gravity loads cause flexural cracks that propagate out from the column generally following the location of the top reinforcement (Figure 9a). Next, as lateral load is applied to the column, the existing flexural cracks widen and extend towards the slab edge. New flexural cracks form further from the column, and others form running diagonally from the column corners toward the corner of the specimen, opposite to the direction of the applied load (Figure 9b). At increased drift levels, torsional cracks begin to form adjacent to the column, running diagonally in the direction of the applied load (Figure 9c). Once the torsional and flexural crack patterns have fully developed, widening of the existing cracks continues with increasing drift levels until finally a punching failure occurs (Figure 9d).

**Figure 9-Typical Crack Progression for a Cyclic Slab-Column Connection: (a) gravity load flexural cracking, (b) flexural cracking at low levels of drift, (c) torsional crack formation at increased levels of drift, (d) fully developed cracking with punch around column. Drift is in the direction of the arrow marked on the column.**

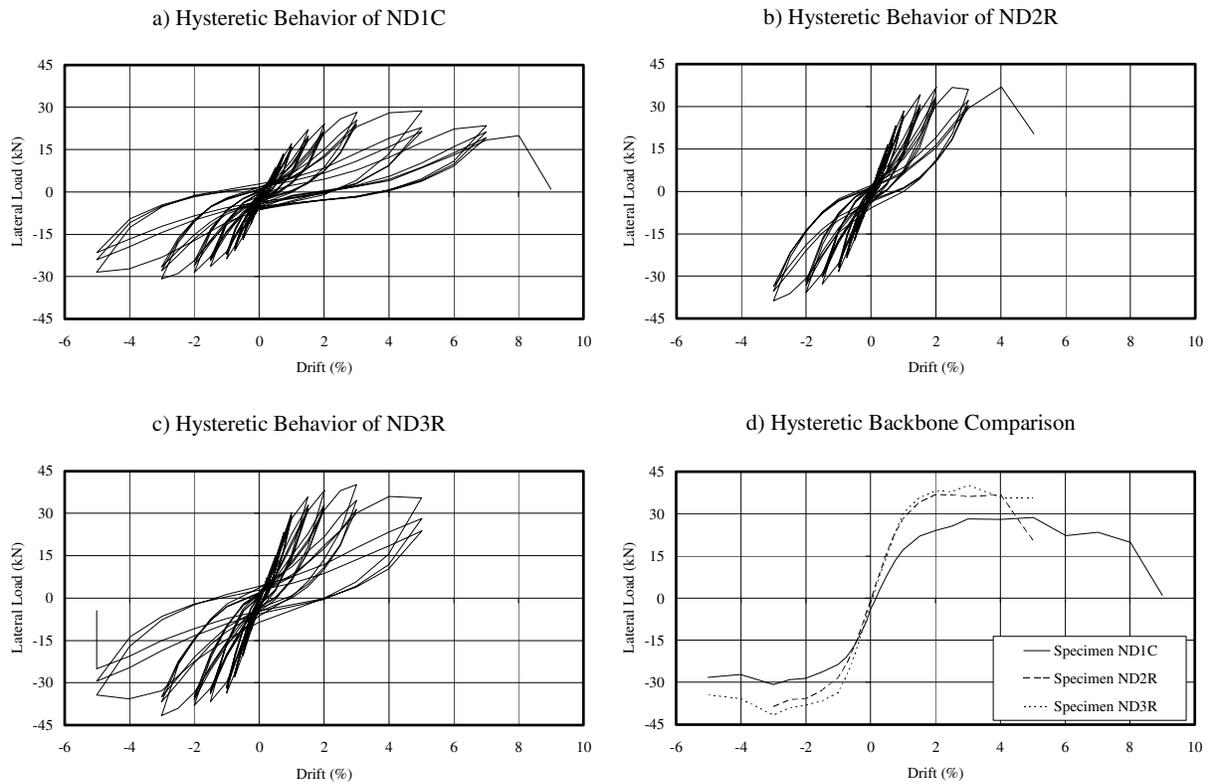
These data include the initial gravity load supported by the column (row 1); the ratio between the initial gravity load and the shear capacity load at the critical perimeter (row 2); the gravity load at failure (row 3)—different from row 2 due to redistribution to the load rods; the maximum horizontal load during hysteresis (row 4); the drift level at the maximum horizontal load (row 5); the maximum drift level before failure (row 6); and the type of failure (row 7). The load-drift relationships for all specimens are shown in Figure 10. Figures 10a through 10c show the hysteretic response of specimens ND1C through ND3R respectively. Figure 10d is a comparison of the backbone curves—defined by the peak lateral load at each drift level—of the hysteretic response of these connections.

**Figure 10-Hysteretic Behavior of Specimens ND1C, ND2R, and ND3R.**

The derived yield drift for specimen ND1C was between 1.0 and 1.33%. The initial stiffness was an average of 26.2 kN per percent drift. This specimen experienced a maximum horizontal load of 30.9 kN at a drift level of 3% as shown in Table 3. The specimen experienced a 20% loss of the peak lateral load (flexural failure) at a drift level of 6% and finally punched at a drift level of 9% (See the bracketed values in Table 2). The response to the loading shows a maximum peak ductility of 3.76 with an associated ultimate ductility of 4.51 [6.77<sup>†</sup>]. The horizontal load after punching decreased to 1.0 kN, 3% of the peak lateral load. The hysteretic response is shown in Figure 10a above.

The derived yield drift for specimen ND2R was approximately 1.2%. The initial stiffness was an average of 31.4 kN per percent drift, a 20% increase over ND1C. This specimen experienced a maximum horizontal load of 38.7 kN at a drift level of 3% as shown in Table 3. This peak lateral load was a 27% increase in capacity over the control specimen. The horizontal load decreased to 35.9 kN before failure, 93% of the peak lateral load. The specimen failed in flexure at a drift level of 5%. The response to the loading shows a maximum peak ductility of 2.5 with an associated ultimate ductility of 2.5. The test was stopped for safety reasons due to the nature of the failure—flexural crack through the thickness of the unreinforced slab. The hysteretic response is shown in Figure 10b above.

The derived yield drift for specimen ND3R was between 1.0 and 1.25%. The initial stiffness was an average of 37.0 kN per percent drift, a 41% increase over ND1C. This specimen experienced a maximum horizontal load of 41.7 kN at a drift level of 3% as shown in Table 3. This peak lateral load was a 38% increase in capacity over the control specimen. The specimen punched at a drift level of 5%. The response to the loading shows a maximum peak ductility of 3.0 with an associated ultimate ductility of 5.0. The horizontal load after punching decreased to 4.4 kN, 10% of the peak lateral load. The hysteretic response is shown in Figure 10c above.

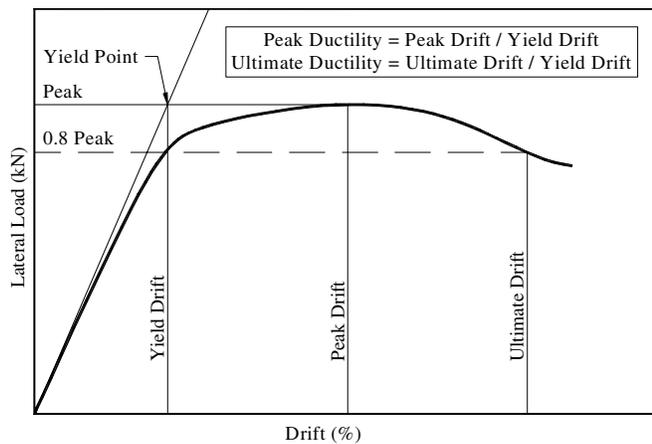
The following section describes the stiffness and ductility of the slab-column connections. The values of ductility are based on a derived yield point and hysteretic backbone curve of each connection as illustrated in Figure 11. Table 3 summarizes the derived ductility information of each specimen in both the positive and negative displacement directions. Extending a tangent to the initial stiffness (column 2) of the specimen to a point where it crosses the value of the peak lateral load (column 4) defines the yield point. The drift at this intersection is the yield drift (column 5). The peak ductility,  $\mu_p$ , (column 8) is the ratio

**Figure 11-Definition of Ductility Parameters.**

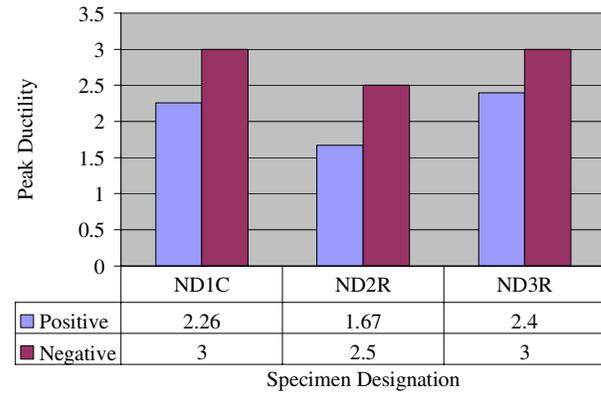
Figure 12 shows a comparison of peak ductility. The results do not suggest any significant change in the peak ductility with the addition of the CFRP. This occurs because the yield drift and drift at peak lateral load are virtually the same in all three cases. Figure 13 indicates a decrease in ultimate ductility created by the addition of CFRP by comparing the ultimate drift levels observed during testing. Flexural failure of ND2R represented an ultimate ductility which was two-thirds of that for the flexural failure (80% decrease in lateral load capacity) of the control specimen (Figure 13a). Punching failure of ND3R represented an ultimate ductility approximately two-thirds of that for punching failure of the control specimen (Figure 13b). This criterion provides a more appropriate comparison since the flexural failure of ND1C at 6% drift does not represent a progressive collapse scenario but its punching failure at 9% does.

Figure 12-Comparison of Peak Ductility.

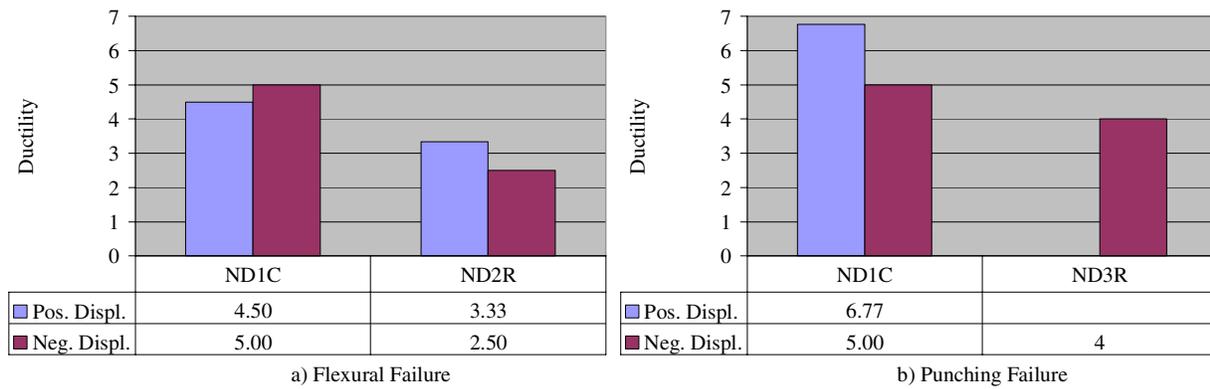
Figure 13-Comparison of Ultimate Ductility.

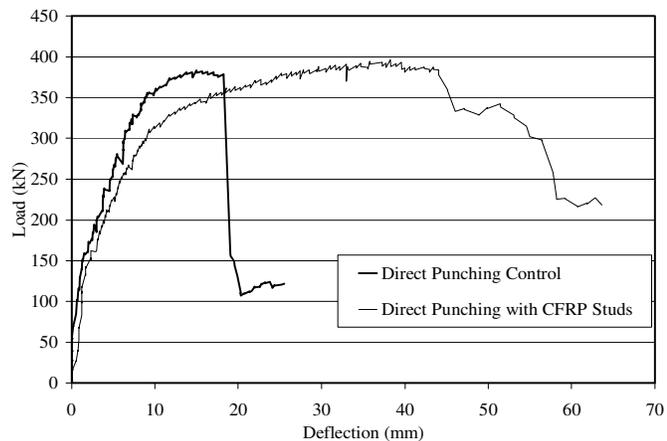
Specimens DPS1C and DPS2R were subjected to monotonic increasing direct punching shear. The load-displacement response of each specimen is shown in Figure 14. The addition of the CFRP shear studs only increased the punching capacity slightly. However, the ultimate deflection increased from 18mm to 44mm, an increase of 244%. This significant improvement in ductility suggests that these CFRP studs could be effective for seismic retrofit of slab-column connections. The authors are currently proceeding with cyclic lateral tests of slab-column connections retrofitted with CFRP headed studs.

Figure 14-Direct Punching Load vs. Deflection.
