## SEISMIC MICROZONATION OF MOQUEGUA CITY, PERU

### SUMMARY

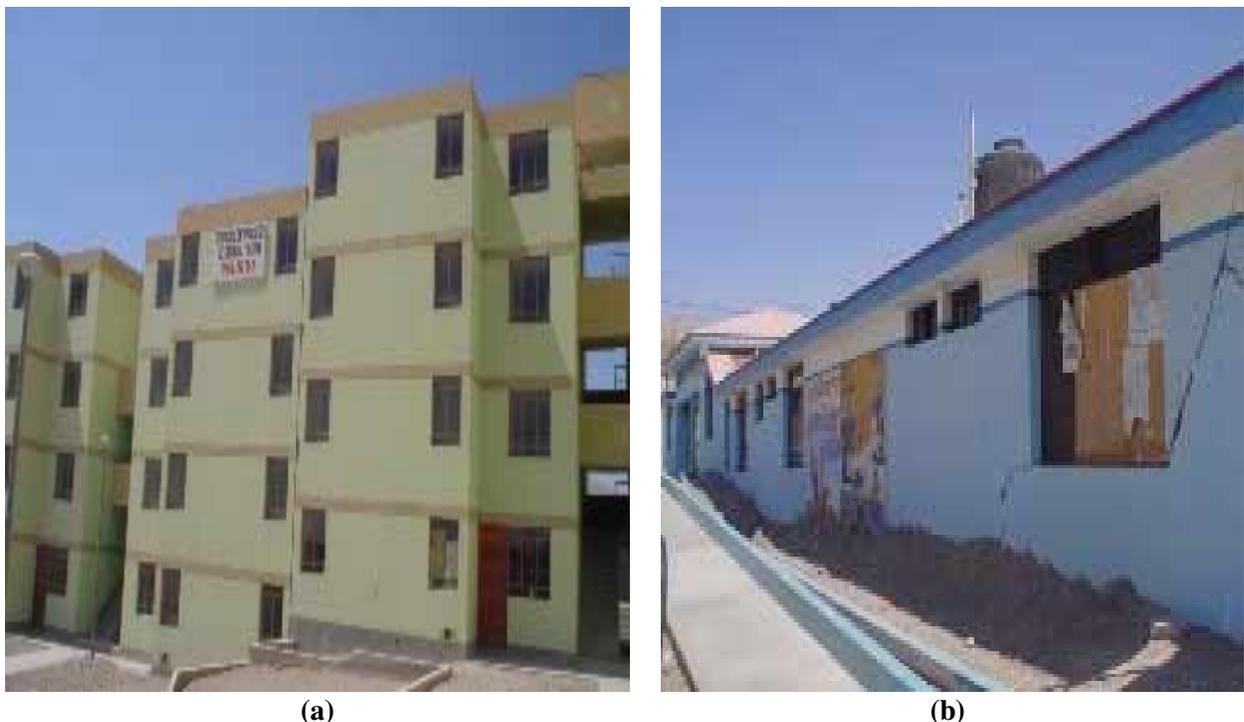
**Figure 1:** Structures Damaged due to swelling of expansive soils in San Antonio Area, Moquegua City. (a) Lopez Albuja Building, built in 1996, and (b) San Antonio Health Center, built in 1999.

After the quake, the local authorities planned to relocate the homeless in the only available expansion area, behind the city surrounding hills, however there were evidences that near this new expansion area highly expansive soils has caused severe damage to structures, as it is showed in the pictures of Figure 1. This figure shows two representative structures in San Antonio Area that were severely damaged by the swelling of the expansive soil, the first one are ten blocks four-story apartment buildings that were built in 1996, and are still unoccupied due to the cracks in their walls and swelling of the floor. The second one is a one story masonry structure health center that was built in 1999, and soon after it was finished wide cracks appeared in its walls due to swelling of the foundation. At the present this center was evacuated and is waiting for retrofitting.

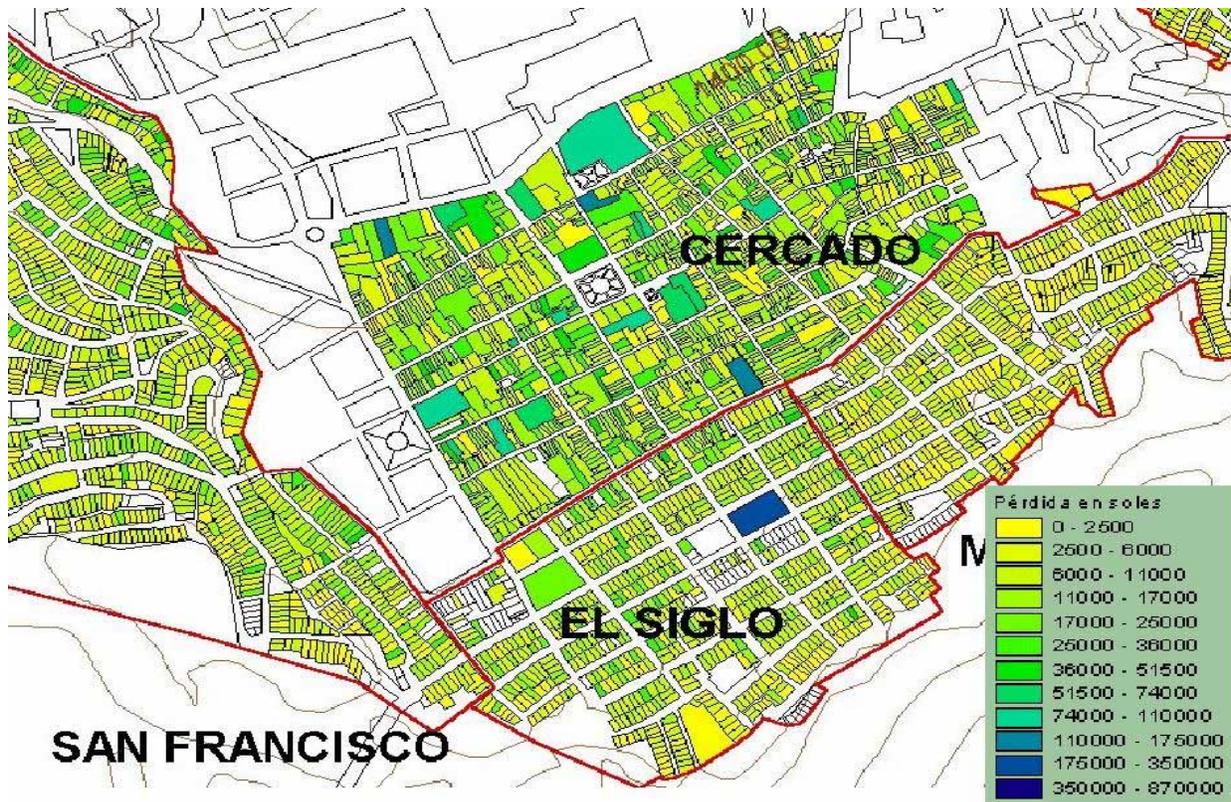
**Figure 7:** Direct Economic Loss Distribution Map of Moquegua City for the June 23, 2001 Earthquake Scenario.

The buildings unit cost was obtained from the property tax database of the Land Registry Office, which has registered about the 80% of the buildings of Moquegua City. This information was overlapped with the damage distribution map for the June 23, 2001 earthquake scenario, to obtain the Direct Economic Loss Distribution Map, shown in Figure 7. The total direct economic loss estimated for this event, considering only the 80% of the buildings in Moquegua City, rises up to 48.11 million soles (approximately 14 million American dollars).
