BEHAVIOR OF PRECAST HIGH-PERFORMANCE FIBER REINFORCED CEMENT COMPOSITE COUPLING BEAMS UNDER LARGE DISPLACEMENT REVERSALS

B. Afsin CANBOLAT¹, Gustavo J. PARRA-MONTESINOS², and James K. WIGHT³

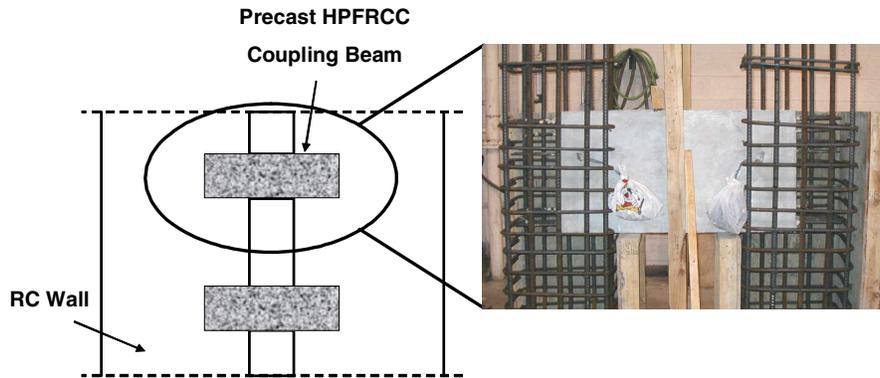
Figure 1 – Proposed Precast HPFRCC Coupling Beams

In this research project, the seismic behavior of HPFRCC coupling beams was investigated. With the use of HPFRCC materials, the reliance on heavily reinforced diagonal cages and the need for confinement reinforcement were expected to be reduced or eliminated. The experimental phase of this research consisted of the testing of three large-scale HPFRCC coupling beams and one diagonally reinforced RC coupling beam under displacement reversals. The main variables investigated were the type of material used in the coupling beams, fiber type, and reinforcement detailing. A precast construction process was proposed because site casting of HPFRCC coupling beams may be difficult for a typical concrete contractor. The precast HPFRCC beams are constructed with sufficient embedment length and reinforcement anchorage to assure proper moment and shear transfer. Then, they are placed between the

walls and regular concrete is cast around them (Fig. 1). This construction process is expected to be practical and attractive for industry because it will not only lead to significant savings in time and workmanship at the site, but also provide good material quality control.

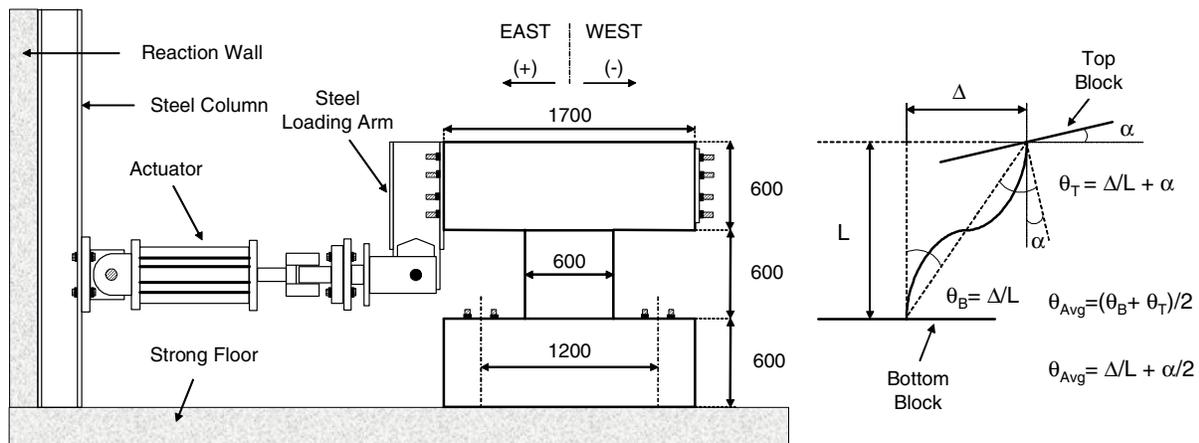
Figure 2 – Specimen Dimensions (mm) and Test Setup

In this experimental program, the feasibility of using HPFRCC materials to simplify reinforcement detailing in seismic-resistant RC coupling beams was evaluated. For this purpose, four coupling beam specimens, including a control RC specimen, were tested under large displacement reversals. As shown in Fig. 2, each specimen consisted of a coupling beam and two stiff RC members representing structural walls. The beam dimensions were proportioned to approximately 3/4 of full scale. After being constructed, the specimens were rotated and one of the walls was connected to a strong floor. In this horizontal position, displacement cycles were applied at the other (top) wall portion through a horizontal hydraulic actuator with its line of action passing through the beam midspan in order to produce an antisymmetrical moment pattern in the coupling beam. The actuator and the upper portion of the specimen were connected through a steel I-section and the load was transferred to the top RC block (RC wall) by means of direct bearing and unbonded threaded bars passing through the top block. The test specimens were braced laterally to prevent out-of-plane movements.

The specimens were subjected to quasi-static cyclic loading in a displacement control mode, following a predefined reversed cyclic displacement pattern. To simulate the demands during an earthquake, several lateral displacement cycles were applied to each specimen, starting from a coupling beam drift of 0.25%, and reaching a maximum drift of 4% (provided that the specimen did not fail at a lower drift level). Each cycle to a given drift level was applied twice to evaluate the loss of strength and stiffness in the specimens during the repeated cycles. Some 0.5% drift cycles were interspersed into the displacement history to evaluate the residual stiffness of the specimens. The horizontal displacement reached at each drift level was monitored through linear potentiometers because LVDT readings from the hydraulic actuator were inaccurate due to deformations in the loading system. Additional potentiometers were also used to check any relative rotation between the RC walls. The lateral displacement applied to the specimens was then based on the calculation of a net beam drift (θ_{Avg}) obtained through the potentiometer readings and taking into account the effect of wall rotation on coupling beam drift (Fig. 2).

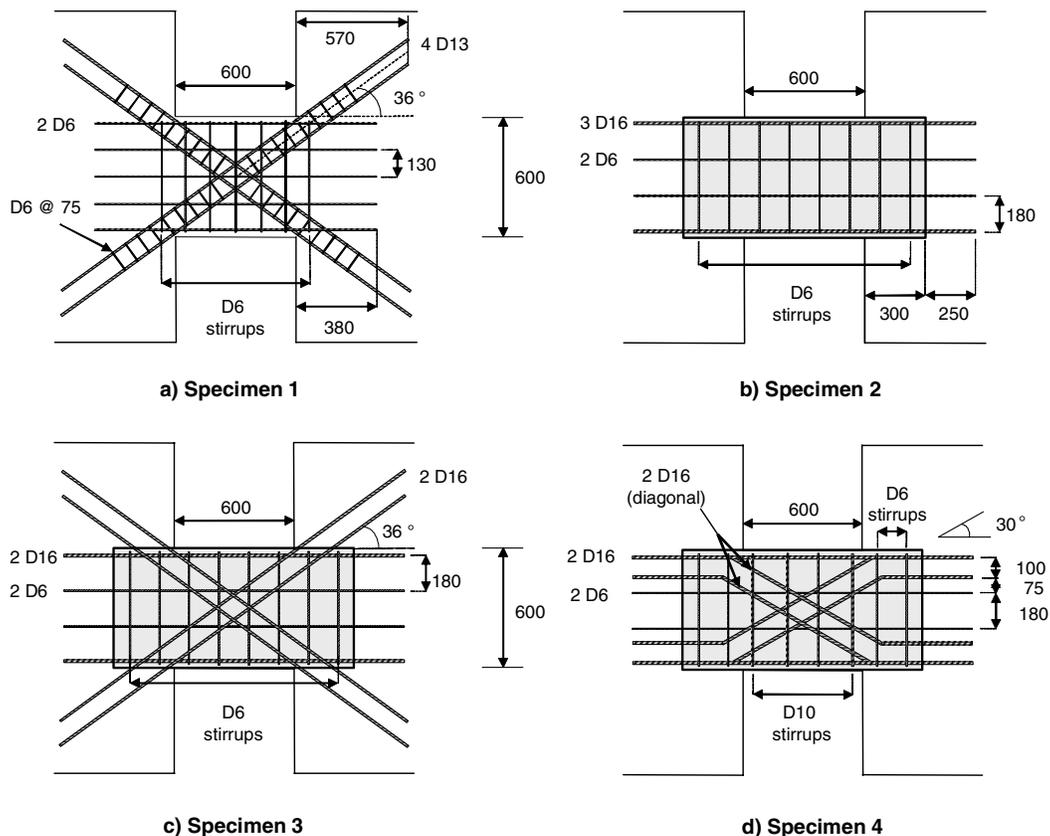
Dimensions in mm. Concrete cover = 50 and 40 mm for RC and HPFRCC specimens, respectively.

Figure 3 - Reinforcement Details of Test Specimens

Specimen 1, used as the control specimen, consisted of a 200 mm (8 in.) wide RC coupling beam with diagonal reinforcement designed and detailed according to the ACI 318 Code [20]. Minimum code requirements for distributed horizontal and vertical reinforcement were applied to increase the demand in the diagonal bars. Fig. 3a shows a sketch of the details used in Specimen 1.

In Specimen 2, a precast HPFRCC coupling beam was constructed with no diagonal reinforcement. The shear capacity was provided by a HPFRCC material containing a 2.0% volume fraction of ultra-high molecular weight polyethylene (PE) fibers and minimum distributed horizontal and vertical reinforcement. Sufficient flexural reinforcement was provided at the top and bottom layers in order to enforce a diagonal tension failure. Also, because of the elimination of diagonal bars and corresponding hoops, the beam width in Specimen 2 was reduced to 150 mm (6 in.) in order to increase the shear demand in the composite material. The reinforcement details of Specimen 2 are shown in Fig. 3b. The precast coupling beam was embedded a distance equal to half its span length into each wall to reduce bearing stresses, and the horizontal reinforcing bars were extended beyond the ends of the beam to provide full development length from the face of the wall (Fig. 3b).

Specimen 3 consisted of a precast HPFRCC coupling beam with the same beam width and amount of distributed horizontal and vertical reinforcement as in Specimen 2. However, two D16 diagonal bars with no confining reinforcement, which corresponded to approximately 80% of the area of diagonal reinforcement used in Specimen 1, were placed in each direction (Fig. 3c). With this configuration, it was

Specimen 4 contained the same amount of diagonal bars used in Specimen 3. However, the diagonal reinforcement detailing was modified to facilitate the construction process for a precast coupling beam. As shown in Fig. 3d, the bars ran diagonally within the beam span and were bent at the beam-wall interface so that they would remain within the depth of the beam. A new composite material, consisting of a cement-based mortar with twisted steel (Torex) fibers [14] in a 1.5% volume fraction, and minimum distributed horizontal reinforcement were used in the coupling beam, but the distributed vertical reinforcement within the beam span was increased to prevent a premature failure at the bending points of the diagonal bars. The beam width was kept the same as in the other HPFRCC coupling beam specimens (150 mm).

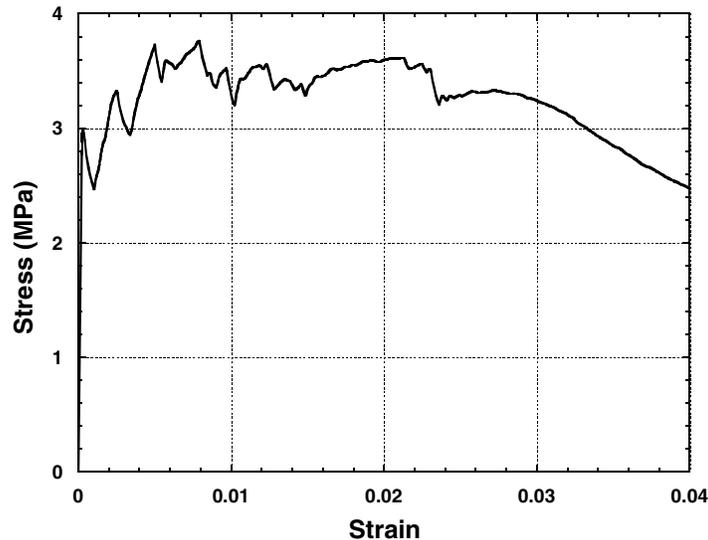
Figure 4 - Typical Tensile Stress vs. Strain Response of Sample Specimen with PE Fibers

In this research study, different mix designs were considered for use in the coupling beams and several specimens were tested in order to evaluate the tensile and compression response of the composite. Dogbone-shaped specimens of two different sizes were used for uniaxial tension tests. Two fiber cementitious materials with the desired multiple cracking behavior in tension were obtained using a 2.0% volume fraction of PE fibers, and a 1.5% volume fraction of Torex fibers. PE fibers are made of ultra-high molecular weight polyethylene, widely used in fiber reinforced plastics for the aerospace industry. A typical tensile stress vs. strain response obtained from a dogbone specimen with PE fibers is shown in Fig. 4. Torex is a twisted steel fiber with excellent frictional and mechanical bond properties [14]. Table 2 lists the properties of the PE and Torex fibers used in this research.

The compressive strengths for the composites with PE and Torex fibers at test day were approximately 57 MPa (8300 psi) and 63 MPa (9100 psi), and the post-cracking tensile strengths were approximately 3.1 MPa (450 psi) and 5.5 MPa (800 psi), respectively. Regular concrete, provided by a local ready-mix concrete supplier, was used in the coupling beam of the first specimen and in the walls of all four specimens. The concrete compressive strength for Specimen 1 on the test day was approximately 41 MPa (6000 psi). All the deformed steel reinforcement used in this study was Grade 60 (420 MPa). Tensile test results indicated a yield stress of 450 MPa (65 ksi) and a tensile strength of 726 MPa (105 ksi).

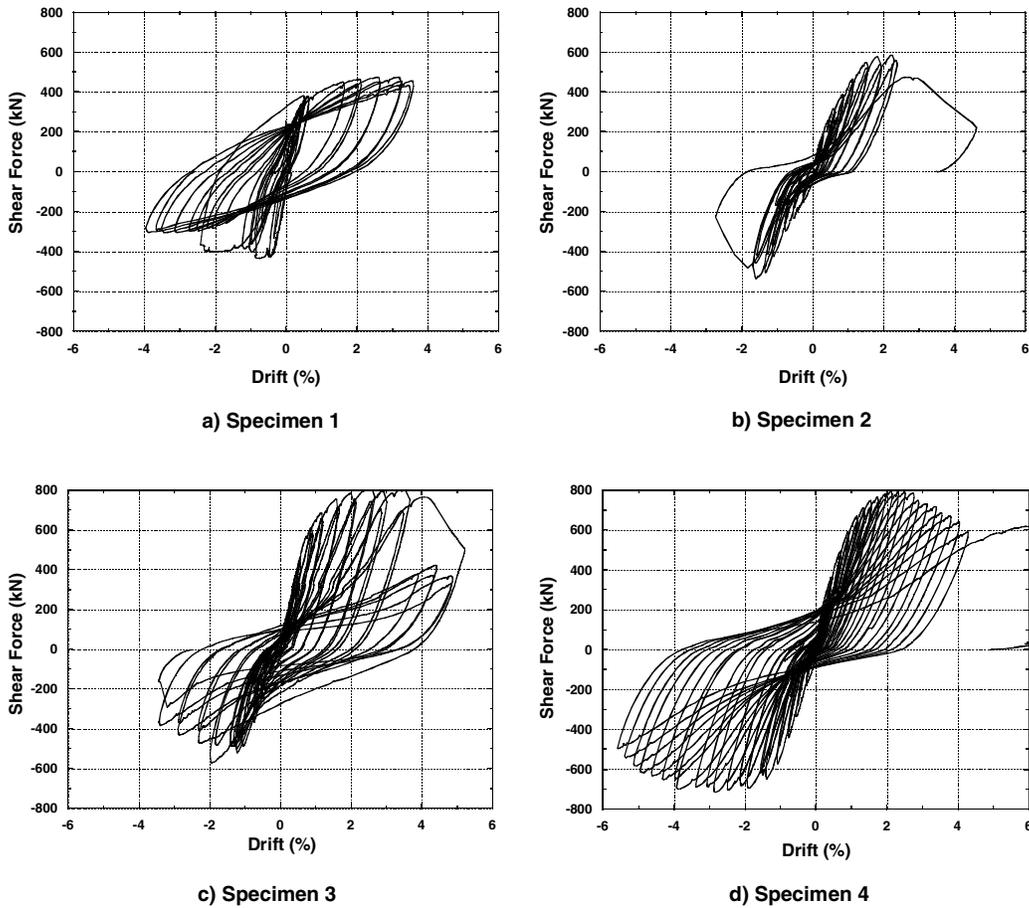
Figure 5 –Shear Force versus Drift Response of Test Specimens

Also, Fig. 5 shows the shear force versus drift response of all four specimens. As mentioned before, the drift levels were adjusted to account for the differential rotation of the wall blocks. As can be seen from Fig. 5a, Specimen 1 had a stable response, which indicated that diagonally reinforced RC coupling beams designed according to the ACI Building Code perform well under high deformation demands. Yielding of the diagonal bars led to wide hysteresis loops with good energy dissipation capacity. In Specimen 1, the shear strength provided by the diagonal bars at yielding was approximately 270 kN, around 60% of the maximum load reached during the test. Therefore, it is likely that this contribution increased significantly during the later drift cycles due to strain hardening of the steel reinforcement.

Specimen 2 consisted of HPRCC coupling beam with PE fibers in a 2.0% volume fraction and no diagonal reinforcement was used. Fig. 5b shows that Specimen 2 exhibited a stable response up to 2.0% drift. However, the beam strength then dropped significantly due to damage localization, followed by fiber pullout. The hysteresis loops showed some “pinching” with less energy dissipation capacity compared to Specimen 1. This pinching is due to the fact that the PE fibers are effective in restraining crack opening, but once unloaded they do not provide any resistance against crack closing. In addition to that, the contribution of minimum distributed horizontal and vertical reinforcement to the force transfer mechanism across cracks during the crack closing process was very limited.

The strength and displacement capacity of the coupling beam in Specimen 3 was significantly increased through the use of diagonal bars confined only by HPRCC material, as observed in Fig. 5c. In terms of strength, the diagonal bars were estimated to contribute approximately 210 kN (47 kips) of the beam shear strength at yielding (26% of maximum beam strength). Consistent with this expected strength, the difference in strength between Specimens 2 and 3 was about 200 kN (45 kips). The maximum load of 800

As mentioned earlier, the shear force versus drift hysteresis loops give a visual indication of the energy dissipation capability of the specimens. From Fig. 5, it was observed that Specimen 1 had good energy dissipation with wide hysteresis loops, Specimen 2 experienced “pinching” due to lack of an efficient force transfer mechanism during unloading, and the supplemental diagonal bars used in Specimens 3 and 4 enabled better energy dissipation with respect to Specimen 2. Energy dissipated per cycle was determined for each specimen by calculating the area enclosed by the hysteresis loops in the shear force versus drift diagrams. To account for different drift levels reached for positive and negative loading directions in a cycle, average drift was used. Fig.11 shows the energy dissipated per cycle for Specimens 1 and 4 with respect to drift levels. As can be observed, the energy dissipation capacity of Specimen 4 was comparable to that of Specimen 1, even though the amount of diagonal reinforcement and beam width were less than that of Specimen 1. For both specimens, there is an almost linear increase in the energy dissipated from 1.5% to 4.0% drift. Beyond this point, energy dissipation per cycle remained constant for

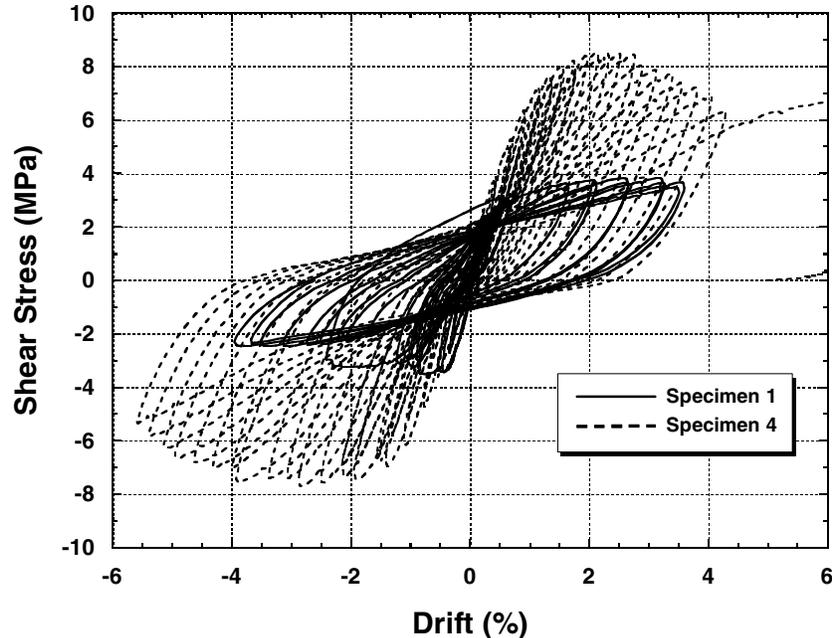
Figure 6 – Shear Stress versus Drift Response of Specimens 1 and 4

Fig. 6 shows a comparison between the shear stress versus drift responses for Specimens 1 and 4. As can be observed, Specimen 4 sustained shear stresses twice as large and possessed substantially larger energy dissipation capacity compared to Specimen 1.

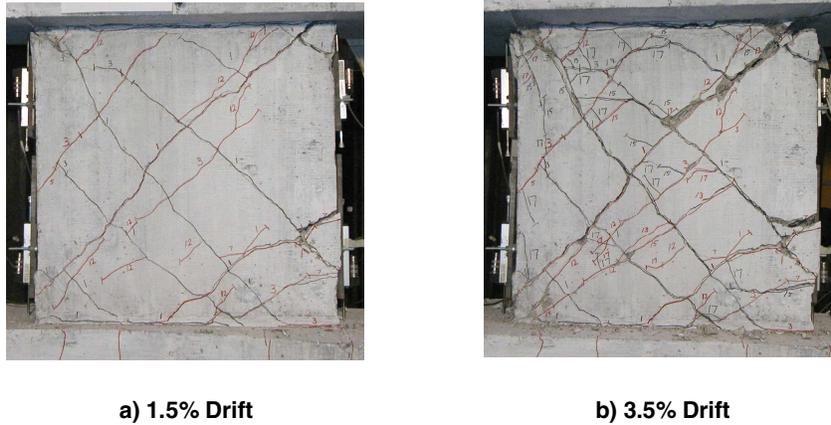
Figure 7 - Cracking Pattern in Specimen 1

For Specimen 1, diagonal cracks began to form in the coupling beam during the cycles to 0.25% drift. These cracks widened substantially at 1.5% drift, reaching a state that could be classified as moderate damage (Fig. 7a). At drift levels larger than 2.5%, severe damage was observed in the coupling beam with concrete spalling and tensile strains in the diagonal reinforcement in excess of 1.5%. Fig. 7b shows the damage level in the RC coupling beam at 3.5% drift. Even though extensive cracking and damage had occurred at the maximum drift level of 4.0%, no clear indication of failure was observed.

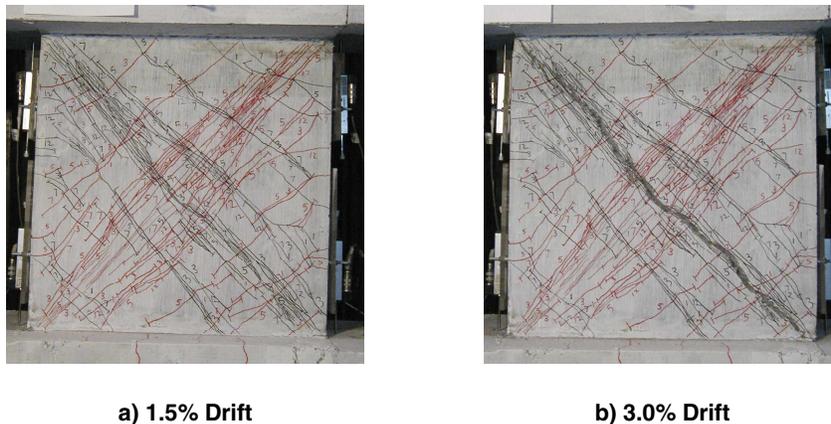
Figure 8 - Cracking Pattern in Specimen 2

In Specimen 2, the first diagonal cracks also formed during the cycles to 0.25% drift. As the test progressed, several diagonal cracks propagated throughout the beam, as opposed to only a few diagonal cracks in the RC coupling beam. At 1.5% drift, the HPCFRCC coupling beam was crossed by tens of hairline diagonal cracks (Fig. 8a). At about 2.0% drift in the negative direction, fiber pullout occurred, leading to the opening of a wide diagonal crack (Fig. 8b) with a subsequent drop in beam strength. When the displacement was reversed, another diagonal crack, perpendicular to the previously formed crack, opened at approximately 3.0% drift and resulted in a diagonal tension failure of the coupling beam.

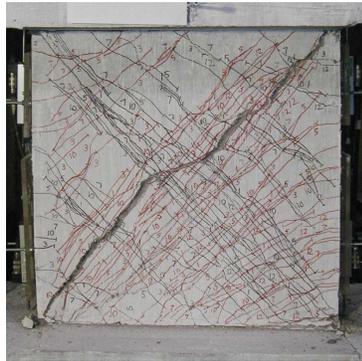
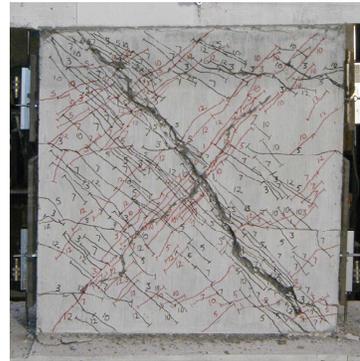
a) Specimen 3 at 4.0% Drift

b) Specimen 4 at 4.0% Drift

Figure 9 - Cracking Pattern in Specimens 3 and 4

Overall damage progress observed in Specimens 3 and 4 was similar to that of Specimen 2. Diagonal cracking began during the cycles to 0.25% drift and a large number of hairline cracks had formed when the 1.5% drift level was reached. At approximately 2.0% drift, damage localization initiated at a few diagonal cracks that spanned opposite corners in the coupling beam. However, contrary to the behavior of

Specimen 2, Specimens 3 and 4 carried the same or an increasing amount of load at drifts up to 4.0% due to the use of supplemental diagonal reinforcement. Figs. 9a and 9b show the cracking pattern in Specimens 3 and 4, respectively.

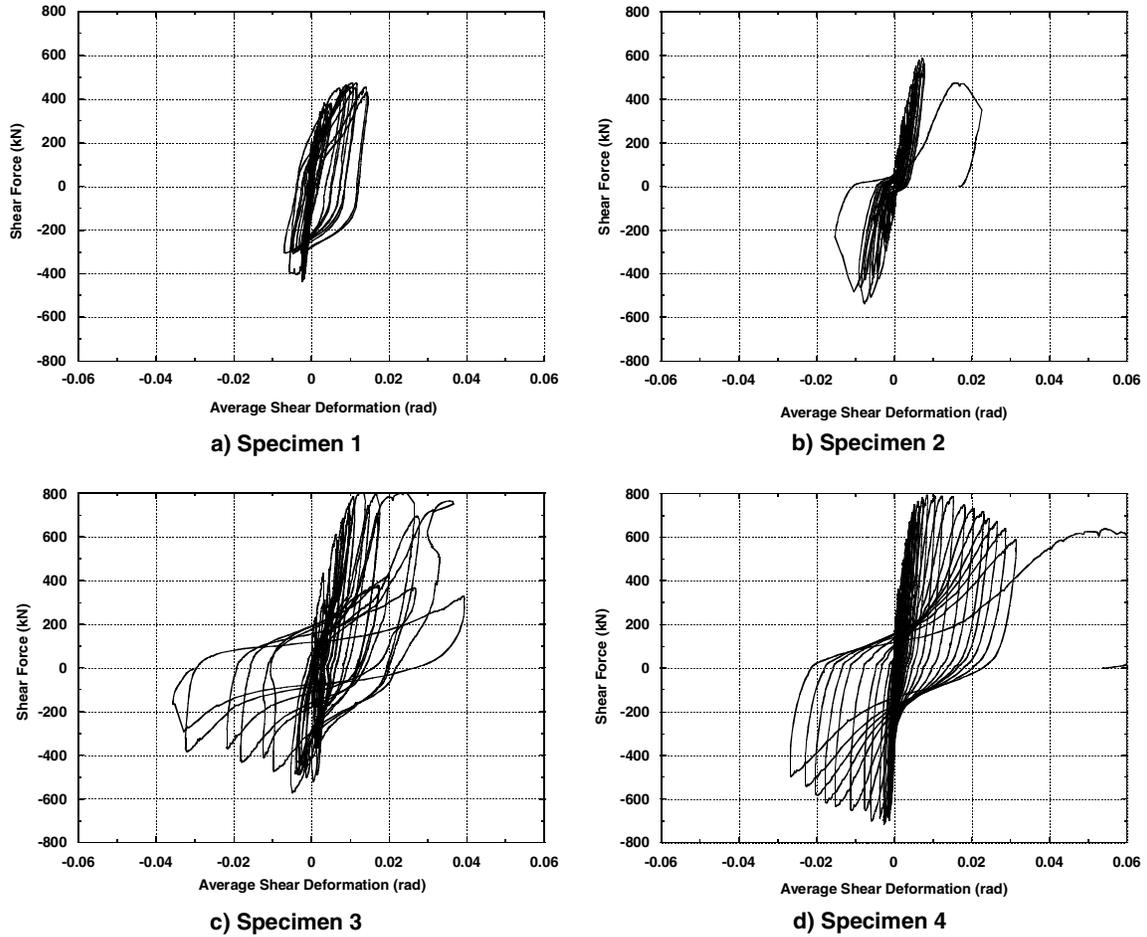
Figure 10 - Shear Force versus Distortion Response of Test Specimens

The shear force versus shear distortion response for the four coupling beam specimens is shown in Fig. 11. Specimen 1, detailed as per the 1999 ACI 318 Code [20], exhibited a stable shear response throughout the test (Fig. 10a). Because the diagonal bars resisted most of the applied shear force, wide hysteresis loops were obtained. The maximum shear distortion measured in Specimen 1 was 1.5% (0.015 rad) at a drift of 4.0%, indicating that large flexural deformations dominated the coupling beam response.

As shown in Fig. 10b, a pinched shear distortion response was observed in Specimen 2 due to absence of an effective force transfer mechanism. During crack opening, PE fibers are only effective in transferring tensile forces between diagonal cracks. When the displacement (load) direction was reversed, the fibers did not resist the crack closing process, and thus only the nominal beam reinforcement contributed transferring forces across cracks. Once the diagonal cracks closed, the specimen regained its stiffness. The coupling beam in Specimen 2 had a shear distortion capacity of approximately 1.0%. At this distortion level, fiber pullout occurred, leading to a significant drop in the strength of the specimen.

In Specimens 3 and 4, the shear distortion capacity was significantly improved due to the presence of the diagonal bars. Specimen 3 sustained a shear distortion of approximately 2.5% in the positive loading direction before a significant drop in strength occurred (Fig. 10c). This large distortion, compared to Specimen 1, also indicates that shear deformations played a dominant role in the specimen response. In Specimen 4, the beam strength decay began before a 2.0% shear distortion as fiber pullout initiated (Fig. 10d). However, because of the increasing strength contribution from the diagonal bars as they strain hardened, the loss of beam shear strength was gradual. In this specimen, a maximum shear distortion of 3.0% was measured during the cycles to approximately 4.0-5.0% drift. During the final push, a shear distortion of 6.0% was measured, just before fracture of the diagonal reinforcement occurred.

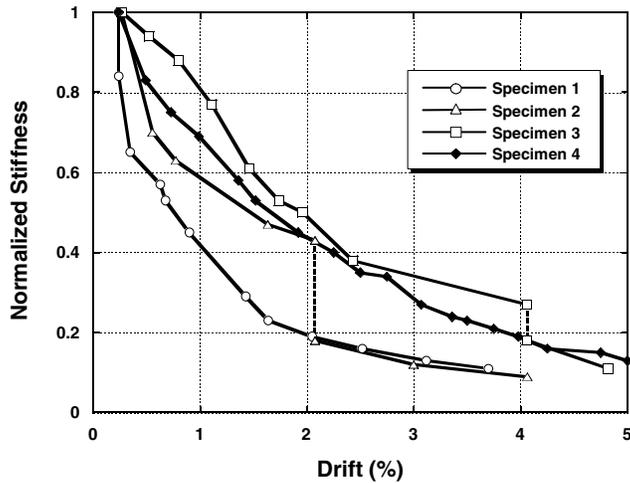
Fig. 12 – Normalized Stiffness versus Drift Response of Test Specimens

Fig. 12 shows the normalized stiffness versus drift response for all four specimens. The stiffness was a secant value measured from peak-to-peak displacement point in each direction. The stiffness values were normalized with respect to the secant stiffness at 0.25% drift in order to account for the variations in specimen parameters. From Fig.12, it can be observed that HPFRCC coupling beams showed better stiffness retention with respect to the RC coupling beam. Normalized stiffness of Specimen 1 decreased significantly after the formation of the first diagonal cracks, whereas the HPFRCC specimens showed a relatively gradual stiffness decrease up to at least 2.0% drift. At that drift level, fiber pullout occurred in Specimen 2, resulting in a sudden stiffness drop. The presence of diagonal reinforcement in Specimen 3 not only delayed this stiffness drop up to 4.0% drift, but also improved the stiffness retention at low drift values. When the normalized stiffness values at 2.0% drift for the four specimens are compared, it can be seen that Specimen 1 maintained only 20% of its initial stiffness, whereas the HPFRCC specimens maintained about 40% to 50% of their initial stiffness.
