CONTAINMENT REINFORCEMENT FOR EARTHQUAKE RESISTANT MASONRY BUILDINGS

SUMMARY

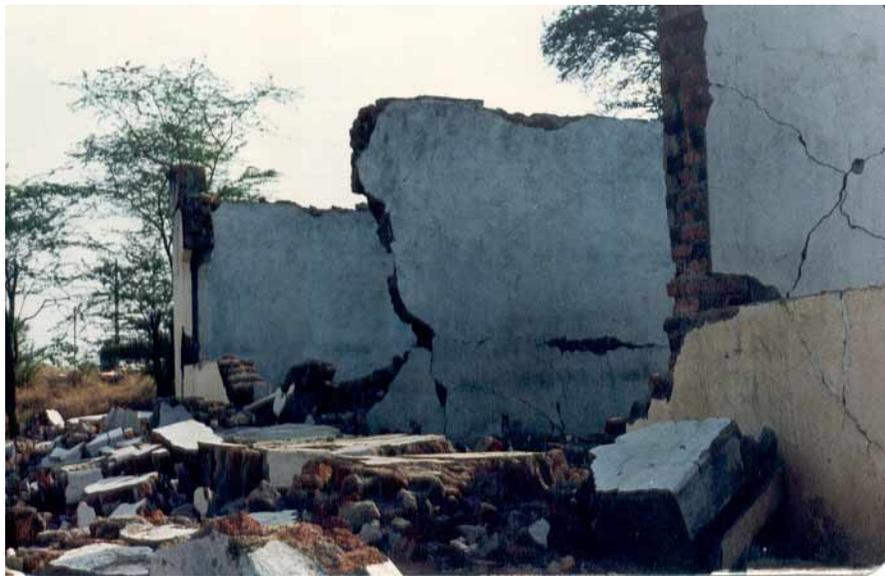
Plate 1: Out-of plane collapse of wall of a school building (Sastur)

The out-of plane failure of brick masonry wall in a place called Sastur after the Latur earthquake is shown in Plate 1. This clearly demonstrates the vulnerability of masonry buildings with light roof during an earthquake. Plate 2 shows another shop building built out of brick masonry in Sastur having walls on three sides and door opening on the remaining one side with all the walls practically intact after the earthquake. This building had mud roof supported on timber posts and beams. Some of the timber posts were adjacent to the walls as could be seen in the photograph (The timber posts have been removed for reuse elsewhere). The presence of timber posts at close intervals adjacent to the walls must have acted as an earthquake resistant feature in the vertical direction and hence prevented the flexural collapse of the walls.

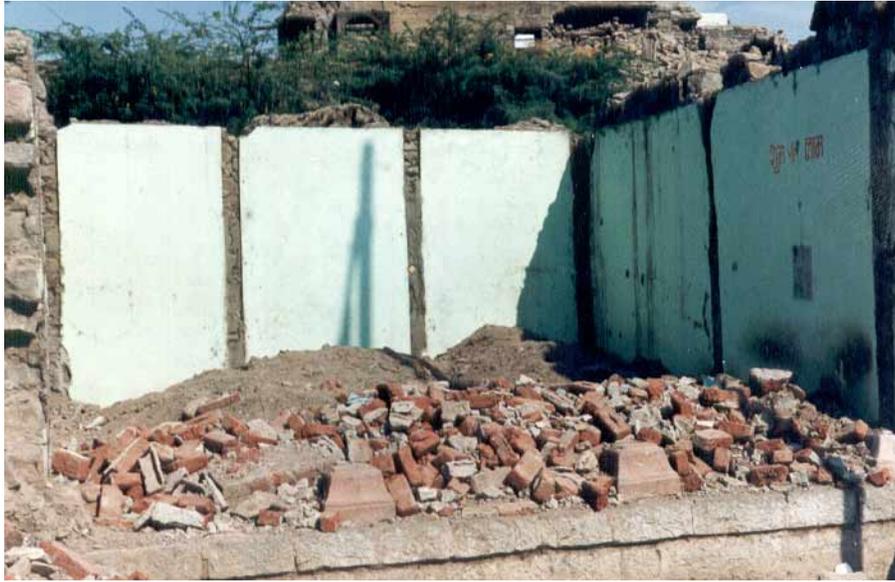
Plate 2: Timber post supported wall of a shop building intact after earthquake (Sastur)

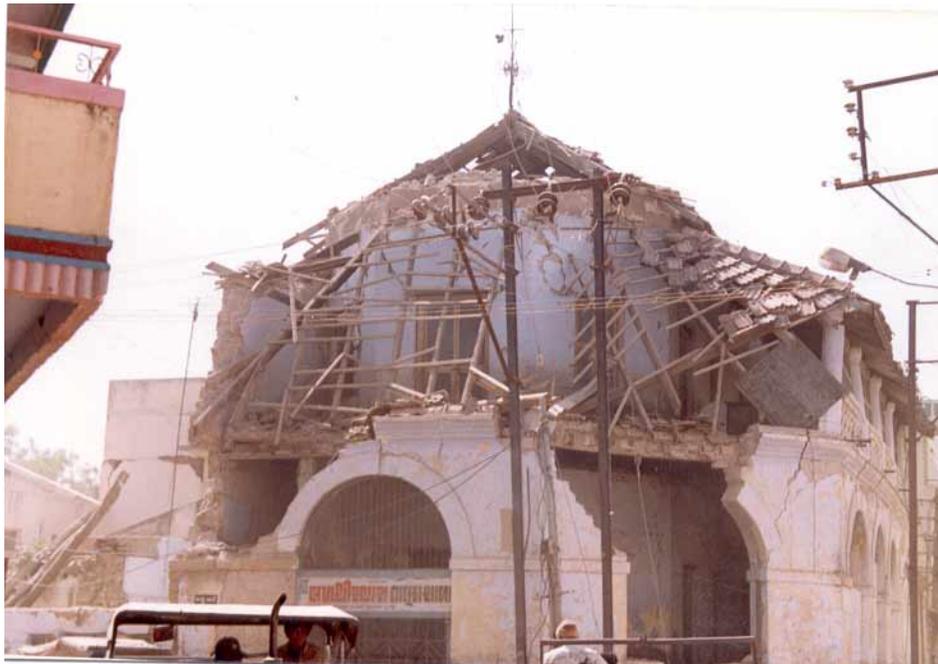
Plate 3: Out-of-plane failure of sandstone in lime mortar masonry wall (Morbi)

The old buildings in the town of Morbi were essentially made of sand stone units with lime mortar. All such buildings performed badly in the Kachchh earthquake, where as neighboring brick-in-cement mortar buildings survived even though they developed extensive cracks. The collapse of buildings was essentially due to out-of-plane failure of walls. Further, buildings with light roofs were more prone to such type of failure. Plate 3 shows one such typical failure.

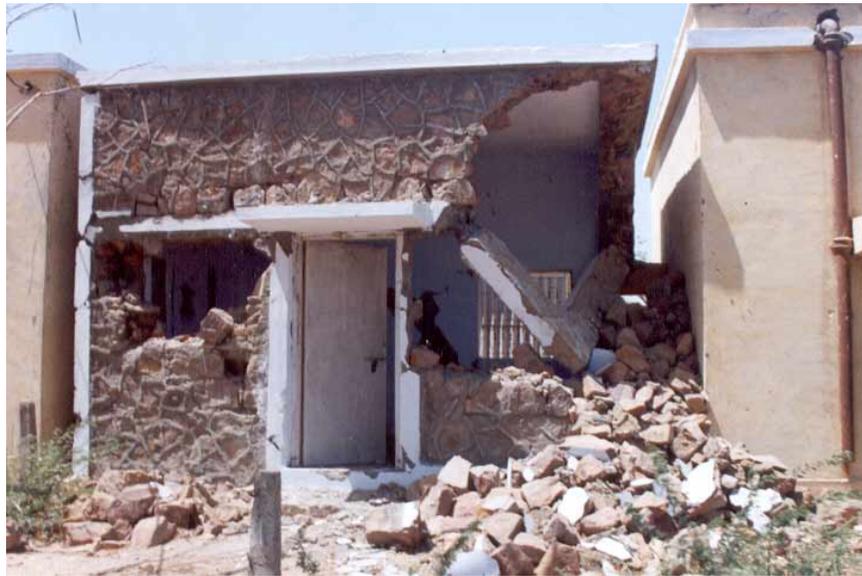
Plate 4: Out-of plane failure of wall leading to collapse of lintel band (Bhuj)

In the new town of Bhuj the masonry buildings built by Central Public Works Department had earthquake resistant features like lintel band and corner reinforcement. Two such buildings were studied. In one building the wall below the lintel band suffered out-of-plane failure and the lintel band also had come down (Plate 4). Plate 5 shows another building, the corners of which has been badly damaged. This building had corner reinforcement. The provision of corner reinforcement is not possible without having a continuous vertical joint, which could trigger separation of walls meeting at the corner at the first jolt during an earthquake.

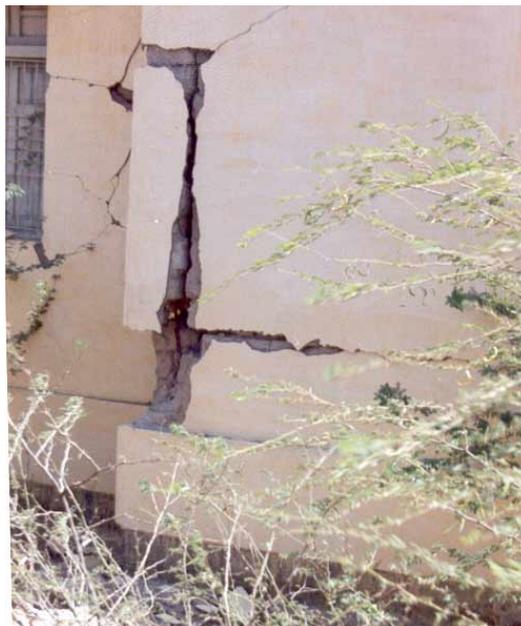
Plate 5: Corner failure in presence of corner reinforcement (Bhuj)

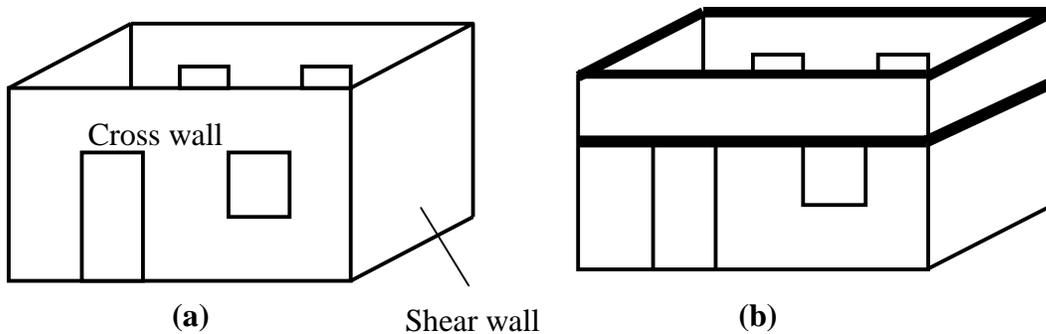
Figure 1: Buildings without roof (a) without bands (b) with RC lintel and roof bands

The walls of a masonry building offer resistance against lateral dynamic loads by developing flexural and shear stresses, during earthquake ground motions. In an attempt to identify the regions in a masonry building where the flexural stresses and shear stresses are a maximum during an earthquake, a linear dynamic analysis has been carried out on a typical single storeyed masonry building of plan dimensions 6.0m x 3.0m, when subjected to earthquake ground motions. It is assumed that the earthquake ground motion is perpendicular to the cross walls of 6.0m length. Two openings were provided in the cross-walls and none in the shear-walls. The following three structural features were considered for the analysis. The schematic diagrams of the buildings are shown in Figure 1 and 2.

1. Masonry buildings without any earthquake resistant features and with light roofing material that is loosely placed at the top edge of the wall. The top edge of walls of such buildings could be assumed to be un-restrained (B–1).
2. Masonry buildings with RC lintel and roof level bands and un-restrained at the top edge. The lintel and roof level bands were in accordance with BIS [2] codal provisions (B–2)
3. Masonry buildings with heavy RC roof and RC lintel band (B–3)

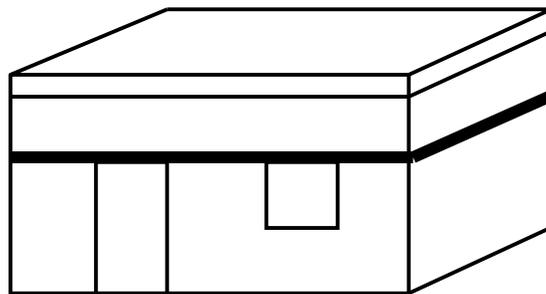
Figure 2: Building with RC roof and lintel band

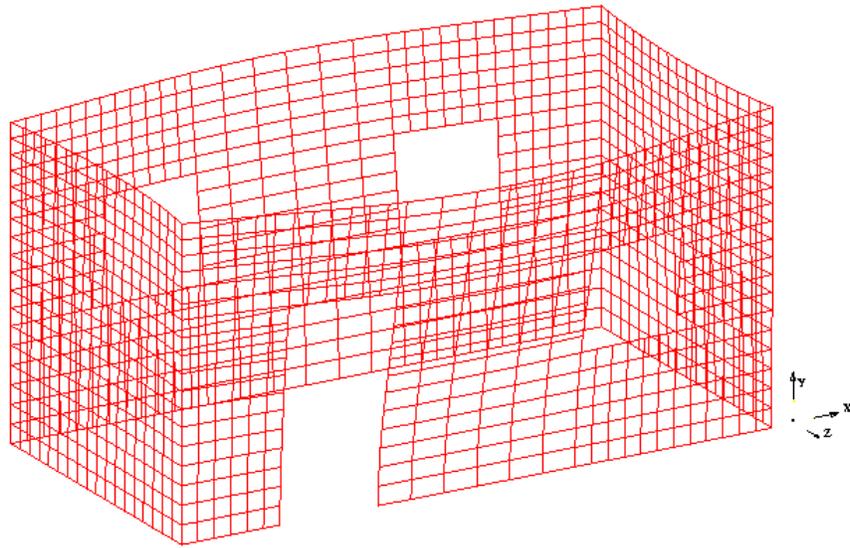
Figure 3: Fundamental mode shape of building without roof

The behavior of masonry buildings under lateral dynamic loads is rather complicated basically due to complexities of the walls such as orthotropy, presence of openings, continuity at junctions of cross-walls and shear-wall etc. However, all these can be conveniently modeled using finite element technique. In the present analysis the finite element model was developed using a commercially available software [8]. The properties used for the FE analysis are presented in Table 1. Free vibration analysis was carried out to obtain the natural frequencies, mode shapes and modal participation factors before carrying out the ground motion analysis. The first four natural frequencies (in Hz) of the buildings analyzed are presented in Table 2. The fundamental mode shape of building without roof and with roof is shown in Figures 3 and 4 respectively.

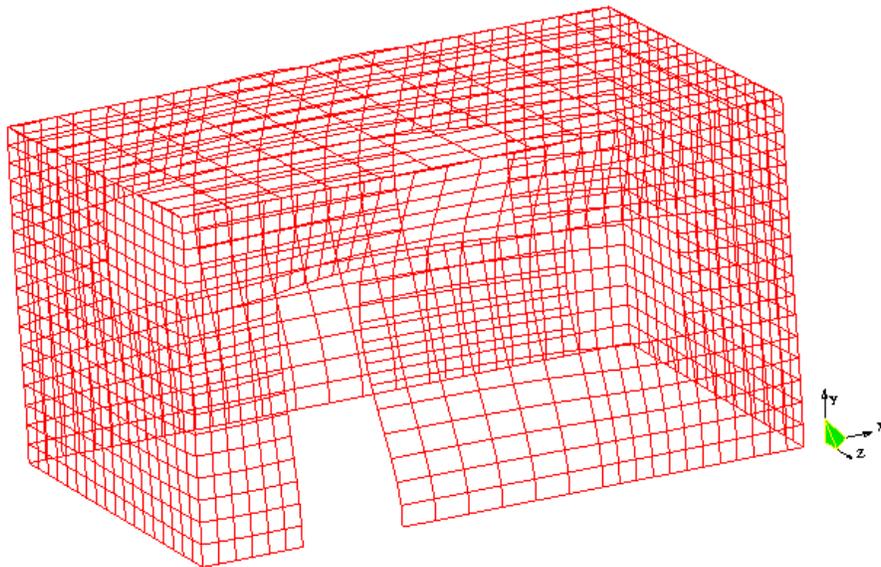
Figure 4: Fundamental mode shape of building with roof

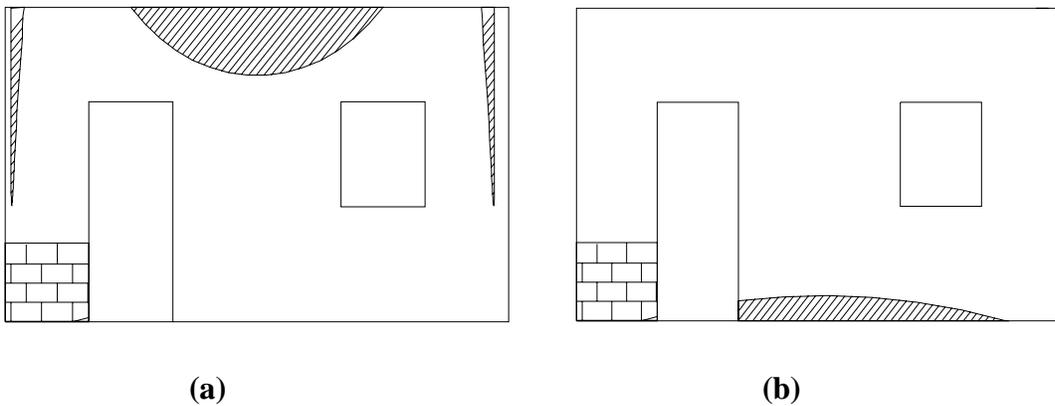
Figure 5: Regions of maximum flexural stress for buildings without roof (a) σ_x (b) σ_y

Table 4 gives the values of the maximum flexural and shear stresses in masonry. The zones of maximum stresses are shown in Figures 5-7. Table 1 also gives the flexural strength and shear strength of the masonry. It is interesting to compare these strengths with the maximum stresses developed. In the case of buildings without roof and without any seismic bands, the flexural stresses developed in the direction parallel-to-bed-joints (at the centre and ends of top edge of the cross-walls) are exceeding the strength in that direction. This could lead to the development of vertical cracks propagating from the centre of the top edge and at the junctions of the walls. The development of cracks at the junctions of walls could also lead to separation of walls at corners. On the other hand, it can be noticed that the presence of horizontal seismic bands or RC roof brings down these stresses significantly. Again in the case of buildings without roof, the flexural stresses in the direction normal-to-bed-joints (at the base of the cross-walls) are exceeding the strength in that direction. These are responsible for the development of horizontal cracks. It is interesting to note that the presence of bands increases the stresses at the base. The values of these stresses are significantly high between the two openings for the buildings with RC roof as well. Indeed this is the vulnerable portion of the cross-wall. Plate 6 shows the collapse of portion of the wall between openings in a school building in Khavda (Gujarat) during the Kachchh earthquake of 2001. The maximum shear stresses developed in the shear-walls are also exceeding the shear strength of masonry reported by Sarangapani [9]. Expectedly, these values are rather high in the case of building with heavy RC roof. These stresses are responsible for the development of the typical 'X' type of cracks in the shear-walls of masonry buildings. It may be remarked that these buildings were analyzed with the ground motion input normal to the cross-walls and hence the flexural stresses are high in the cross-walls and shear stresses are high in the shear-walls. It is possible that these walls could experience a combination of both stresses. It may also be remarked that the separation of walls at the corners hastens the out-of-plane collapse that are noticed very commonly in a majority of low-rise masonry buildings. It is thus clear that there is a need to impart ductility by way of providing reinforcement along both directions in masonry to prevent such catastrophic failure of walls.

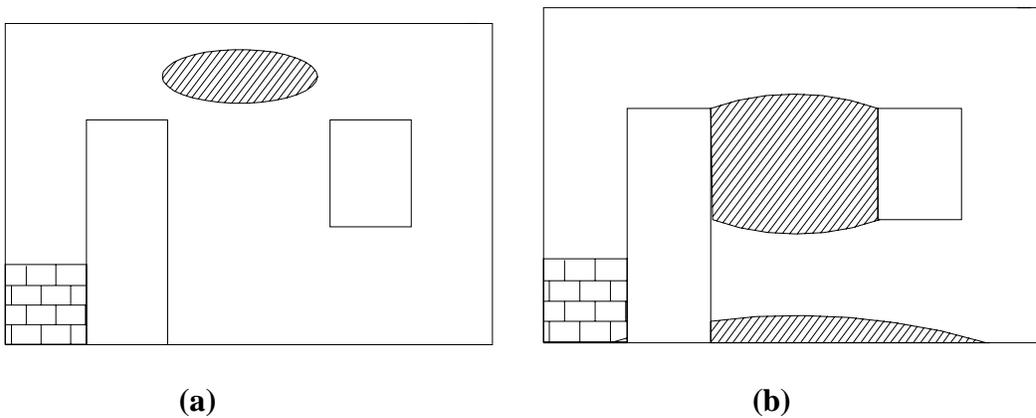
Figure 6: Regions of maximum flexural stress for buildings with roof (a) σ_x (b) σ_y

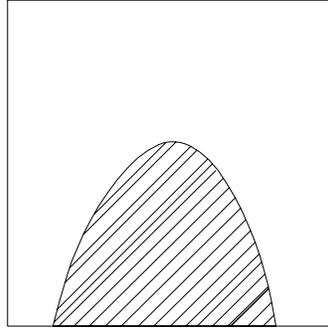
Figure 7: Regions of maximum shear stress in shear-walls (τ)

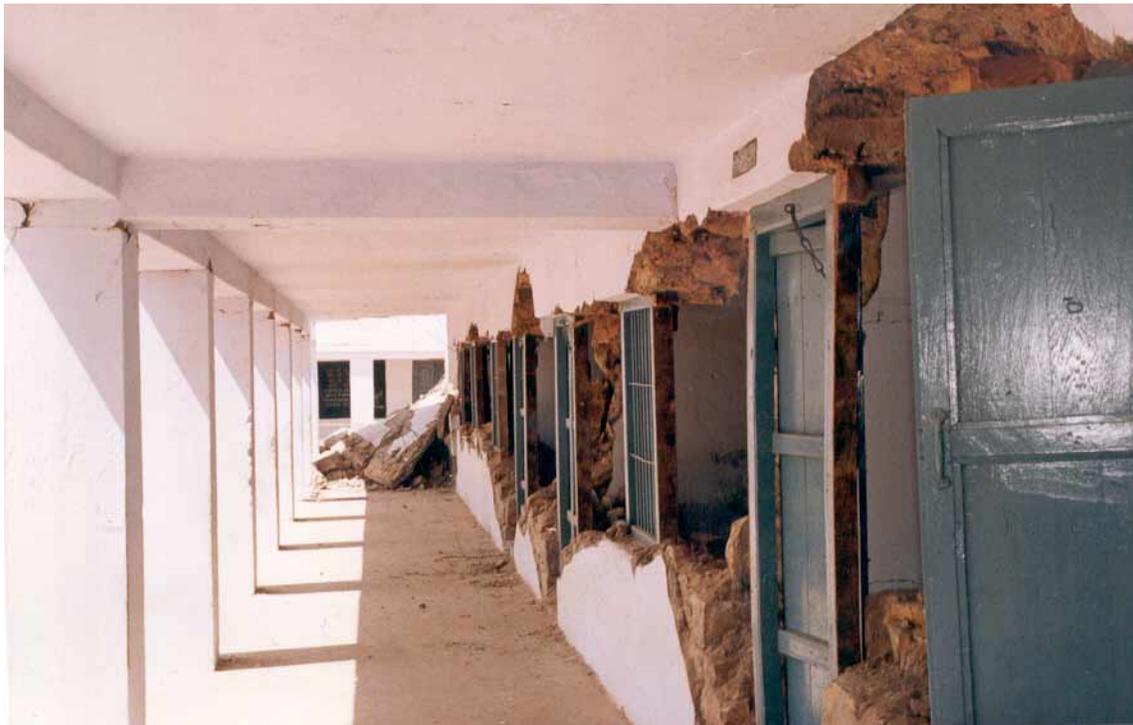
Plate 6: Collapse of walls between openings (Khavda)

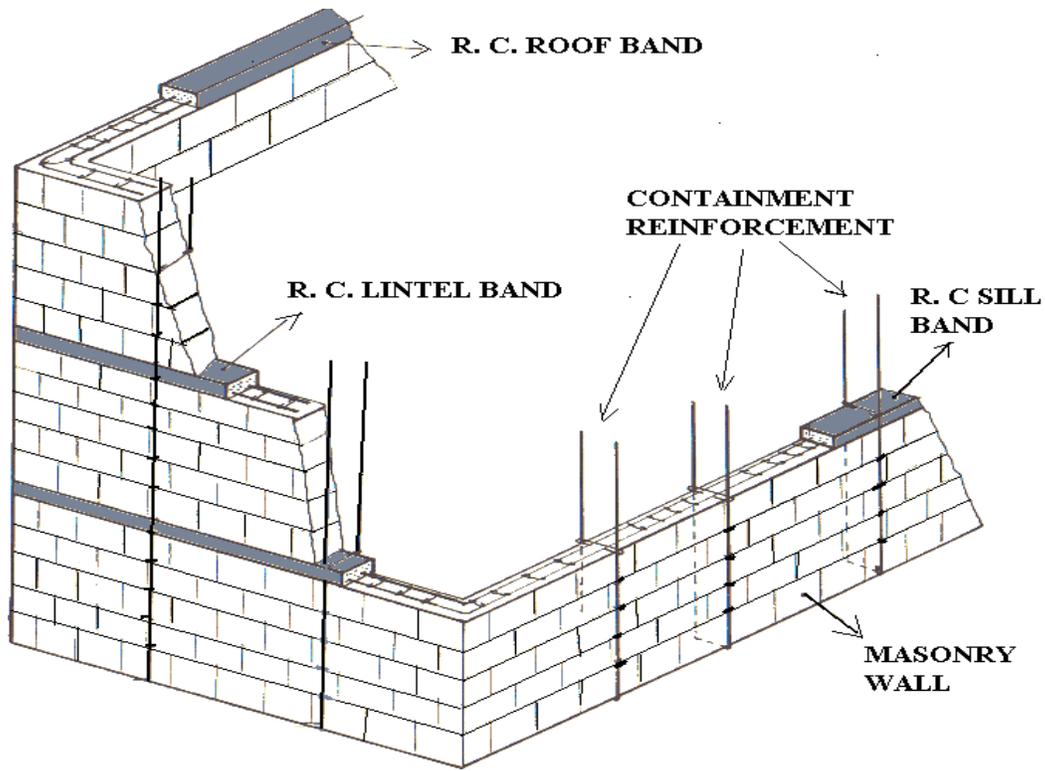
Figure 8: Masonry building with horizontal R.C. bands and containment reinforcement

Based on the field investigations of buildings after an earthquake and dynamic analysis of a typical masonry building subjected to ground motion, it can be concluded that existing provisions of BIS [2] for earthquake resistant design are inadequate to prevent collapse of masonry buildings due to out-of-plane failure of walls. Two important aspects of any earthquake resistant feature are ductility and integral connectivity of the various structural components of the building. It is rather easy to derive both these in the case of reinforced concrete framed structures than in load bearing masonry buildings. Unreinforced brick masonry, generally has poor flexural strength and practically no ductility in flexure. The masonry wall behaves like a plate in two-dimensional bending, when subjected to lateral load during earthquakes. Hence there is a need to reinforce the wall in both horizontal and vertical directions to impart ductility to the wall. It is rather easy to introduce reinforcement and embed it in a thin layer of concrete in the horizontal direction through the bed joints of the masonry, which results in horizontal bands at various

levels. These R.C. bands also integrally connect the various walls of the building together. The provision of vertical reinforcement poses certain difficulties. The conventional approach is to provide reinforcement in the middle of the wall enclosed by concrete. This will be inefficient since half of the wall thickness will be ineffective during the bending of the wall and the ductility of the wall will be limited to compressive strain capacity of the masonry. Further, the interface between the concrete enclosing the vertical steel and the masonry will create a vertical joint which is contrary to the concept of masonry construction. Such an interface between two materials having significantly different elastic properties will facilitate formation of vertical cracks. In order to overcome the above difficulties a new and an innovative way of providing vertical reinforcement on the surface of masonry wall has been developed which is called as “**containment reinforcement**”. In this technique the steel rod is wrapped around the wall in the vertical direction with reinforcement anchored at the top and bottom to the roof and plinth R.C. bands. Further the rods on either faces of the wall are held together at intermittent levels by steel ties/links passing through the bed joints of the masonry. The links are necessary to prevent the buckling of the steel rod present on the compression side of the wall. For the containment reinforcement to be effective, it is essential for it to remain hugged to the wall at all times during an earthquake. Such vertical reinforcement has to be provided at intervals ($\approx 1\text{m}$) along the length of the wall, adjacent to door and window openings and at corners of the building. Figure 8 shows a schematic view of a masonry building with horizontal bands and containment reinforcement. A similar concept of wrapping the walls with flexible nylon straps both in the vertical and horizontal directions was explored by Ginell et al [10] for retrofitting adobe brick buildings to withstand earthquakes. However, nylon straps are unlikely to be effective since they have low modulus of elasticity (520MPa) compared to steel. McKay [11] suggests a similar way as containment reinforcement for reinforcing masonry retaining walls to assist in resisting lateral pressure

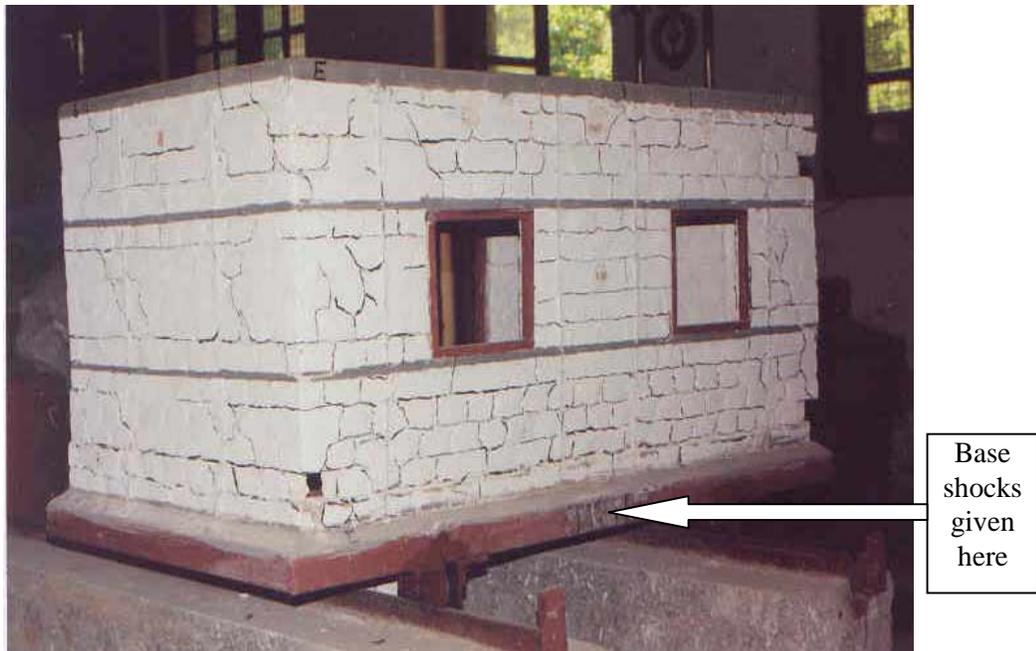
Plate 7: Building model with horizontal bands and containment reinforcement after 60 base shocks

To understand the complex behaviour of masonry buildings during ground motion, sophisticated facilities like shake table with instrumentation are needed. However, such tests on full-scale prototype are prohibitively expensive. In this context studies on small-scale models become indispensable. Further, in this study a simple version of a shake table called shock table has been adopted to examine the efficacy of masonry building models with containment reinforcement. This test involved imparting base shocks to the table, over which the building model is mounted, using a pendulum impact device. Details of the shock table and various building models investigated with results have been presented elsewhere (Jagadish et al [12]). The building model with only horizontal bands withstood a total energy of 670.71 Nm before it became non-functional, whereas the building model with horizontal bands and containment reinforcement was capable of withstanding a total energy of 1966.7 Nm without collapsing. Plate 7 shows the building model with horizontal bands and containment reinforcement after 60 base shocks amounting to energy of 1966.7 Nm.
