NONLINEAR ANALYSIS OF A COLLAPSED HEATER STACK

SUMMARY

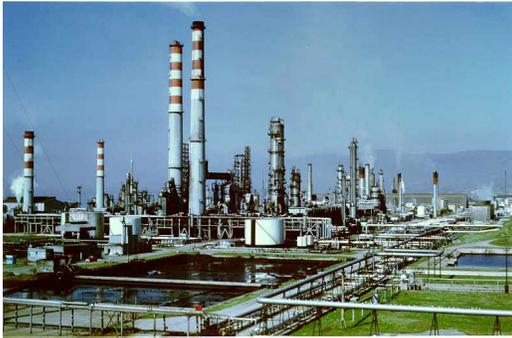
Figure 1. Heater stacks before earthquake

The reinforced concrete chimney shown near the center of Figure 1 collapsed during the earthquake. The debris cut many lines, which fueled fires that shut down the refinery for months.

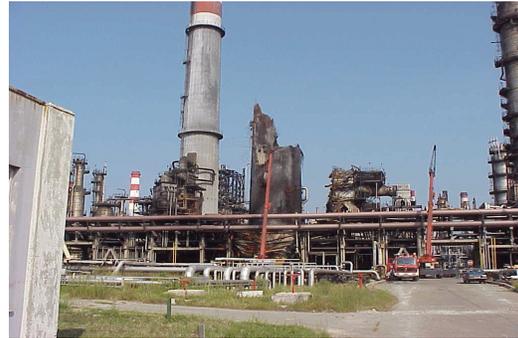
Figure 2. Heater stacks after earthquake

Referring to Figure 2, the collapsed heater stack is shown next to a similar structure that survived. The collapsed stack was 115 m high and was distinguished by a large rectangular opening for the flue duct that circumscribed an arc of about 50° . The bottom of the 3.7 m x 4.95 m duct opening was about 30 m from the base. The remnants of the stack are shown more clearly in Figure 3, where it is evident that the failure occurred in the vicinity of the opening.

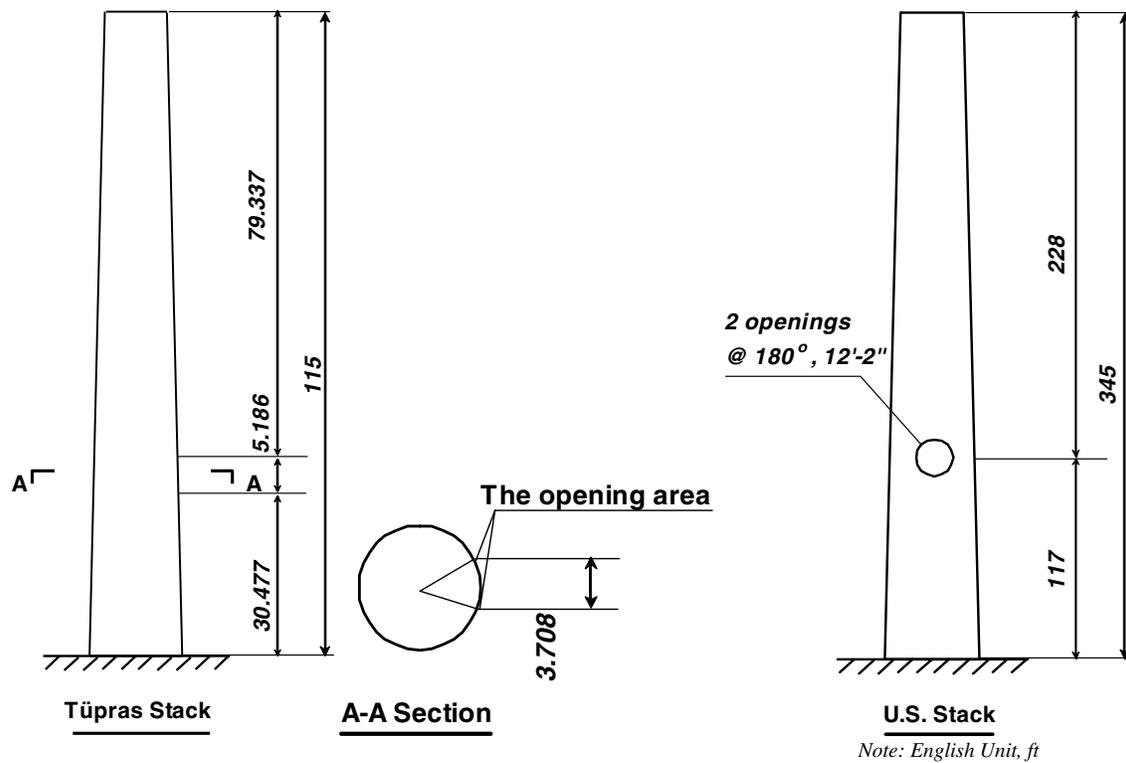
Figure 4. Chimney elevations

Elevations of the Tüpras chimney and the U.S. chimney are shown in Figure 4, and the steel reinforcing details can be found in Reference 2

The 115 m high Tüpras stack had a bottom outside diameter of 10.3m and a top outside diameter of 6.60 m. The thickness at the bottom was 0.45 m and at the top 0.20 m. It is a single flue reinforced concrete chimney lined with bricks and glass wool. The brick liner started from an annular reinforced concrete slab at level 30.50 m, close to the rectangular flue duct opening, and is supported by corbels at 10 m intervals.

The U.S. stack is dimensioned in English units, which are retained since the reinforcing bars are also specified in these units. It is 345 ft. high, and the bottom outside diameter is 31.54 ft. while the top outside diameter is 23.62 ft. In contrast to the Turkish stack, it has two diametrically opposite round openings.

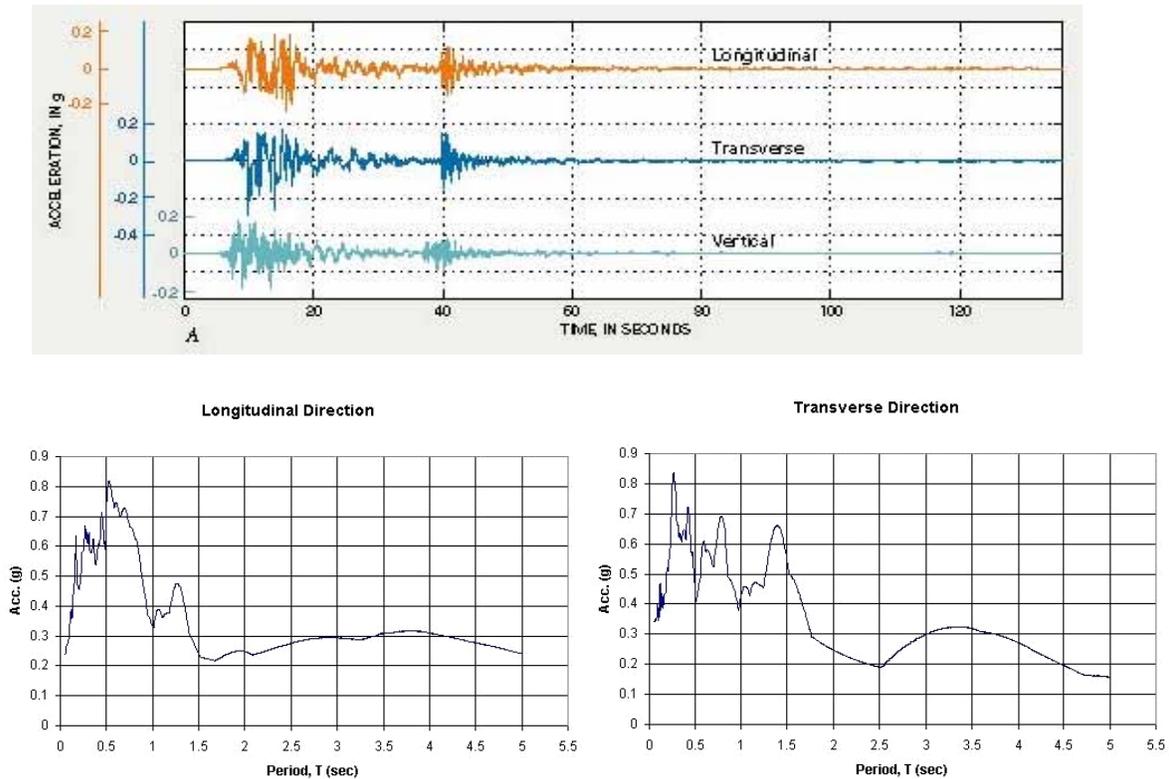
Figure 5. YPT time history and response spectra

In Figure 5, the time history of the motion recorded for three directions, and the corresponding response spectra for the transverse direction are shown. The spectrum for the longitudinal direction is similar.

A comparison of the demand from the YPT response spectrum shown in Figure 5 and the capacity of each stack based on a linear dynamic analysis was presented in Reference 2. It was concluded that the Tüpras stack was subjected to an earthquake somewhat in excess of the design event. Since other similar stacks in the immediate vicinity survived with minimal damage, the large opening was the likely triggering point for the collapse. It is anticipated that the U.S. stack, having lighter reinforcement and large openings, would have suffered the same fate.

From the YPT response spectrum shown in Figure 5, an equivalent Acceleration-Displacement Response Spectrum or Demand Spectrum may be constructed using the procedure of ATC-40 [9]. Since the basic procedure described in ATC-40 emphasizes a smoothed spectrum, such a curve is constructed from the mean ordinates in the Acceleration-Period space and mapped into the Acceleration-Displacement space. Also, a smoothed spectrum for the mean plus one standard deviation is plotted in the same way. The latter spectrum is recommended to account for near-fault effects [10]. Finally, a UBC-97 spectrum is constructed as an example of a modern design spectrum incorporating near-fault effects.

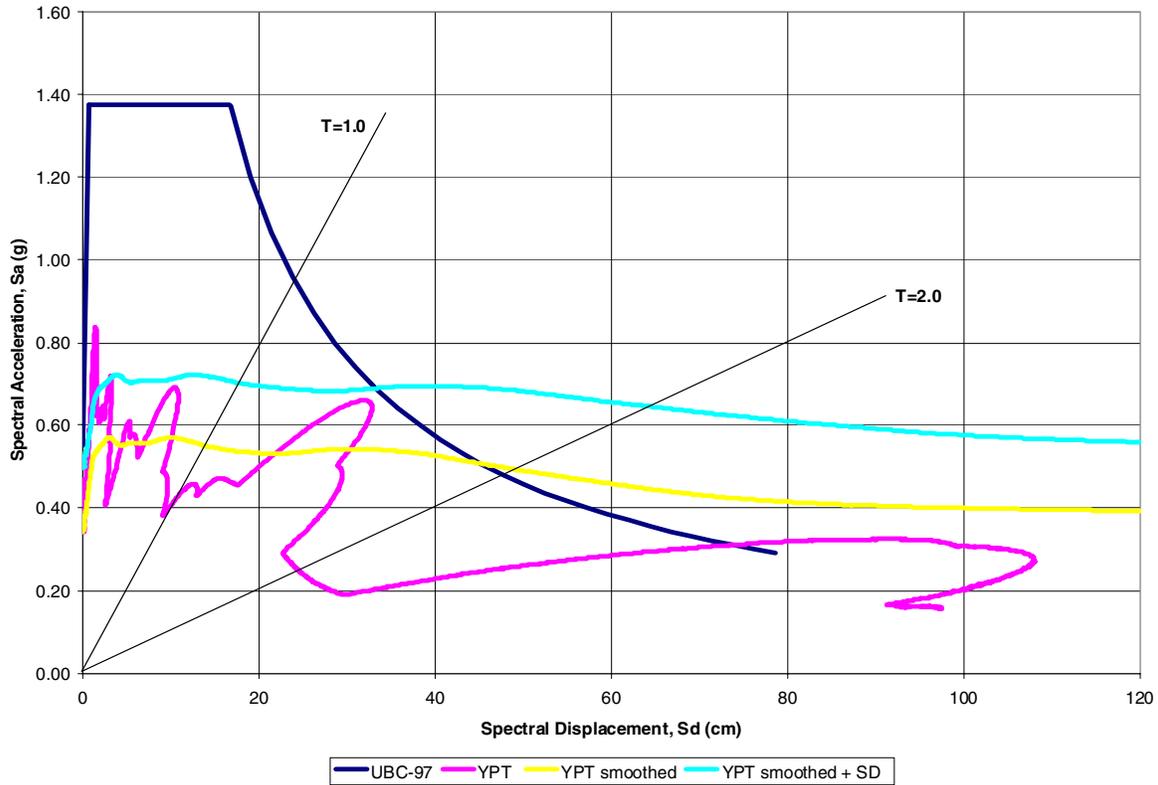
Figure 6. Demand curves

All of these demand curves are shown in Figure 6.

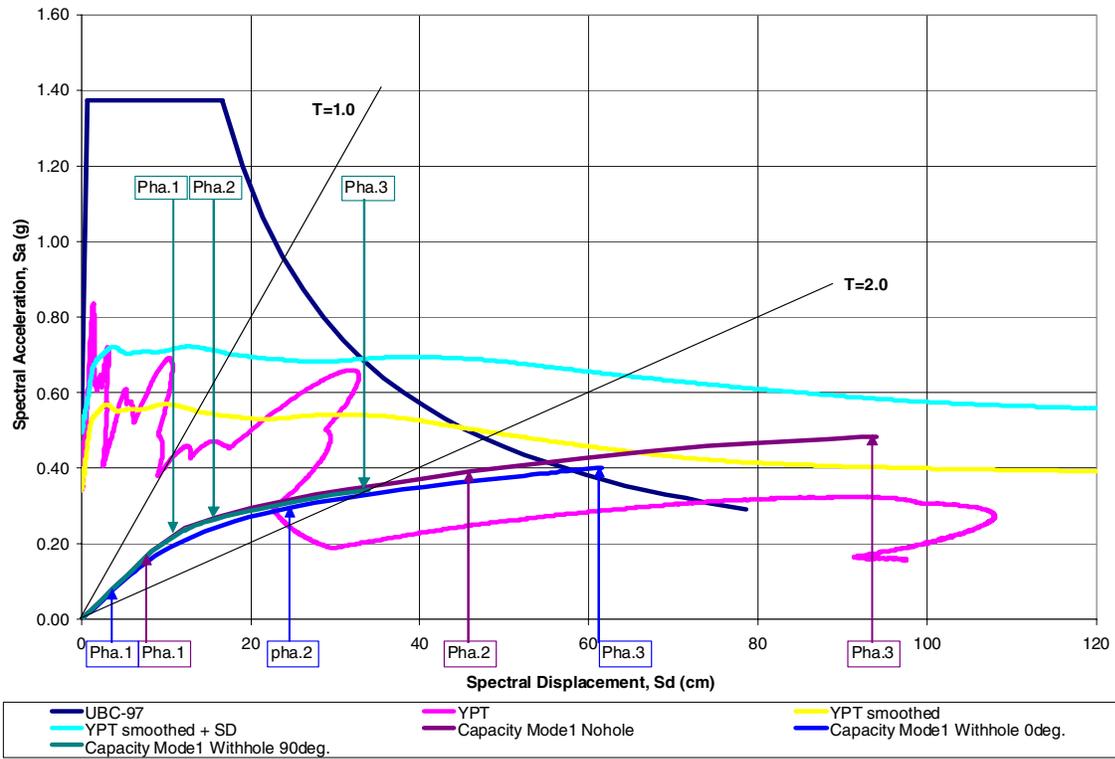
Figure 7. Demand curves vs. first mode capacity curves

The pushover capacity curves of the first and SRSS modes of the stack are plotted along with the demand spectra in Figures 7 and 8. In addition to the aforementioned demand curves, three pushover analysis curves are now plotted: the model without the opening; the model with the opening pushed parallel (0 deg.) to the opening; and then pushed perpendicular (90 deg.) to the opening. Figure 7 is based on a pushover profile following the shape of the first mode while Figure 8 was constructed from the SRSS profile.

Figure 7 shows that the model without the opening performed very well with ample ductility, which is consistent with the study of Wilson [4]. The capacity of the model with the opening (90 deg.) is the lowest of the three pushover cases while the failure point for the model with the opening (0 deg.) is between the other two. It is clear from the figure that neither the 90 deg model nor the 0 deg. model capacities meet the demand of the smoothed YPT spectrum. The capacity of the 90 deg. model is especially indicative of the possible failure mode of the structure during the earthquake in that it does not intersect the smoothed demand curve.

In order to better track the cracking development during the analysis, three phases of cracking patterns are plotted for each pushover curve, the initial crack phase, the middle crack phase, and the failure phase. The locations of these phases on the capacity curves are shown in Figure 7. For the model without an opening, as shown in Fig. 9, the flexural cracks started at the base level and extended upwards to about two-thirds of the stack height. The failure of this structure is clearly due to flexure. For the model with an opening, pushed at 0 deg. and shown in Fig. 10, the failure mode initiated with the cracks around the opening and developed downward to the base level. After the opening apparently attracted most of the cracks, the failure occurred when the cracking propagated to the middle height of the stack. For the model with an opening pushed at 90 deg. and shown in Figure 11, the first cracks occurred at the base level and the area around the opening. Then more cracks developed around the opening and at about one-third of the height from the base. The formation of many critical shear cracks around the opening, as shown in details in Fig.12, leads to the failure. Compared with the other two pushover results shown in Figure 9 and 10, the flexural cracks along the stack height shown in Figure 11 are much less developed before the collapse occurred.

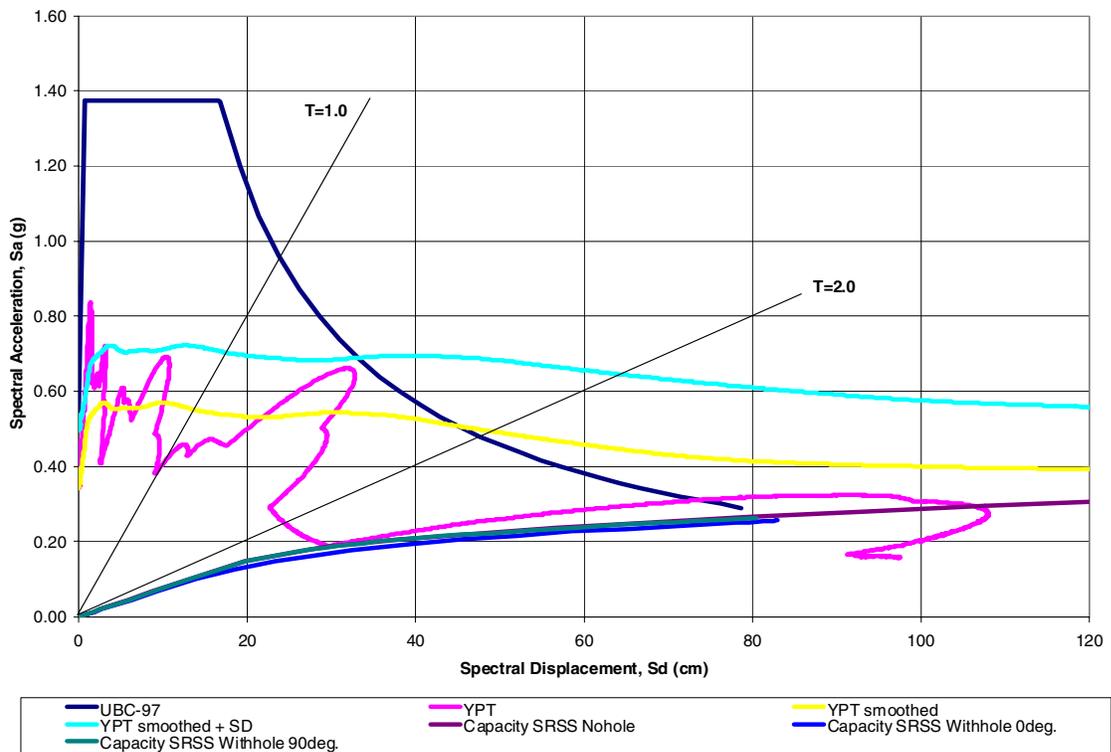
Figure 8. Demand curves vs. SRSS mode capacity curves

A similar analysis was performed for the SRSS pushover profile. As shown in Figure 8, the sequence of three capacity curves is very similar to those for the first mode profile. It is observed that all of the capacities for the structure under the SRSS load pattern are comparatively less than the first mode pattern results. Furthermore, the two cases for the stack with the opening do not even meet the demand of the **unsmoothed** spectrum. The cracking pattern for this case is very similar to the previous plots shown on Figures 9 - 12. Further results are available on the project website: <http://www.cive.wustl.edu/~whuang/>.

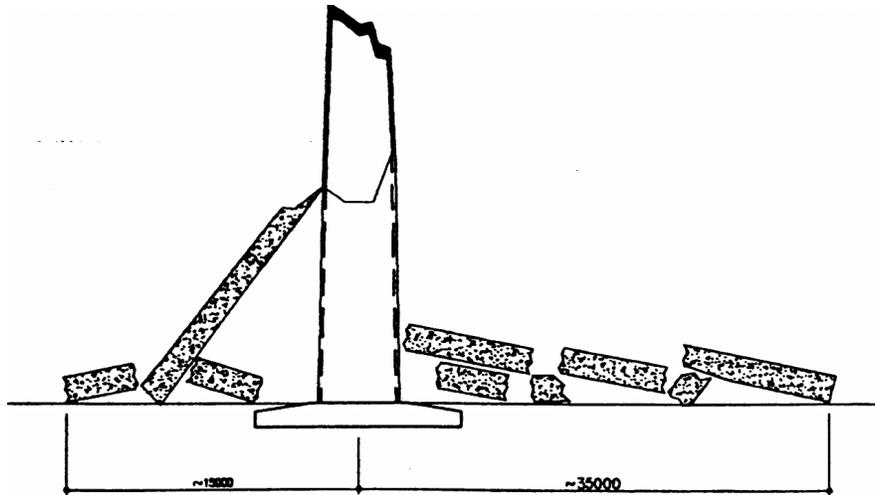
Figure 13. Fragments of collapsed tower looking straight on at the opening

A sketch of the debris from the collapsed tower was made available to the authors. This is shown in Figure 13 and seems to confirm that the loading at 90 deg to the opening presents the weakest capacity for static resistance.
