## **STRUCTURAL CRITERIA TO MEASURE THE BENEFIT OF RETROFIT MEASURES FOR USE IN INTERDISCIPLINARY EFFICIENCY STUDIES**

**Maria BOSTENARU DAN<sup>1</sup>**

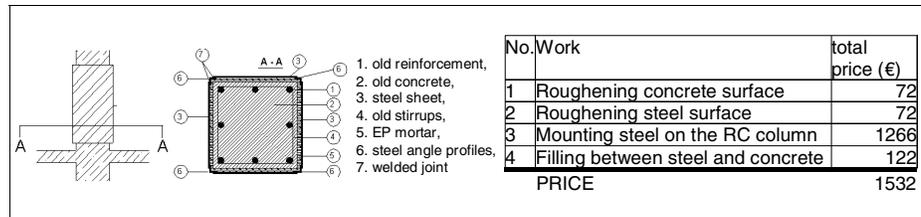
**Figure 5: Steel jacking of columns (after Bostenaru[4])**

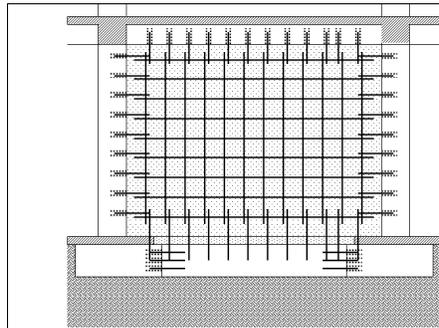
**Figure 6: Structural walls within chosen frames (after Bostenaru[4])**

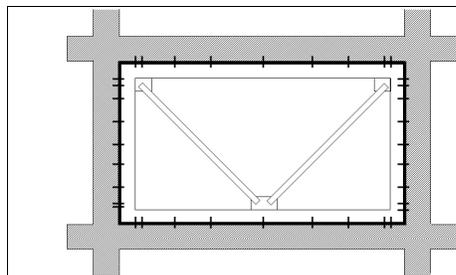
**Figure 7: Steel diagonals within chosen frames (after Bostenaru[4])**

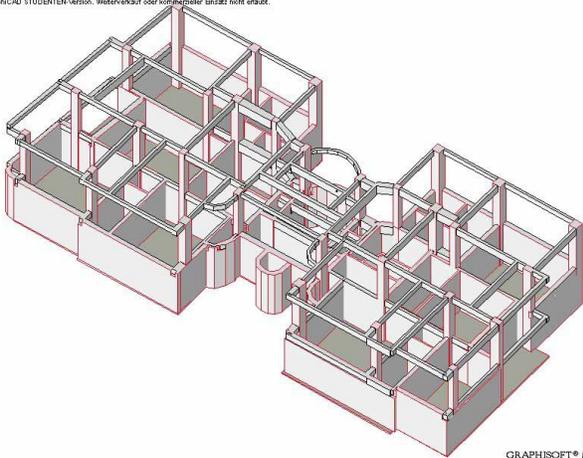
Figure 8: Axonometrie of current floor and structure of "Interbelic" (from Bostenaru[4])

This structural model of a real building with ground floor, basement and five upper floors has a relatively regular structure in height, by having only the basement different from the upper floors, but a highly irregular structure in plan, due to the distribution of columns but mainly to those of beams. The beams are not directly supported by columns in most of the cases, but by other beams and there are consoles at two of the four facades (fig. 7). The same reinforcement details used for the model buildings with regular shape described previously were taken. A proposed retrofit scheme with structural walls is also available. However, this does not fit in any of the schemes previously described (fig. 8). For this building more methods have been combined into a retrofit strategy. They include addition of structural walls and jacketing of columns. Structural walls are added on both sides of the middle bays and on the corresponding frames on the short sides of the building. On the long side four structural walls are added symmetrically to the centre of the building. These do not fill a frame as the existence of windows has been taken into consideration. The structural walls have much wider sections (25-30cm) as usually for such (15cm in new buildings, 20cm in the regular structure models here). Finally, two of the middle most solicited columns have been jacketed. The effect of the measures is a reduction of irregularity in plane. On the other side, the solution proposed presents the disadvantages described of increasing the section of structural members, altering the façade. It was tried though, that the intervention does not alter the quality of space. The structural walls present barbell sections, which could not be modelled for the analysis. For the analysis 10 bars of 28mm in each jacket were considered. For structural walls the same reinforcement bars were used. The retrofit could be well modelled in the software package used. For the column jacketing a special defined section was available in the software, which takes into account the bond between new concrete in the jacket and the old concrete in the original member. A fine FEM grid could be provided only with two elements for each member, due to model complexity and the already high number of nodes.

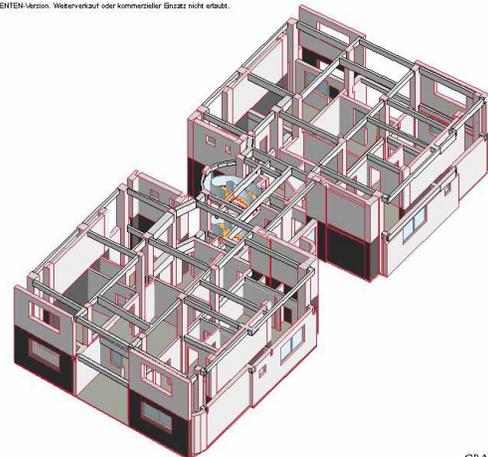
Figure 9: Seismic retrofit technique for "Interbelic" (from Bostenaru[4])

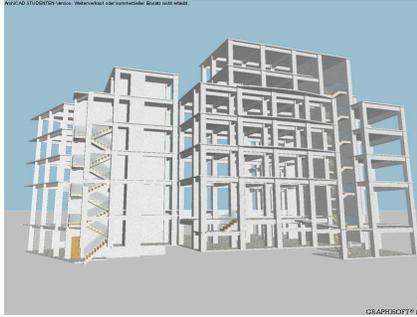
Figure 10: Perspective of the structure of model “Calderon”

Model “Calderon” consists of ground floor, basement and five upper floors, from which two present recesses (fig. 10-12 and 14). The building can be subdivided into a complex of two wings separated by a seismic joint: an L-shaped and a highly irregular one with four upper floors only, which additionally has a commercial higher ground floor. The slab over the basement has strong variations in vertical position, laying sometimes over a half-basement. In this case the retrofit was faked, as in the first analysis step the existing reinforced concrete structural wall was not modelled.

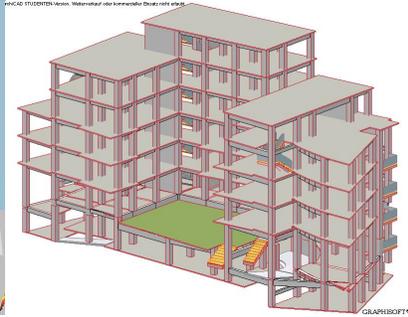
Figure 11: Axonometric view of model “Calderon”

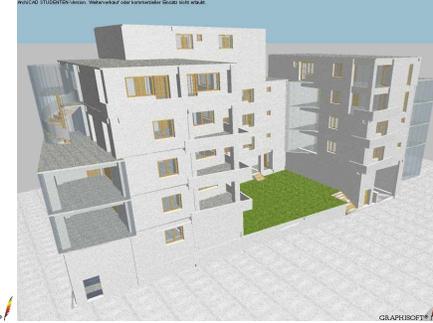
Figure 12: Current floor of the building which served as model for “Calderon”

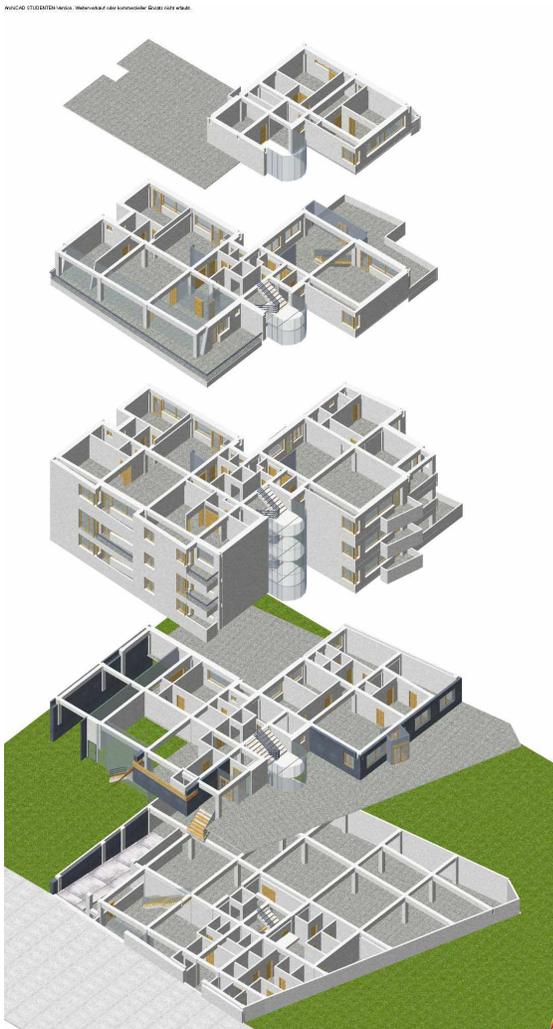
Figure 13: Axonometric view of all floors of the building which served as model for “Eminescu”

Model “Eminescu” consists of ground floor, basement and five upper floors from which the last two lay in recesses (fig. 13 and 15). The building is L-shaped, but within the building columns are distributed relatively regularly. The building has a huge basement, largely exceeding the size of the upper floors, half-height out of the ground. The heights are relatively constant, despite the commercial ground floor.

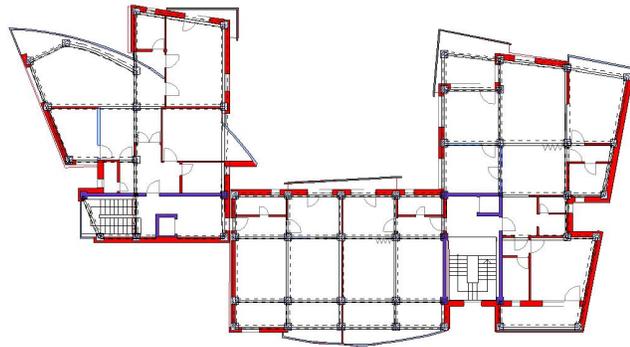
Figure 14: Perspective view of the building which served as model for “Calderon”

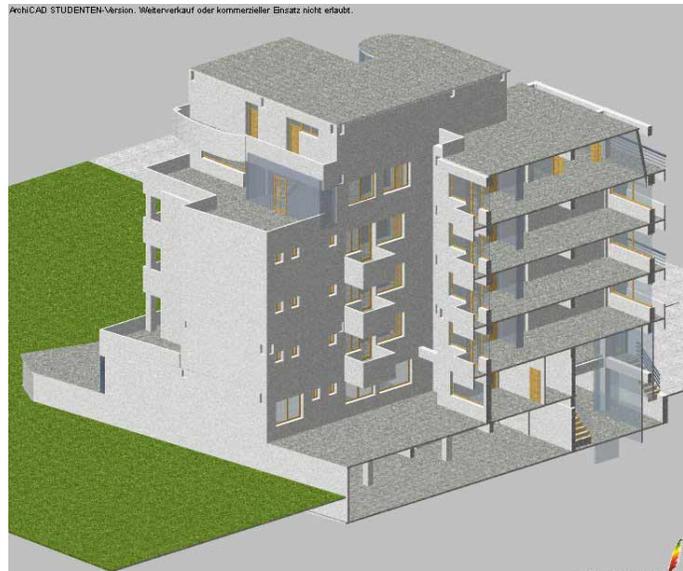
Figure 15: 3D section of the building which served as model for “Eminescu”

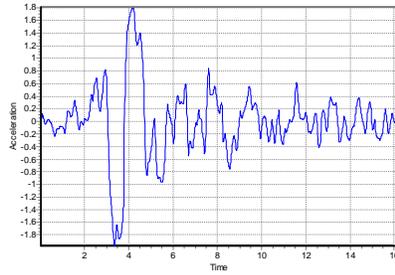
**Figure 16: Accelerogram for the strong movement in 1977, epicentre in Vrancea, N-S direction (data from Ambraseys[6], software SeismoSignal[3])**

Permanent loads  $1.4 \text{ t/m}^2$  have been considered. These have been modelled as lumped masses at the upper end of the columns. For dynamic loads three different accelerograms have obtained from the European Strong Motion Database (Ambraseys[6]) and converted using SeismoSignal (SeismoSoft[3]), for the earthquakes in 1977, 1986 and 1990 (table 2). All three acceleration components of a „Vrancea“ earthquake had been applied simultaneously. The accelerograms as whole had been applied separately and successively as well. The records of the 1977 earthquake in station 39 (fig. 16-18) show the strength of the component in the vertical direction. For the strong ground movement in 1990, two selected records were employed, in order to emphasize the difference in peak acceleration and amplitude obtained at two different locations for the same earthquake. The duration of registered strong oscillations was different (24, respectively 50s) and, more important, the peak ground acceleration for the station 3186 was higher. Although the damages induced by the 1990 earthquake in the location of station 3186 were higher, they remained relatively small. The Thessalonica earthquake from the 20<sup>th</sup> of June, seemed to be suitable for the portability study purposes of this work for two reasons: first because many of the retrofit measures in this study are of Greek provenance and thus could potentially perform better on home structures and second because the same building type can be find in Bucharest and Thessalonica.

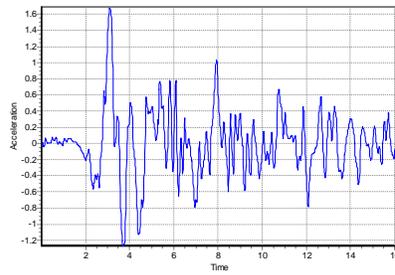
**Figure 17: Accelerogram for the strong movement in 1977, epicentre in Vrancea, E-W direction (data from Ambraseys[6], software SeismoSignal[3])**

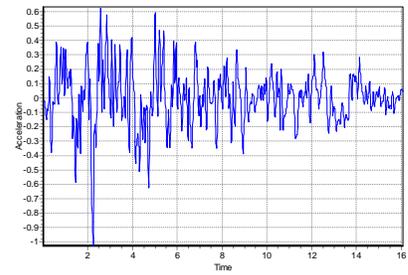
**Figure 18: Accelerogram for the strong movement in 1977, epicentre in Vrancea, vertical direction (data from Ambraseys[6], software SeismoSignal[3])**

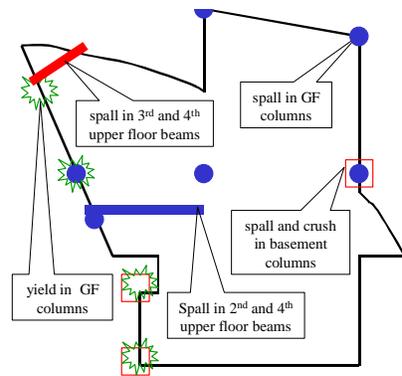
Figure 20: Most damaged elements in the left wing of model “Calderon”

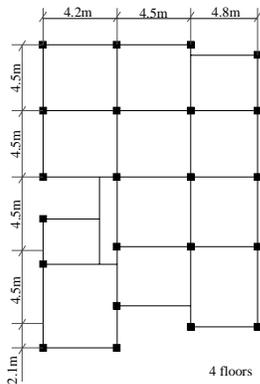
Figure 21: Scheme of mid-rise building plan

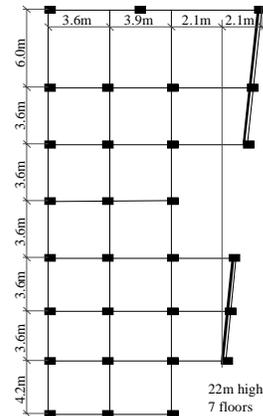
Figure 22: Scheme of high-rise building plan

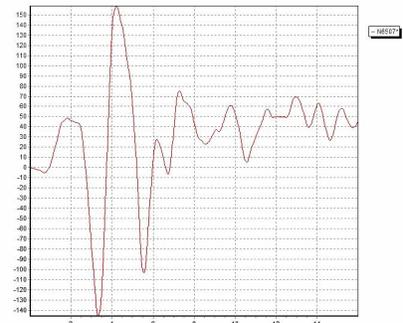
Figure 23: Displacement time history for model „Eminescu“, fine mesh grid, under the impact of the 1977 Vrancea earthquake, as predicted by analysis with SeismoStruct[3]

An observation concerns the shape of the response in the displacement time history depending on discretisation of the finite elements mesh. One element is considered for each structural member describes the coarse grid. Subdivision of structural members into elements define the fine grid. These topographies are used in order to optimise computation of results in FEM. Both “Gregor“ and „Özzi“ show in the analysis run on the course grid a slightly damped, but harmonic looking sinusoid (table 4). „Eminescu“ and “Calderon“ do show another type of response (fig. 23). There is first a big impulse, which damps to a more irregular but very low amplitude curve. When subdivision is introduced, the shape of the curve for „Calderon“ and “Eminescu“ remains the same. In case of „Calderon-left“, due to the highly irregular shape and the relatively big spans (many of them 6m), which in the small size of the building led to a small number of columns, the structural response has been bad. After about 10 seconds of dynamic solicitation, the structural load could not be applied anymore, as a displacement of 4.5m (equal to the average beam span) was reached! This can be seen as a „clean“ crash. The building would not survive the earthquake. This result is confirmed in the fine grid analysis. In the analysis of the retrofitted building it was clear that, despite numerical collapse, the structural collapse was predicted to be avoided. For „Calderon-right“ the response has been computed as being good. Only a maximum displacement of 150m is reached. The building is categorised, like „Eminescu“ to be earthquake safe.

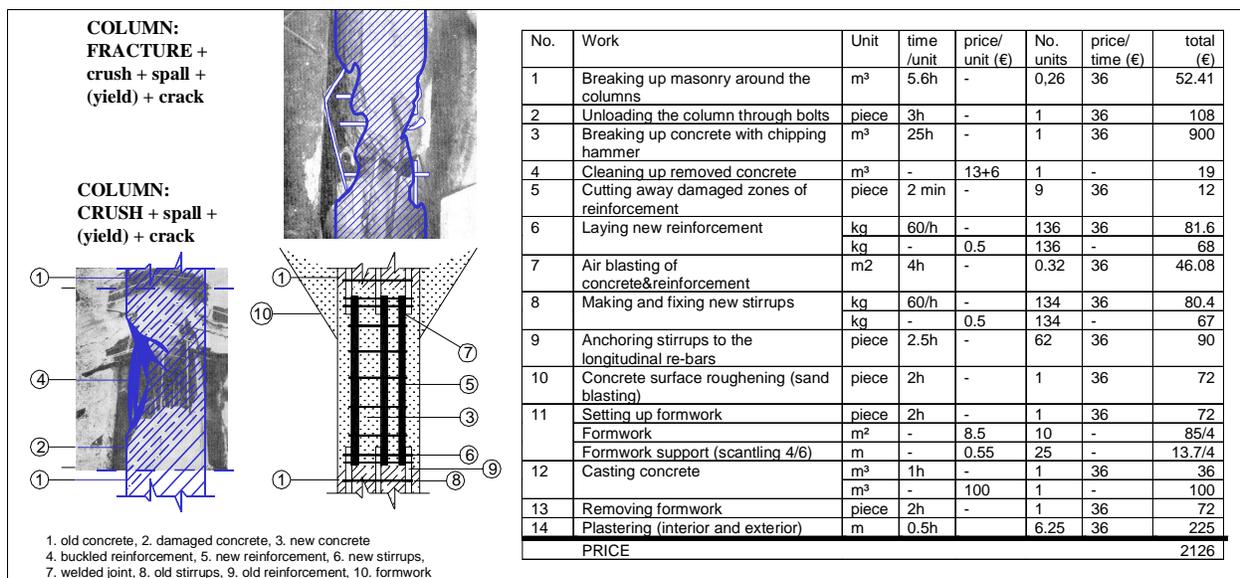
Figure 24: Damage image, repairation approach and device directory for repairing severe column damage (after Bostenaru[4])

To each of the progressive damage types predicted in the simulation a “damage image” could be assessed. Such damages do not describe only the failure modes, but build the basis for the design of repair measures. After taking into consideration all combinations of failing to meet certain performance criteria in steel or concrete sections of the structural members three basic types for each beams and columns were defined. Severe damage till concrete crush or reinforcement fracture requires partial replacement of the structural member in whole depth (fig. 24 and 25). For these a damage image, based on those from the Vrancea earthquake 1977 (Bălan[12]) and a detailed repair approach, outgoing from the drawings in Penelis[7] for columns, but for both columns and beams a detailed to device directory level were provided. The costs for the repairation of all kind of damages, like also the costs for retrofit presented before, were calculated using material prices and salary values in Germany.

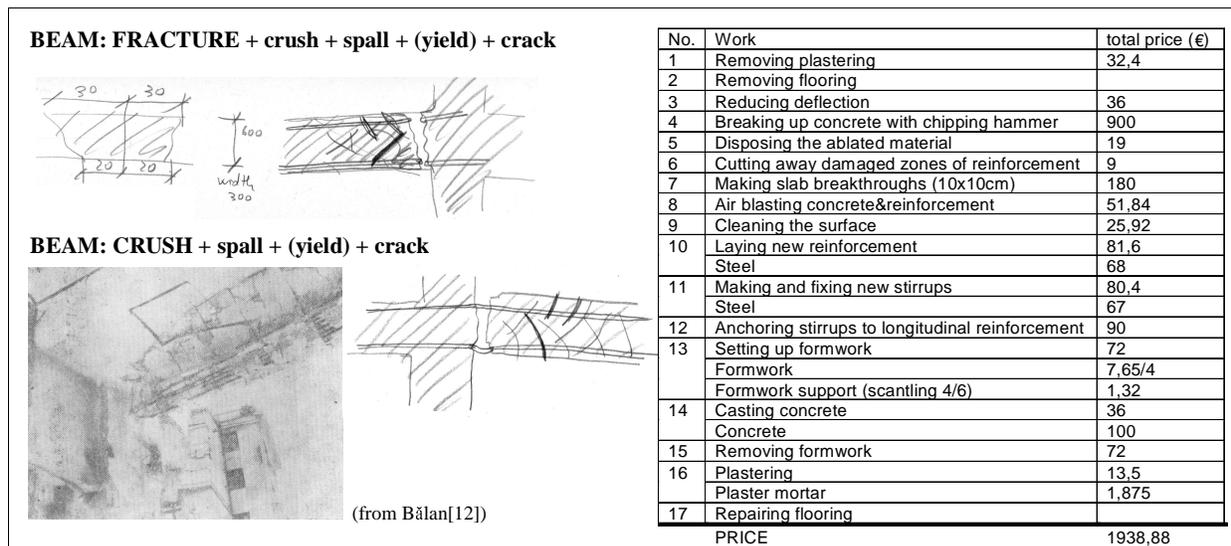
Figure 25: Damage image, repairation approach and device directory for repairing severe beam damage (after Bostenaru[4])

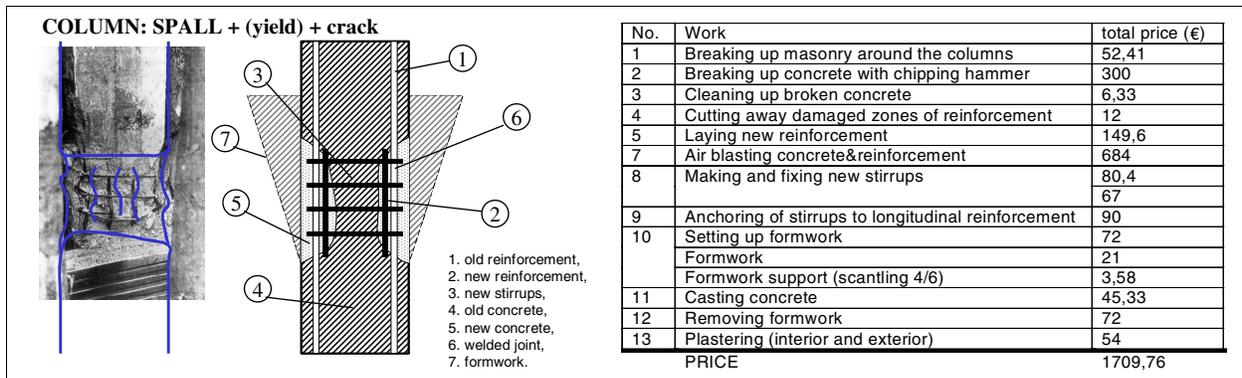
Figure 26: Damage image, reparation approach and device directory for repairing moderate column damage (after Bostenaru[4])

Moderate damage till spalling of cover concrete needs local superficial repair (fig. 26 and 27) For these a damage image was compiled, based on those from the Vrancea earthquake 1977 (Bălan[12]) and a detailed reparation approach, outgoing from the sketches in Penelis[7] for columns and from NTUA[13] (drawings by Bourlotos[14]) for beams. In both cases a detailed to device directory level were provided.

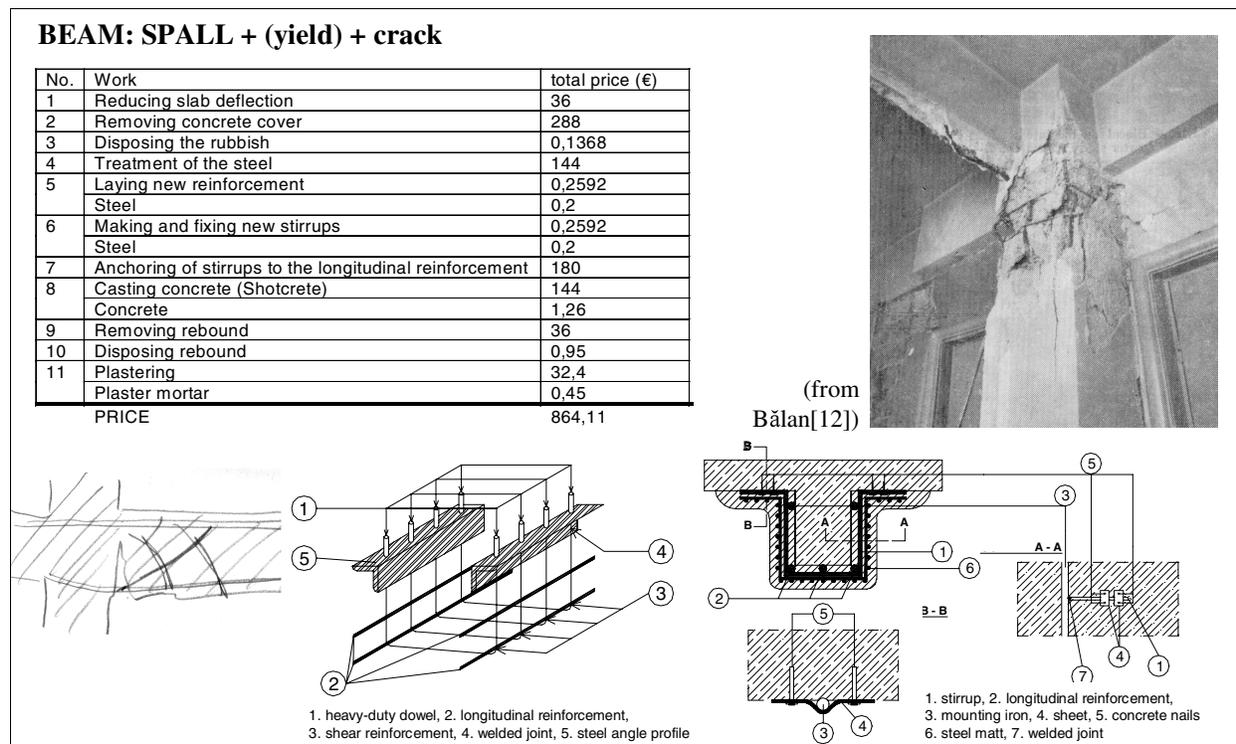
Figure 27: Damage image, reparation approach and device directory for repairing moderate beam damage (after Bostenaru[4])

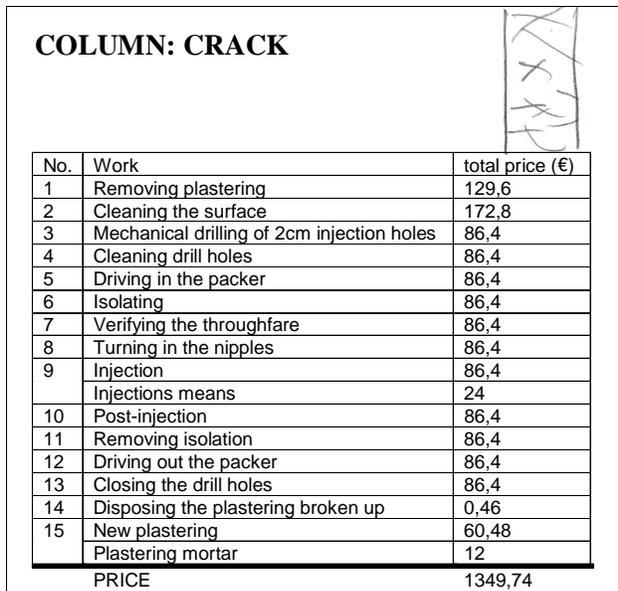
Figure 28: Damage image, reparation approach and device directory for repairing slight column damage (after Bostenaru[4])

For slight damage through cracking repair consists usually out of epoxy resins injections. Thus besides of a damage image sketch only the device directory for the reparation has been provided (fig. 28 and 29). For all levels of damages, the repair costs for beams and columns vary only slightly. Thus a unitary repair cost depending on the specific cumulated damage only could be assigned and multiplied by the number of elements presenting this, being columns or beams.

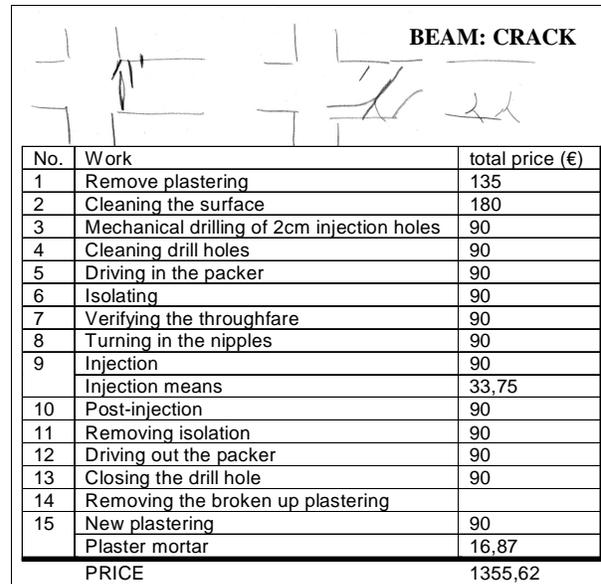
Figure 29: Damage image, reparation approach and device directory for repairing slight beam damage (after Bostenaru[4])

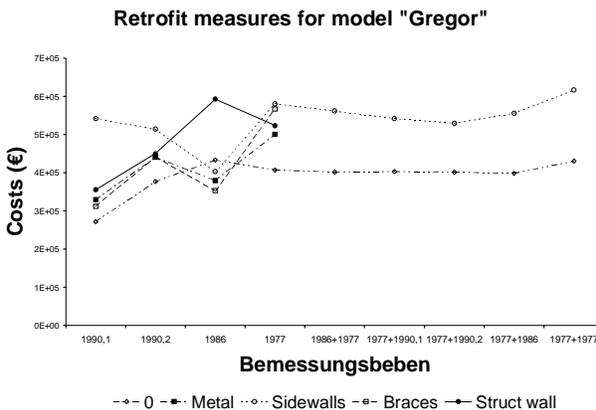
Figure 30: Costs curves for retrofit type alternatives

Using the results from the structural assessment the costs for repair for the whole model were computed. Adding the costs assigned for retrofit, computed on the basis presented in the paragraph on modelling, the total costs for retrofit and repair were computed. In case of successively applied earthquakes a more expensive retrofit in the earthquake preparedness phase can lead to a decrease in the amount of damage and subsequent repair costs, as shown in the diagrams in figures 30 and 31 for models “Gregor” and “Özzi” and various retrofit options.

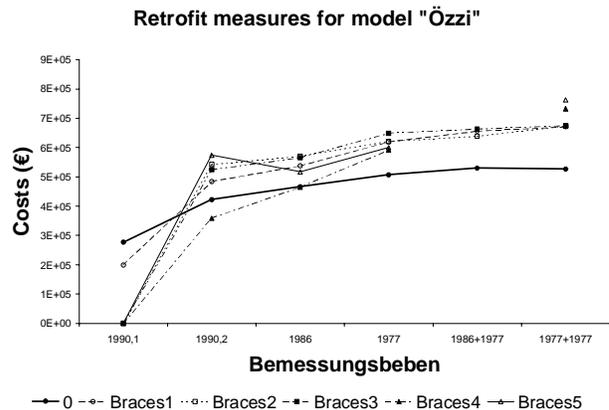
Figure 31: Costs curves for retrofit layout alternatives

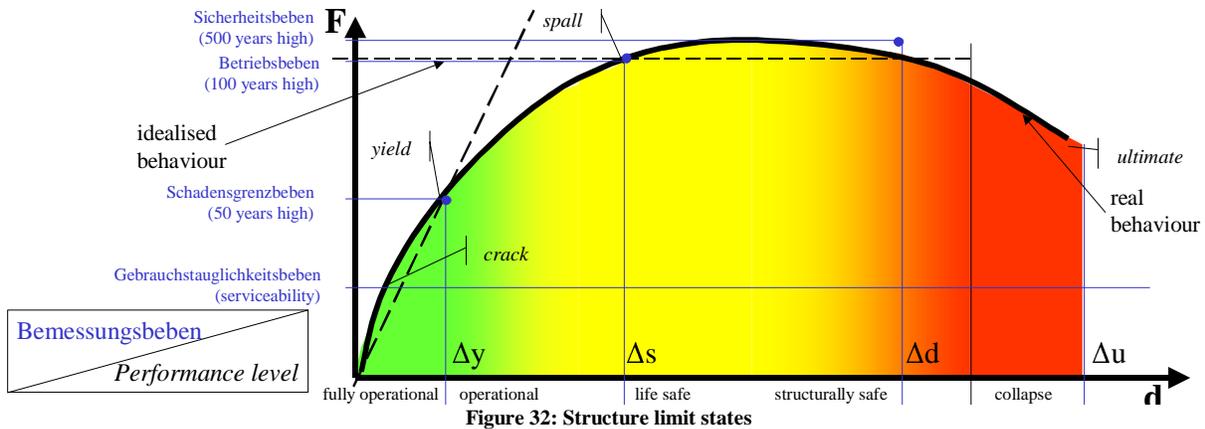
Further, connection with the concept of performance levels (SEAOC[15]) was necessary. In figure 32 the progressive damage states are shown related to a typical pushover curve. Certain displacement values describe the likelihood of reaching certain material stress-strain values. Typically, the “size” of the earthquake considered is given on the vertical axis of base shear. However, the German term of “Bemessungsbeben” (Paulay[16]), meaning design earthquake, can be also associated to the displacement performance levels, as it defines the earthquake at which such a state has to be provided for.
