USING HIGH RESOLUTION SATELLITE IMAGERY TO DETECT DAMAGE FROM THE 2003 NORTHERN ALGERIA EARTHQUAKE

Ellen RATHJE¹ and Melba CRAWFORD²

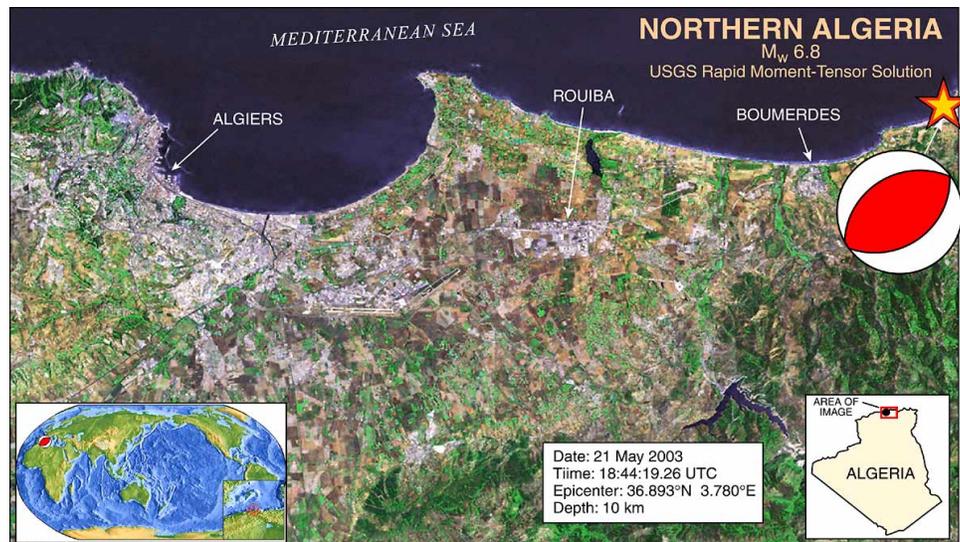
Figure 1. Epicenter of the Northern Algeria earthquake and city of Boumerdes [16]

The Northern Algeria earthquake ($M_w = 6.8$) occurred on 21 May 2003 along the northern coast of Algeria, east of the capital city of Algiers (Figure 1). The northern coast of Algeria is an area of high seismicity that coincides with the boundary between the Eurasian and African plates. This thrust event occurred on a previously unknown northeast-trending reverse fault that dips predominantly to the south. Preliminary fault rupture inversions indicate that the fault ruptured bilaterally from its epicenter, approximately 30 km to the west and 20 km to the east. The zones of largest slip occurred near the epicenter and near the western terminus of the rupture [EERI 15].

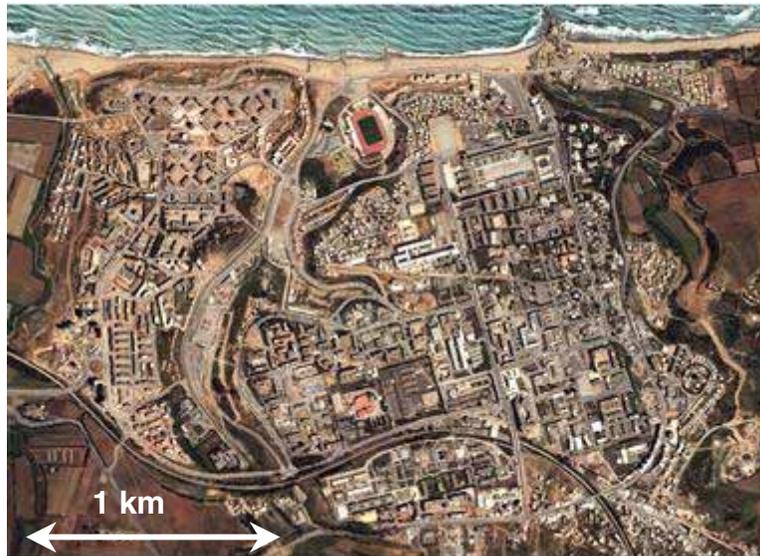
Figure 2. Pan-sharpened satellite image of Boumerdes acquired on 23 May 2003 (from DigitalGlobe)

possible attempt to capture an image of Boumerdes, but it had a large off nadir angle because of the location of the satellite at that time. By 18 June 2003, the satellite orbit allowed an image of Boumerdes to be collected at a much smaller off-nadir angle. For each date, a 2.8-m resolution multispectral image and a 0.6-m resolution panchromatic image were obtained and fused to create pan-sharpened color images at 0.6-m resolution. Figure 2 is the 23 May 2003 pan-sharpened satellite image of the entire city of Boumerdes.

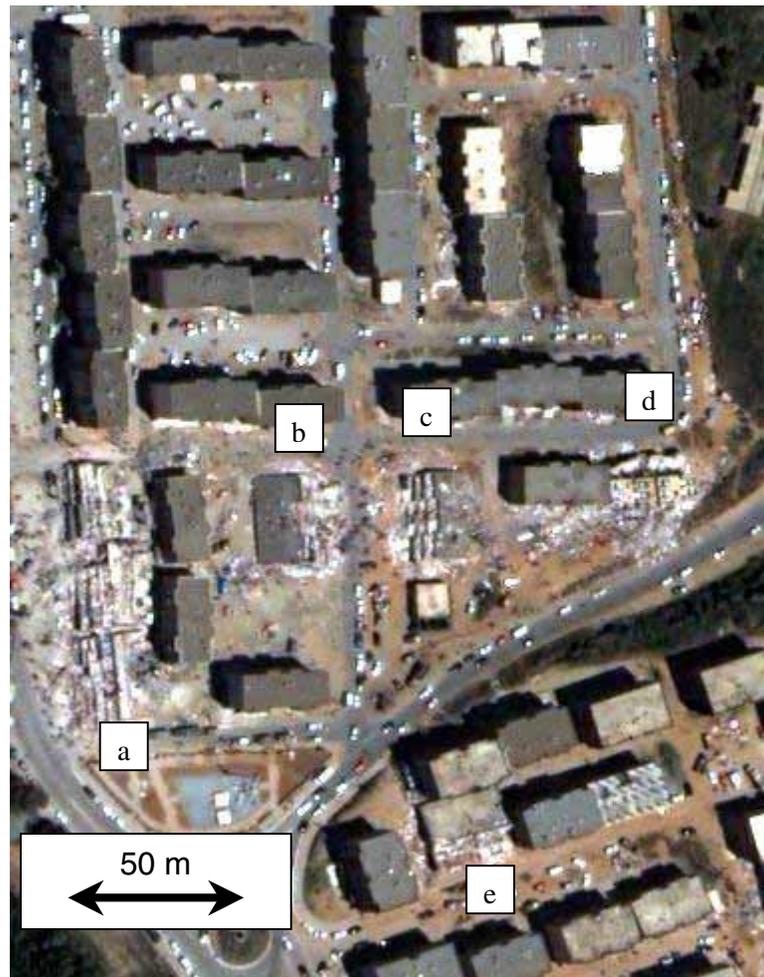
Figure 3. Post-earthquake, pan-sharpened image of southwestern Bouterdes

Initial investigations focused on using semi-automated thematic classification to identify heavily damaged buildings in a small section of southwestern Boumerdes using only the post-earthquake image. Figure 3 shows the pan-sharpened 23 May 2003 image of this section of Boumerdes. This section of Boumerdes was chosen because fully collapsed structures are readily visible, but many undamaged are also present. Classification of this Boumerdes image focused on trying to accurately identify the five fully collapsed and pancaked structures labeled (a) through (e) in Figure 3. All image analysis was performed with the software ENVI 3.4 [Research Systems, Inc. 17].

Visual inspection of this image indicates that the damaged areas have distinct color (i.e. spectral) characteristics, as well as textural characteristics. The challenge is to identify which characteristics best distinguish between damaged and undamaged areas. For this initial evaluation of distinguishing characteristics, five general classes within the image were defined: (1) collapsed structures and debris, (2) asphalt and undamaged buildings, (3) soil, (4) vegetation, and (5) shadow. Training areas for each class were identified within the image, each area encompassing between 1,000 and 2,000 m². These training areas represent only a small percentage of each class within the image. After defining the training areas, classification was performed with a maximum-likelihood, supervised classification algorithm. In supervised classification, the training data are used to estimate the characteristics/attributes of each class and then the remaining pixels in the image are labeled as one of the defined classes based on the class the

Texture characteristics are useful in image classification because they are related to the “smoothness” or “roughness” of gray scales across an image. Visual inspection of Figure 3 suggests that collapsed areas have rough texture, with large variations in tone over small distances, while the undamaged areas have smooth texture, with little variation in tone over distance. Therefore, texture should help distinguish collapsed areas from undamaged areas.

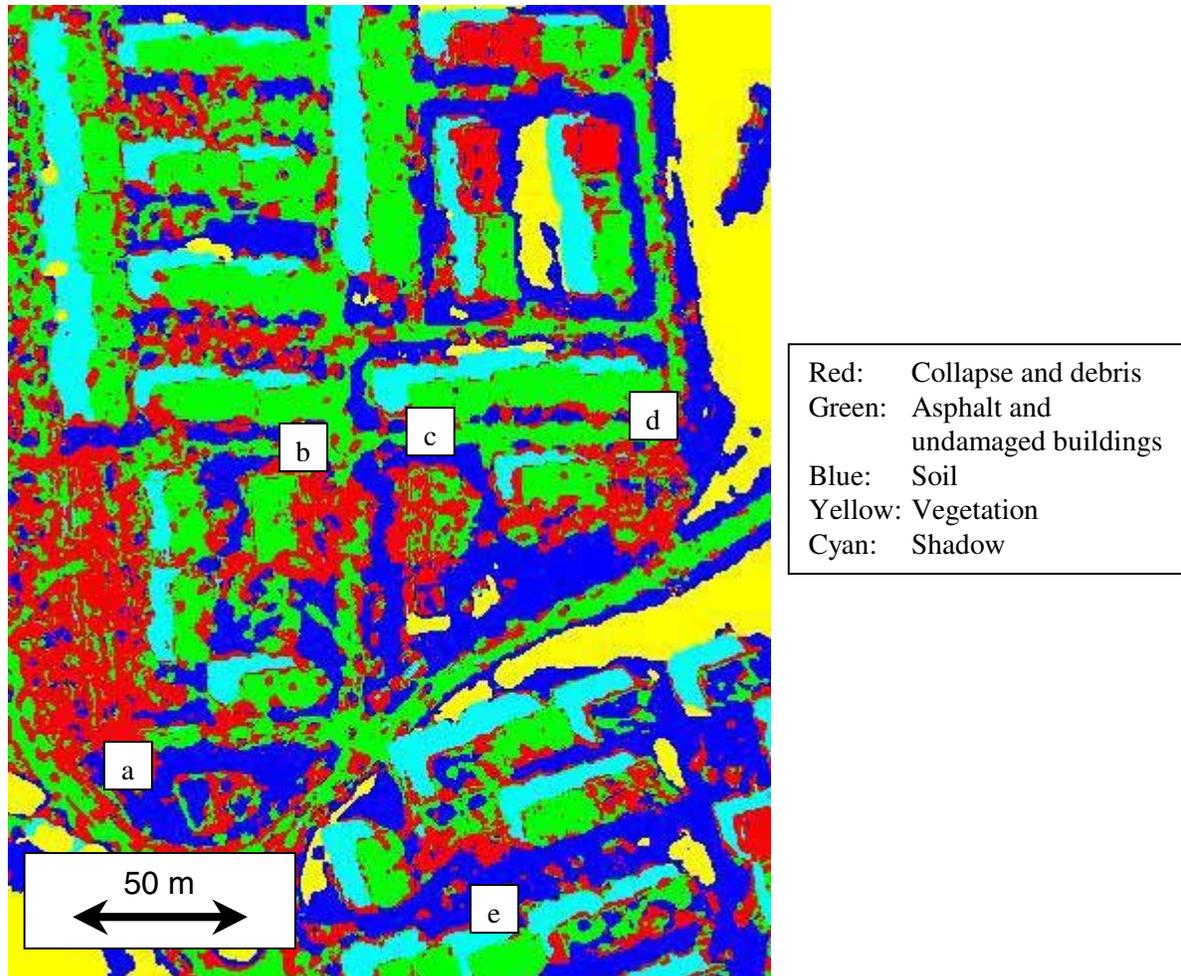
Figure 4. Classification results using only four spectral bands

The resulting maximum-likelihood classification using only spectral data is shown in Figure 4. In this figure the red areas represent collapse and debris (Class 1), the green areas represent undamaged buildings and asphalt (Class 2), the blue areas represent soil (Class 3), the yellow areas represent vegetation (Class 4), and the cyan-blue areas are building shadows (Class 5). Approximately 73% of the collapse area (Class 1), as defined by the five collapsed buildings, is accurately identified as collapse and debris. This corresponds to a 27% omission error. Additionally, approximately 53% of the classified collapse areas

(i.e., red areas in Figure 4) do not correspond to the identified collapse areas. This represents a 47% commission error. These misclassified areas are located predominantly north of the collapsed buildings. Visual examination of Figures 3 and 4 reveals that these areas correspond to regions that have a spectral signature similar to the collapsed areas. Note the white cars and building roofs misclassified as collapse near the top of the image because their color is similar to the collapsed structures. The large commission error for the collapse class (Class 1) is not surprising based on the results of the separability analysis, which indicated that Classes 1 and 2, and Classes 1 and 3 displayed low separability. To better distinguish between damaged and undamaged areas, textural measures were considered in the classification.

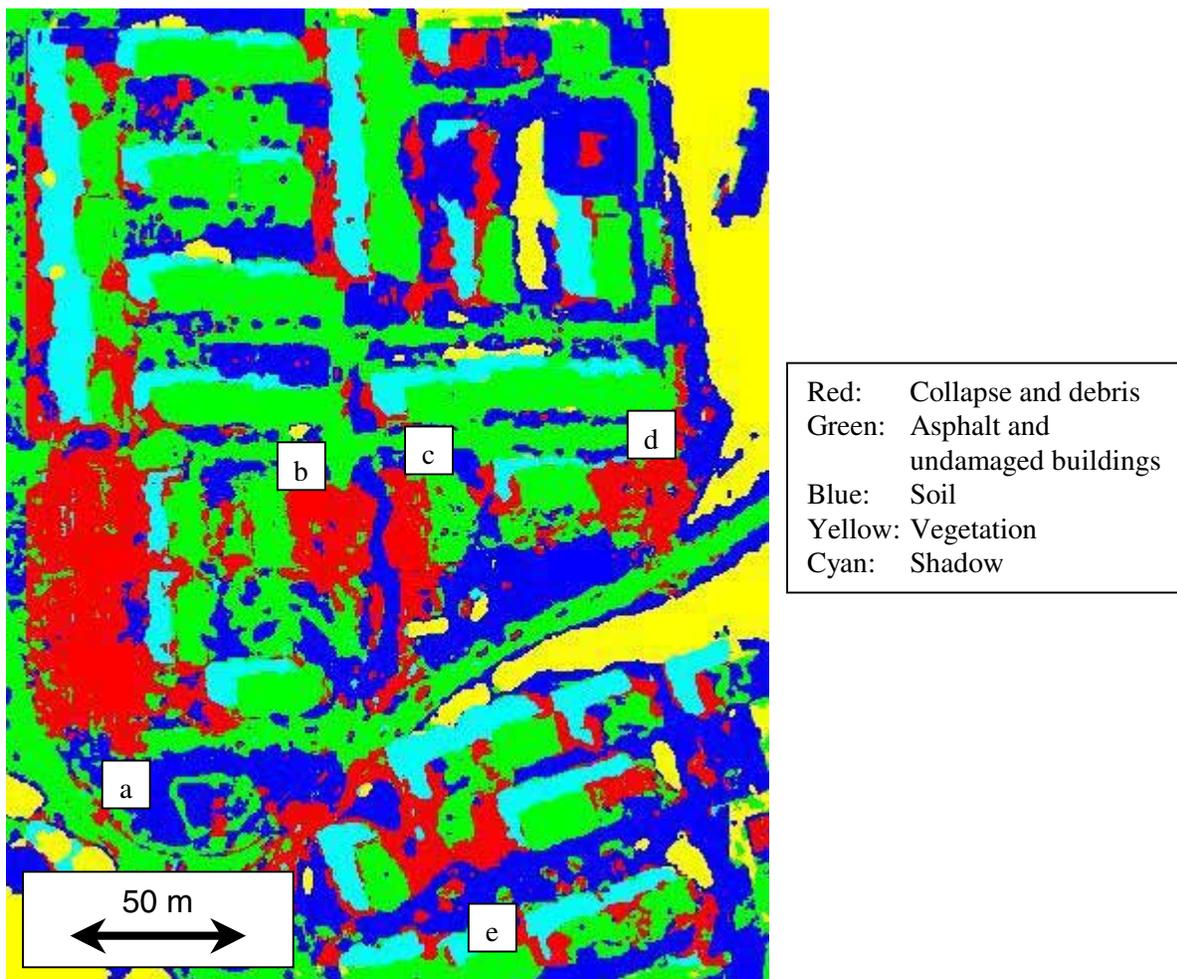
Figure 5. Classification results using CON and DIS textural measures and four spectral bands

Maximum-likelihood supervised classification was performed using the four spectral bands and the two texture measures CON and DIS. The same training classes from the previous analysis were used. The four spectral bands and the two texture measures were used as input for the classification. The resulting classification using both spectral and textural measures is shown in Figure 5. The collapsed areas are better classified in this analysis, with only a 15% omission error. The commission error (classifying undamaged areas as collapsed areas) is still relatively high, with about 35% of the red areas in Figure 5 representing undamaged areas. However, these areas tend to be spatially distributed throughout the

image and do not confuse visual identification of the collapsed buildings. The final classification image allows the analyst to distinguish between zones with heavy damage (bottom of image) and zones with little damage (top of image). Most of the red areas in Figure 5 that do not correspond with collapsed buildings tend to represent areas with closely spaced cars that have textural and spectral characteristics that are similar to the collapsed areas.

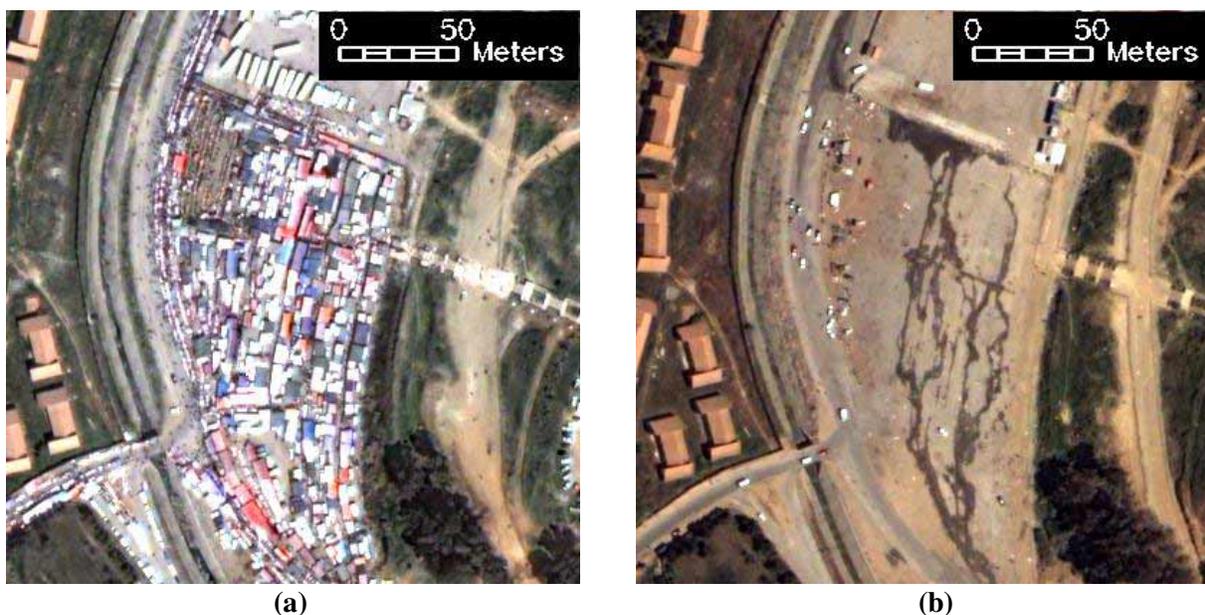
Figure 6. Non-earthquake changes in satellite images acquired on (a) 22 April 2002 and (b) 23 May 2003.

Change detection algorithms identify all differences that are present between two images. When using change detection to distinguish regions damaged by an earthquake, it is important to consider what changes in the images are not due to the earthquake. This issue is particularly critical for high-resolution satellite images, which capture various features that are highly transient. For example, Figure 6 shows a region of Boumerdes acquired before (April 2002, Figure 6a) and after (May 2003, Figure 6b) the earthquake. Although these images represent the same section of the city, there are significant spectral and textural differences in the image. These differences are caused by a large collection of vehicles that were present in April 2002, but not in May 2003. Change detection methods would classify this part of Boumerdes as significantly changed, although the change was not caused by the earthquake. Other non-earthquake changes that may be identified by change detection algorithms include construction of new

infrastructure, seasonal changes in vegetation, and partial cloud cover. Because of these issues, results from automated change detection results should be visually examined to ensure that the areas identified as changed were, in fact, changed by the earthquake.

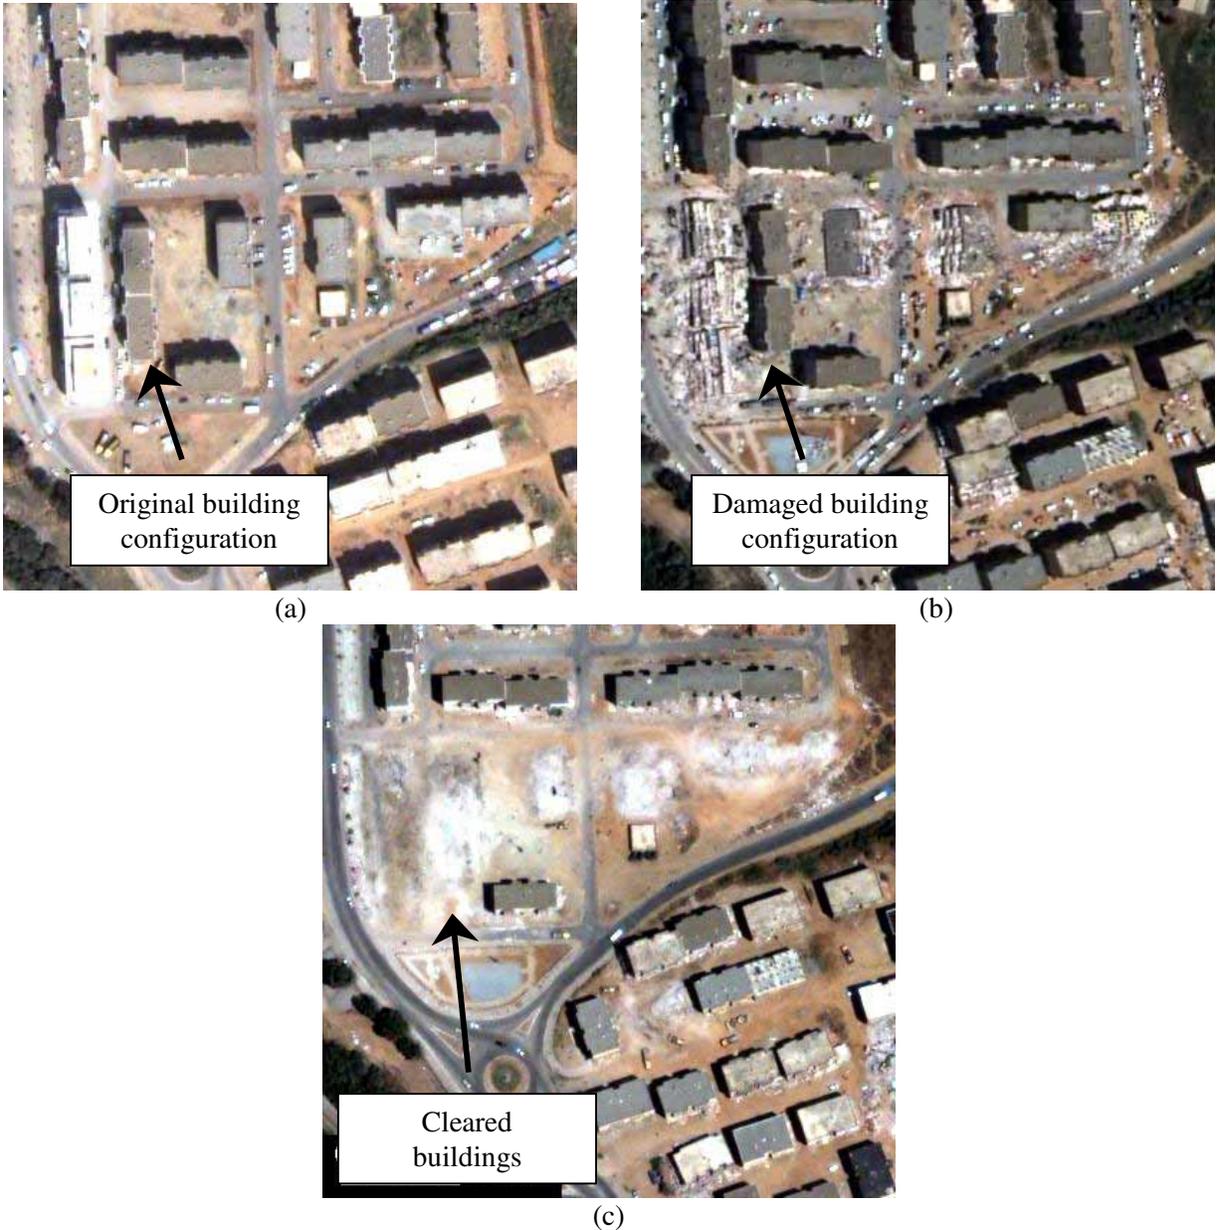
Figure 7. Identification of partially damaged buildings by comparing (a) 22 April 2002, (b) 23 May 2003, and (c) 18 June 2003 satellite images.

Thematic classification of these images via the maximum likelihood method only allows fully-collapsed and pancaked buildings to be identified. Change detection can detect less dramatic damage because of the comparison between the pre-earthquake and post-earthquake configurations. Figure 7 again focuses on the damaged areas in southwestern Boumerdes. Figure 7a shows the pre-earthquake image, while Figures 7b and 7c are the post-earthquake images. If one considers only the 23 May 2003 post-earthquake image (Figure 7b), only the fully-collapsed buildings can be readily identified. No other damaged structures can be definitively identified. However, comparison of the 22 April 2002 image (Figure 7a) and the 23 May

2003 image (Figure 7b) reveals that the two buildings in the center of the image have translated significantly (approximately 5 m) from one another. This amount of movement is indicative of severe earthquake damage. This hypothesis is confirmed by the 18 June 2003 image (Figure 7c), which reveals that both of these buildings (along with the five fully-collapsed buildings) have been demolished and removed.

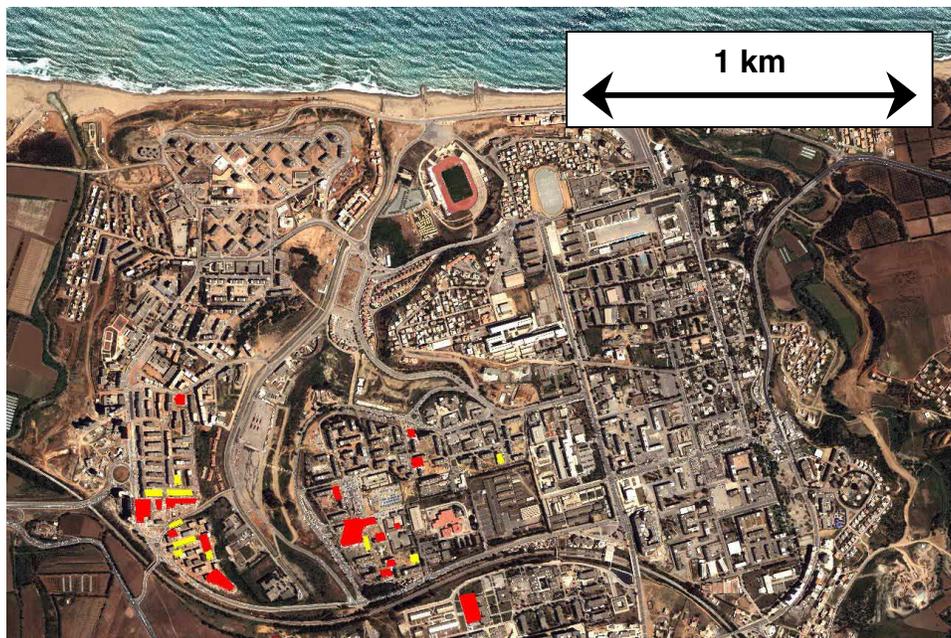
Figure 8. Collapsed (red) and heavily damaged (yellow) structures identified from visual examination of pre- and post-earthquake images.

For the small city of Boumerdes, it is possible to visual examine and compare the pre- and post-earthquake images to identify earthquake damage. Using the three satellite images acquired as part of this study, fully-collapsed and heavily-damaged structures were identified through visual examination. The resulting map of fully-collapsed (red) and heavily-damaged (yellow) structures is shown in Figure 8. This map clearly shows a concentration of damage in the southwestern part of the city. No heavily damaged buildings were identified in the northern or eastern sections of city, although moderate structural damage may have occurred in these areas. Unfortunately, earthquake reconnaissance reports published to date for the Northern Algeria earthquake [15] do not describe in the detail the damage patterns across Boumerdes, and therefore, the damage patterns in Figure 8 cannot currently be verified with ground truth data.

[15], the concentration of damage in southwestern Boumerdes may be an indication of enhanced ground shaking due to soft soil conditions. A 1:500,000 scale geologic map of Algeria [Cornet 19] indicates that the majority of Boumerdes is founded on Pleistocene, lacustrine clays, with Quaternary alluvium found along river channels. The damaged areas in Figure 8 straddle the north-flowing river that runs through Boumerdes. Therefore, these areas may be underlain by younger alluvial sediments that amplified ground motions. Further investigation into the geology and soil conditions can confirm this hypothesis.
