DESIGN OF FRP JACKETS FOR SEISMIC STRENGTHENING OF BRIDGE T-JOINTS

Chris P. PANTELIDES¹, Jeff B. DUFFIN², and Lawrence D. REAVELEY¹

SUMMARY

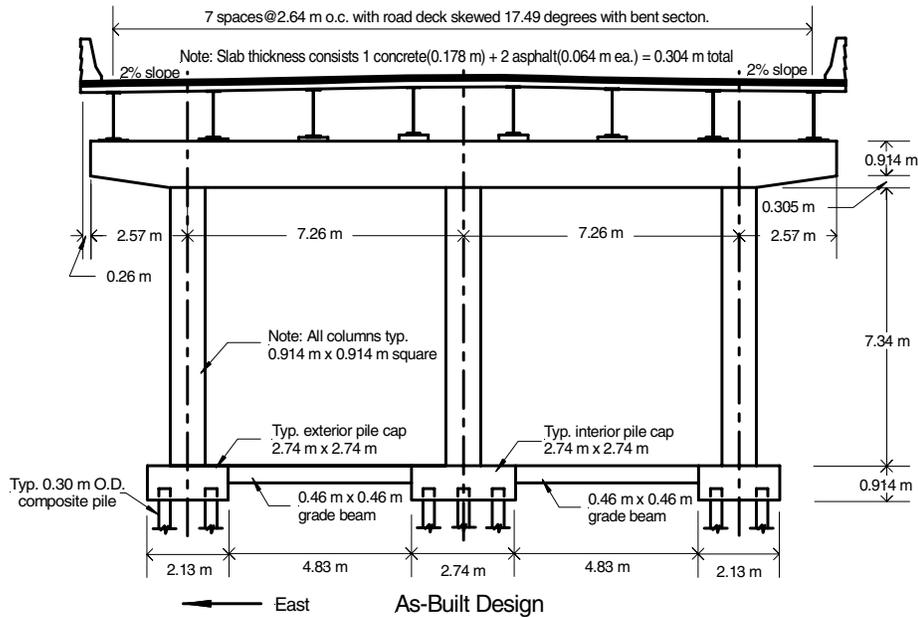
Figure 1. Typical bent structure for both the 1998 and 2000 bridge tests.

All of the bridge bents tested in 1998 and 2000 had approximately identical as-built details. The superstructure consisted of three columns, a bent cap, eight steel girders, and the deck. The 7.34-m high columns were 0.914 m square, while the bent cap was 19.66 m long, 0.914 m wide, and 1.219 m high, tapering to 0.914 m from the exterior columns to the ends, as shown in Fig. 1. Each column had sixteen 32 mm reinforcing bars around its perimeter extending from the top of the pile cap to within 310 mm of the bent cap top fiber, as shown in Fig. 2(b). The transverse reinforcement consisted of 13 mm single hoops starting at 152 mm from the base of the column and spaced at 305 mm up to the bent cap bottom,

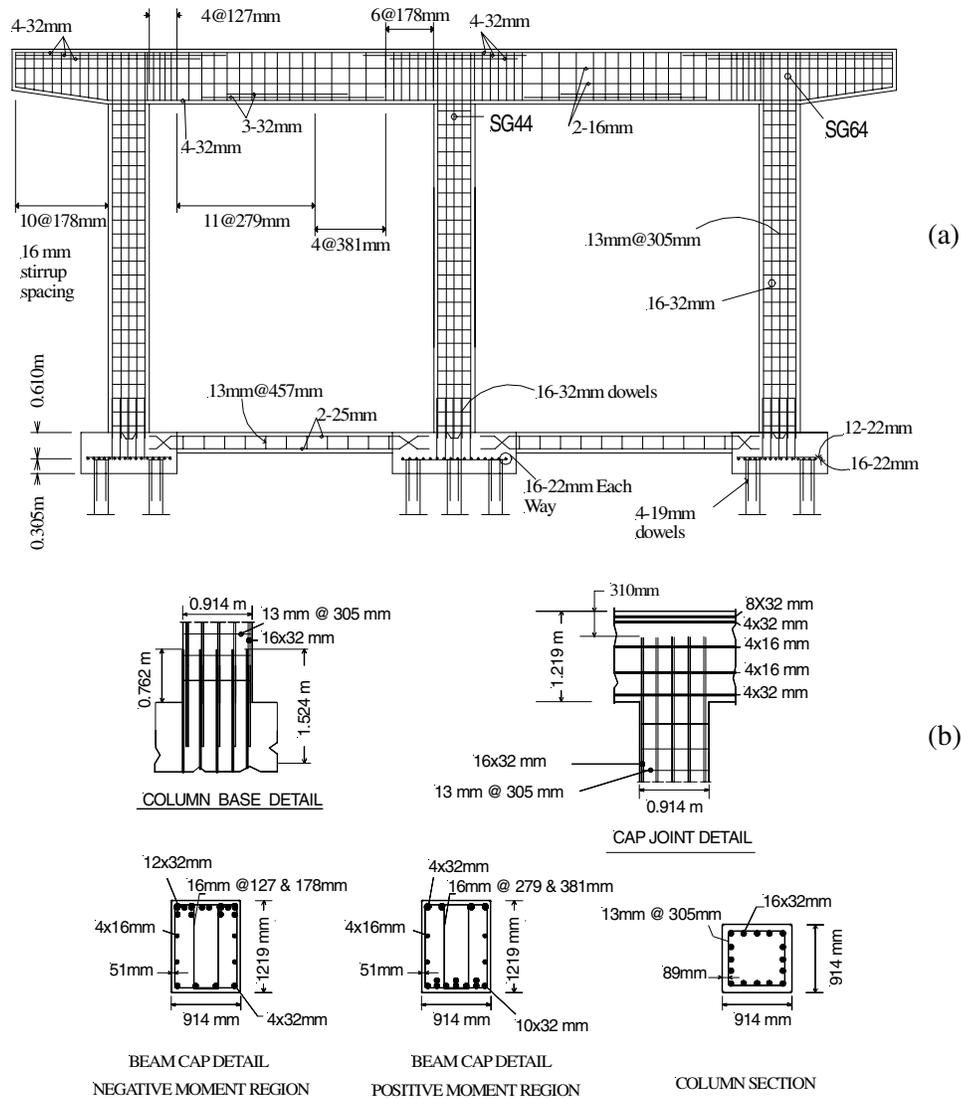
Figure 2. Reinforcement for the 1998 and 2000 bridge tests: (a) longitudinal, (b) cross-sections.

as shown in Fig. 2. At the base of each column, there were 16 dowels 32 mm in diameter with lap splices extending 0.762 m (24 bar diameters) above the pile cap, as shown in Fig. 2(b).

The bent cap flexural reinforcement consisted of 32 mm and 16 mm bars; for transverse reinforcement, 16 mm double stirrups were used, as shown in Fig. 2(b) at the variable spacing of Fig. 2(a). There were no vertical stirrups or horizontal hoops present in the bent cap-column joints. The concrete cover was 51 mm in the bent cap and 89 mm in the columns.

The three columns were supported on reinforced concrete pile caps. The two exterior caps measured 2.13 m square and 0.914 m thick; they were supported on four cylindrical concrete filled steel piles, 0.305 m in diameter and approximately 18.30 m deep. The interior cap was 2.74 m square, 0.914 m thick, and was supported on five piles. Connecting each pile cap was a 0.46 m square concrete strut reinforced with four 25 mm bars with 13 mm stirrups spaced at 457 mm, as shown in Figs. 1 and 2(a). The exterior pile caps were each reinforced by a row of sixteen 22 mm bars perpendicular to the plane of the bent, and a row of twelve 22 mm bars parallel to it. This reinforcement was located 0.61 m below the top of the pile cap. The interior pile cap was reinforced similarly except that the parallel row had sixteen 22 mm bars, as shown in Fig. 2(a). There was no transverse reinforcement in the pile caps.

Damage was observed on the bent cap near the west bent cap-column joint. A flexure/shear crack formed starting at the top of the bent cap, 1.73 m east of the west column, as shown in Fig. 11; this is the end point of the four 32mm negative moment steel bars, as shown in Figs. 2(a) and 11. From onsite

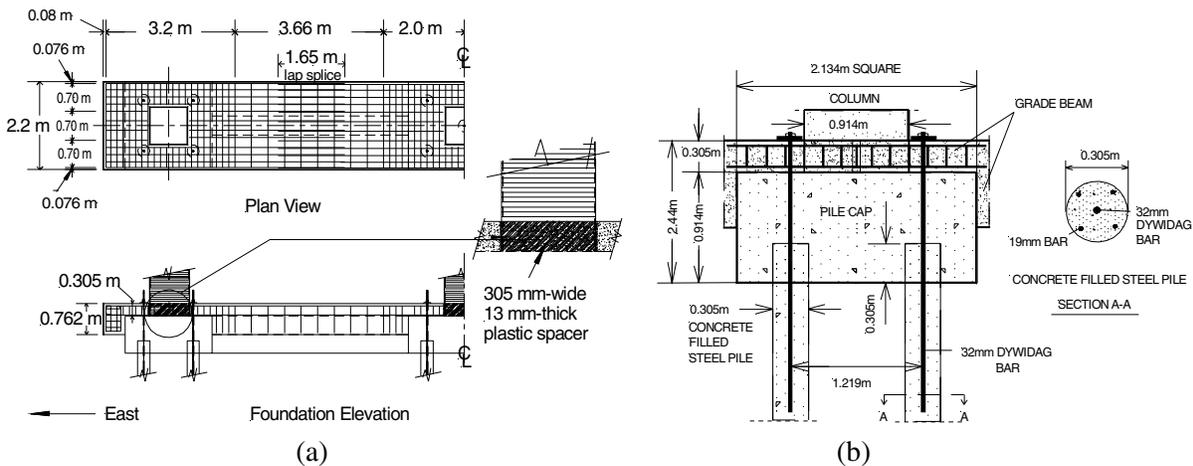
Figure 3. Grade beam retrofit: (a) plan and longitudinal section, (b) grade beam-to-pile connection.

The 305-mm diameter concrete-filled steel piles were embedded into the 0.914-m thick pile cap a distance of 0.305 m, as shown in Fig. 3(b). The piles were connected to the pile cap with four 19 mm bars extending 0.305 m into the pile cap. For the expected ultimate lateral load, the steel area and anchorage length would have been insufficient to resist pullout failure of the piles, as was shown from a pushover analysis by Duffin [11]. A 38-mm hole was cored through the pile cap into the pile for a distance of 2.44 m, and the pile was anchored to the pile cap using a 32 mm Dywidag bar epoxied into the hole. This detail was implemented for the four corner piles of each pile cap.

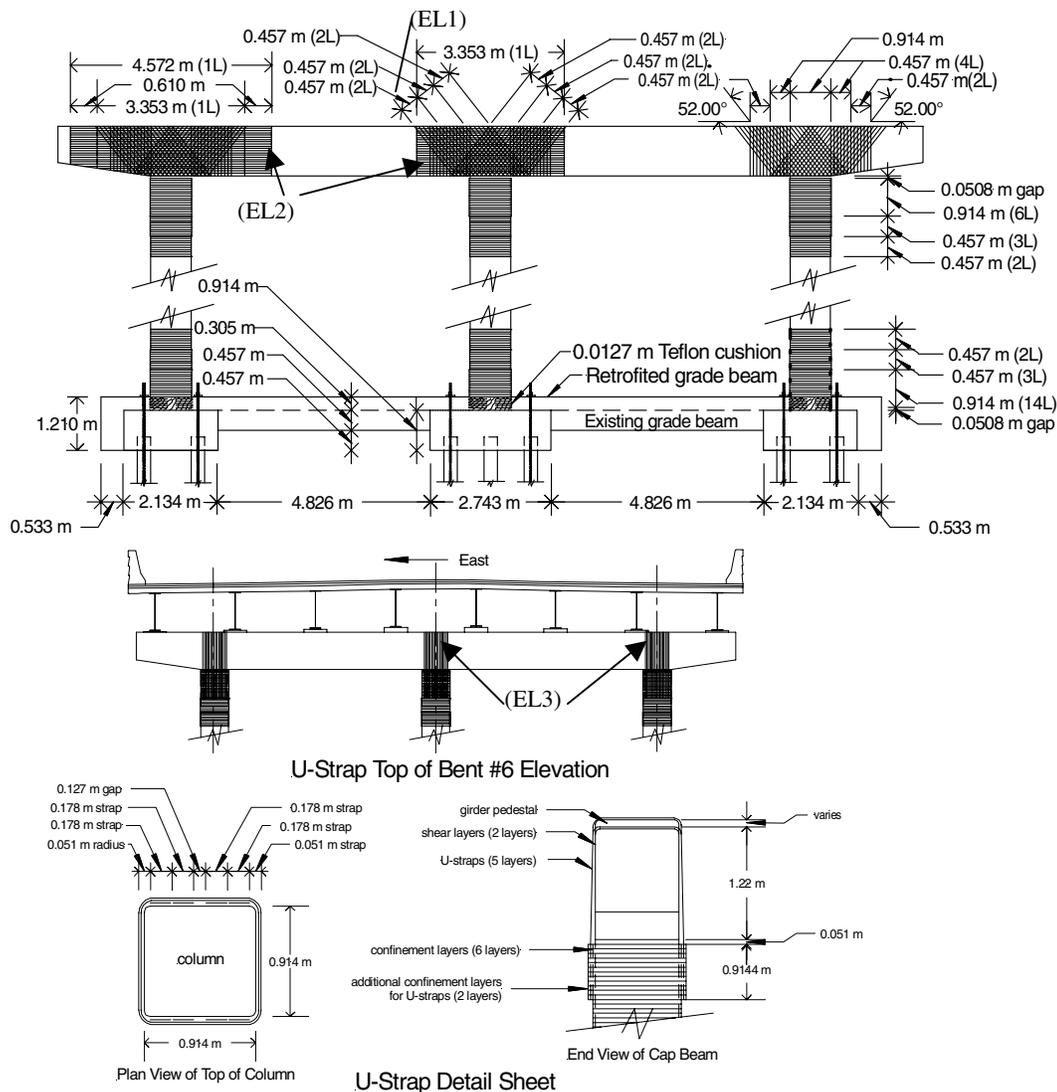
Figure 4. CFRP composite retrofit design of Bent #6-2000 test (xL = no. of Layers).

The superstructure was retrofitted with carbon FRP composites with the goal of increasing the displacement ductility of the as-is bridge bent. The actual FRP composite application on Bent #6 is shown in Fig. 4. The FRP composite properties, composed of carbon fabric fibers with epoxy resin were obtained from tensile coupons manufactured on-site and tested per ASTM D3039 [12]. Each layer of FRP

Figure 4 shows that the bottom of each column had an identical pattern of FRP jacket designed for the following criteria: (1) flexural hinge confinement, (2) lap splice clamping, and (3) shear strengthening; a

50 mm gap was left above the pile cap, after which 14 layers of FRP composite extended 914 mm, followed by three layers for an additional 457 mm and finally another two layers for 457 mm. The RC grade beam was built after the FRP composite was applied, so a 13-mm thick plastic spacer was used to separate the FRP jacket from the grade beam concrete, as shown in Fig. 3(a). The three column tops were retrofitted with FRP jackets for flexural hinge confinement and shear strengthening; a 50 mm gap was left below the soffit of the bent cap, after which six layers of FRP composite extended 914 mm, followed by three layers for 457 mm and another two layers for 457 mm, as shown in Fig. 4.

FRP composite jackets in the bent cap-column joints were provided consisting of three elements as shown in Fig. 4: (EL1) ankle wrap FRP composite sheets for resisting diagonal tension which were applied at 52 degrees from the horizontal, (EL2) FRP composite strips with unidirectional fibers in the direction of the bent cap axis for shear and flexural strengthening, and (EL3) FRP composite U-straps clamped at the column faces going over the bent cap, whose purpose was to anchor the longitudinal column steel bars terminating 310 mm from the top of the bent cap, as shown in Fig. 2(b); these bars had insufficient anchorage details and are known to pull out from the concrete in the joint at low drift ratios as shown by Park et al. [14].

The FRP reinforcement for element EL1 consisted of two layers at $\pm 52^\circ$ from the horizontal on both faces of the bent cap, as shown in Fig. 4. The FRP reinforcement for element EL2 for the east bent cap-column joint were two sheets, one 1.219 m wide and 4.572 m long sheet on both faces of the bent cap in the bent cap axis direction, and one 1.219 m wide and 3.353 m long sheet; for the middle bent cap-column joint there was only one 1.219 m wide and 3.353 m long sheet on both faces, as shown in Fig. 4; there was no EL2 FRP reinforcement for the west bent cap-column joint. The FRP reinforcement for element EL3 was identical for each column, consisting of five continuous layers of two 356 mm-wide U-straps per column; the FRP U-straps were applied at one face of the column 914 mm below the bent cap soffit up the bent cap and down the other face for the same length, as shown in Fig. 4; these FRP U-straps were clamped by two additional 914 mm wide FRP jackets around the column.

The FRP composite design along the bent cap axis (element EL2 in Fig. 4) and a revised design of the FRP composite U-straps (element EL3 in Fig. 4) are described here; a more detailed development can be found elsewhere [11]. The bending moment, axial loads, and shear forces, for each bent cap-column joint, were determined from a static pushover nonlinear analysis using program DRAIN-2DX [15]. The internal forces obtained from the DRAIN-2DX model at the peak lateral load were applied to joint faces and checked for static equilibrium. The vertical and horizontal joint internal shear stresses were obtained by dividing the joint vertical and horizontal internal shear forces by their respective face area, thus establishing the final conditions for plane stress for the bent cap-column joints, as shown in Fig. 5. Subsequently, the principal tensile stresses and principal directions were determined for the bent cap-column joints. The principal tensile stresses are used to determine the required number of FRP layers for EL1 (ankle wrap FRP composite sheets).

The design for element EL2 (FRP composite fibers parallel to bent cap axis) and EL3 (FRP composite U-straps), as shown in Fig. 4, follows the method proposed by Duffin [11]. The bending moment demand found from the DRAIN-2DX analysis, M_D , is resisted by the moment capacity of the beam contributed by tensile and compressive steel, M_S , and the moment capacity contributed by the FRP composite, ΔM_C .

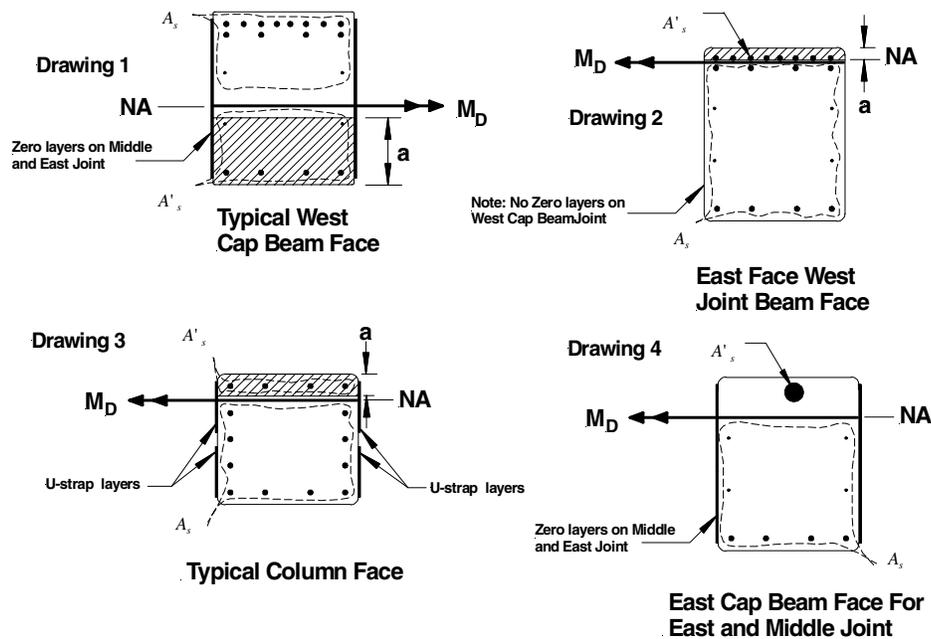
Figure 5. Moment demands on the bent cap-column joints for Bent #6-2000.

Equation (1) is valid at any bent cap section such as Drawing 1, 2, or 4 in Fig. 5, or a column section, such as Drawing 3 in Fig. 5. The moment capacity contributed by tensile and compressive steel, M_S , is obtained using standard expressions from reinforced concrete design. The additional moment capacity contributed by the required layers of FRP composite, ΔM_C , is obtained by reference to Fig. 6 as ([Duffin 11]):

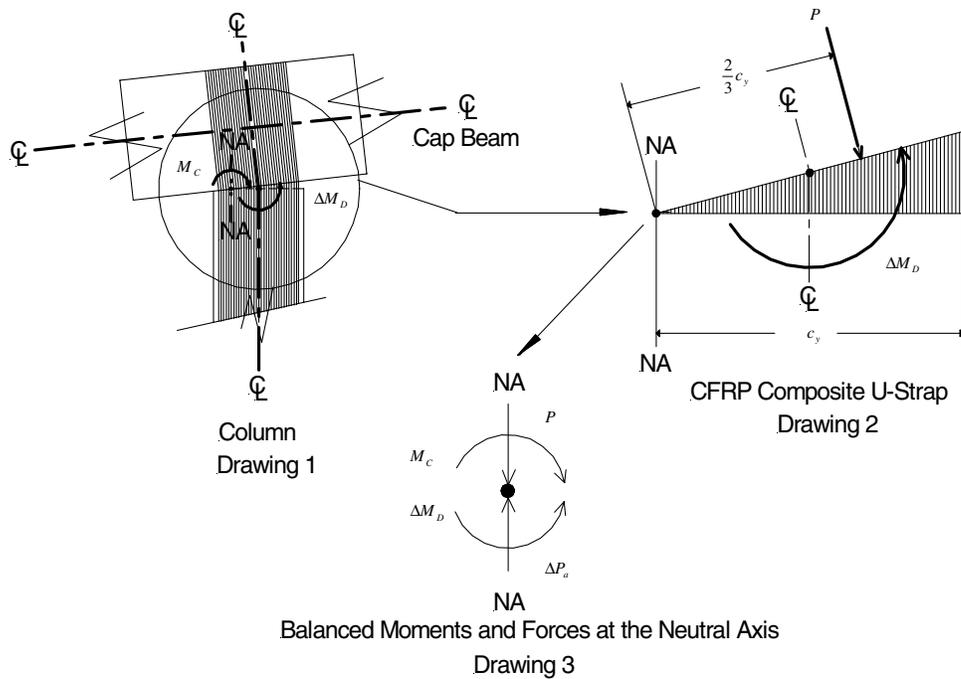
Figure 6. Equilibrium conditions for the additional moment and force from FRP U-Strap.

where σ_C = tensile stress in the FRP composite (720 MPa for the FRP U-straps EL3, but only 20% of this value for the FRP composite layers parallel to the bent cap axis, EL2, because these layers debond prematurely from the concrete), T_C = axial tensile force in the composite, A_C = cross-sectional area of FRP composite in tension, I_C = moment of inertia of FRP composite in tension, and c_y = distance between neutral axis and extreme FRP fiber in tension. Figure 6 shows application of Eq. (2) for the (EL3) FRP composite U-straps; the same equation applies for the (EL2) FRP composite strips with unidirectional fibers in the bent cap.

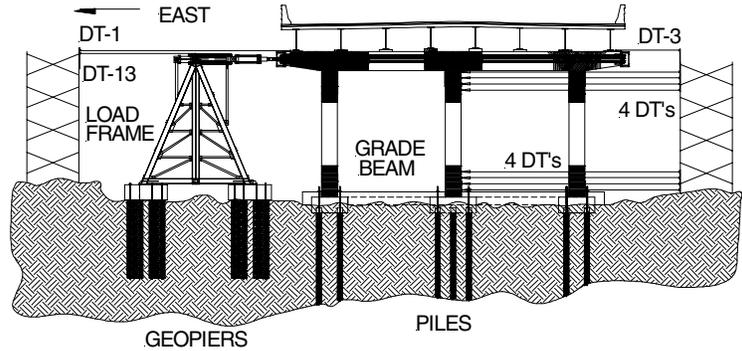
Figure 7. Loading and horizontal displacement transducers.

Bent #6S was tested using a quasi-static cyclic lateral load applied at the bent cap centerline using a 2700 kN hydraulic actuator mounted at the top of a steel load frame, as shown in Fig. 7. Each cycle was repeated three times, the test was displacement controlled, and was terminated when the load dropped 47% from the peak lateral load. The steel frame sat upon two foundations, as shown in Fig. 7, both of which were supported by geopiers, which are a form of stone columns. The actuator was connected to a steel yoke, which provided a flat surface to distribute the pressure evenly across the surface of the bent cap end in the push mode, as shown in Fig. 7. On the opposite end, there was a similar yoke, joined to the first by twenty 13 mm-diameter prestressing steel cables, which provided the tension for pulling the bent; the cables were prestressed only to take out the sag and did not increase the bent capacity. The deck span (21.87 m) between Bent #5S and Bent #6S and the eight steel plate girders supporting it provided the gravity load.

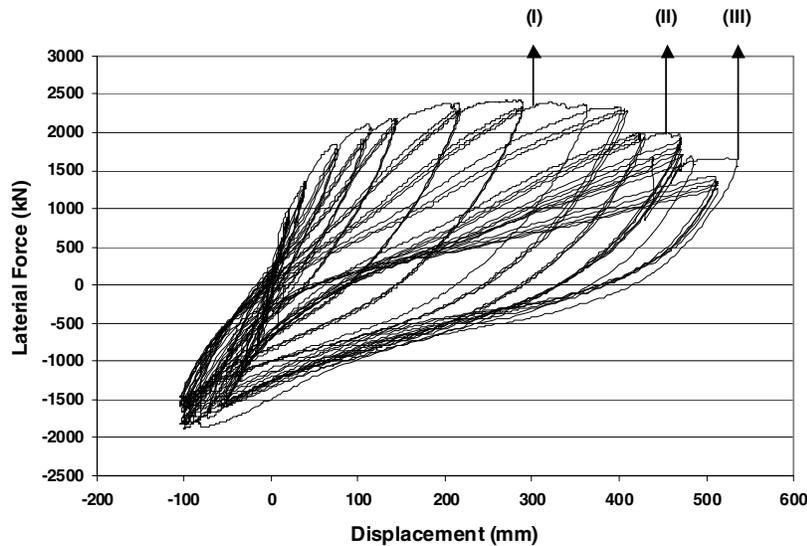
Figure 8. Bent #6-2000 hysteretic behavior: (I) 4% Drift, (II) 5.5% Drift, and (III) 6.8% Drift.

The hysteresis of the force-displacement behavior of the structure for the system, including both the superstructure and the grade beam is shown in Fig. 8; even though the behavior was asymmetric, the retrofitted bent dissipated a large amount of energy and reached a drift ratio of 6.8%. The performance of Bent #6S is characterized by three performance levels as noted in Fig. 8: (I) Rupture of FRP U-straps at the east and west bent cap-column joints, as shown in Fig. 9(a) for the east bent-cap column joint; (II) Longitudinal column steel pullout at the east and west bent cap-column joints, as shown in Fig. 9(b) for the west bent-cap column joint; and (III) Longitudinal column steel lap splice failure at the base of the three columns, as shown in Fig. 10.

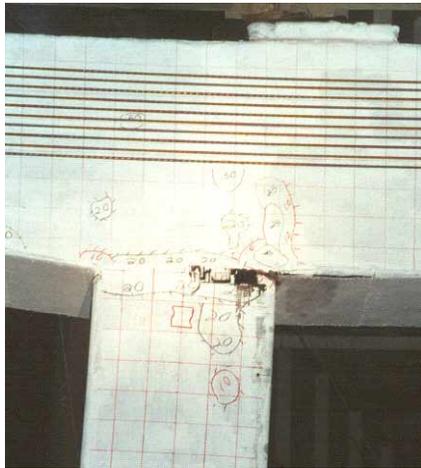
Figure 9. Performance levels: (a) Level (I) east bent cap-column FRP U-Strap failure at 4.0% drift ratio; (b) Level (II) debonding of west bent-cap column steel showing 16 mm gap.

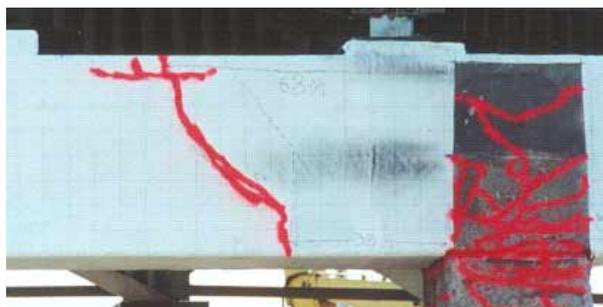
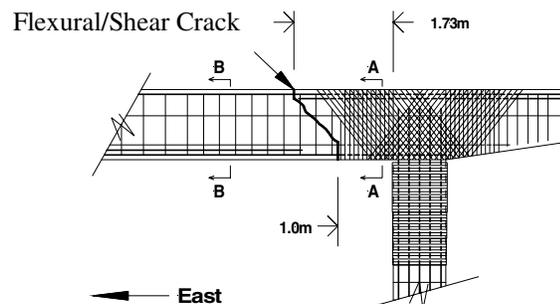
Figure 11. Cracked bent cap east of west column at 6% drift.

observations, the crack started as a flexural crack at 4.0% drift, continued to develop diagonally and had completely developed at a drift of 6%, reaching a crack width of 1.3 mm. The crack occurred because of the high negative moment and insufficient tensile steel and stirrups; there were no FRP composite layers parallel to the bent cap axis as provided for the east and middle columns shown in Fig. 4. This crack shows the importance of FRP composite element (EL2) in the bent cap-column joint retrofit, the FRP composite strips in the direction of the bent cap axis for shear and flexural strengthening.

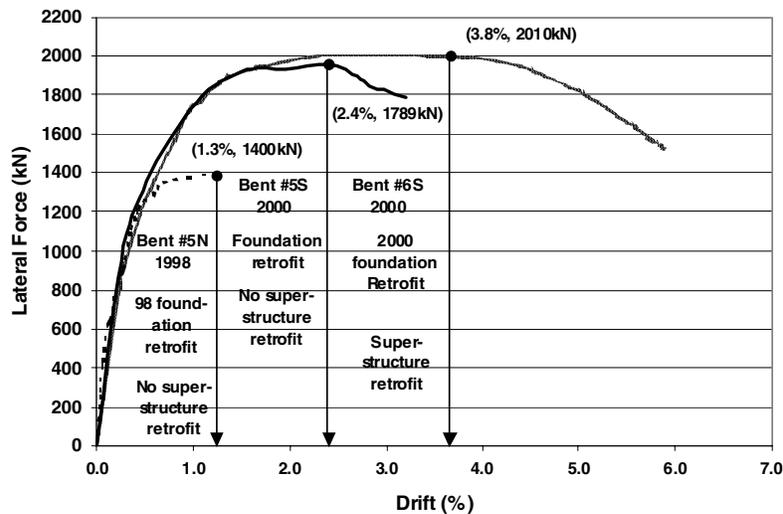
Figure 12. Performance comparisons: Bent #5N-1998, Bent #5S-2000, and Bent #6S-2000.

The displacement ductility of Bent #6S was found as 5.76, for Bent #5S as 3.50, and for Bent #6N from the 1998 test as 4.64. A comparison was made to the Bent #5N test, which was tested by Pantelides et al. [7] in the as-is condition and had no RC grade beam or FRP composite retrofit. The load vs. drift behavior for Bent #5N is compared to that of Bent #5S and Bent #6S in Fig. 12. As expected, Bent #5N had the least lateral load capacity, and smallest displacement ductility at 2.8; Bent #6S with the grade beam retrofit and the FRP composite retrofit had the best performance and 2.06 times the displacement ductility of Bent #5N; this shows that the seismic retrofit satisfied the displacement-based retrofit design performance goal of increasing the displacement ductility.
