RAILROAD LIFELINE DAMAGE IN EARTHQUAKES

William G. Byers, P.E.¹

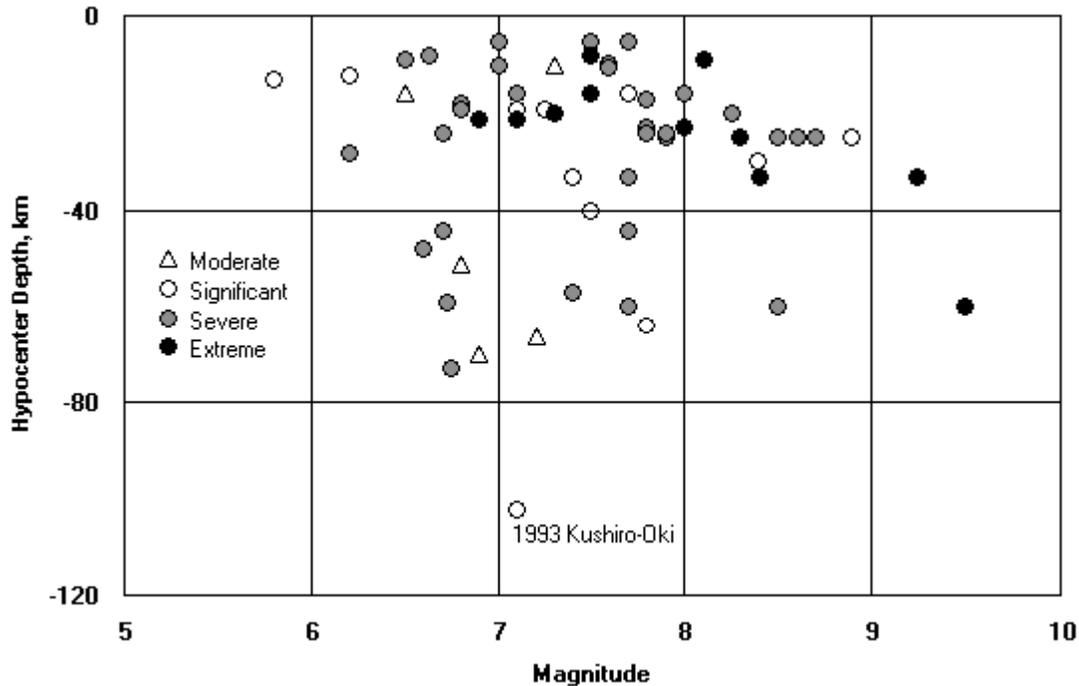
Figure 1. Severity of railroad damage related to magnitude and depth of 60 damaging earthquakes.

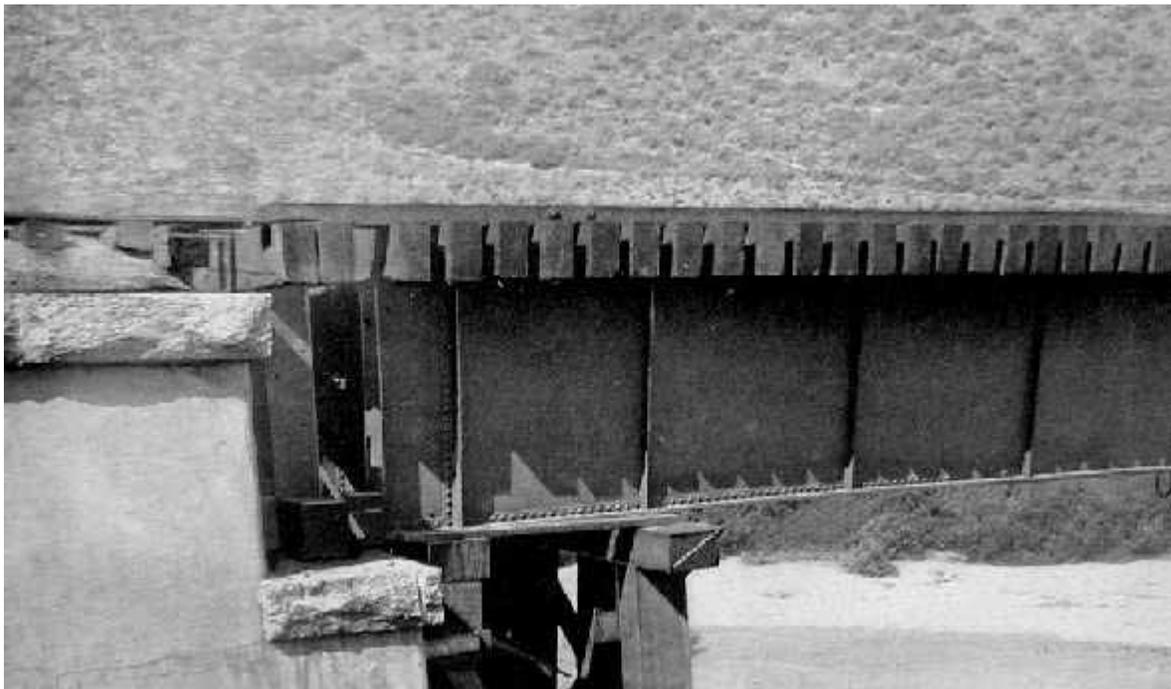
Figure 2. Span displacement due to separation of piers and abutment caused by fault offset at Pajaro River. Plate 65.B of Lawson [5]

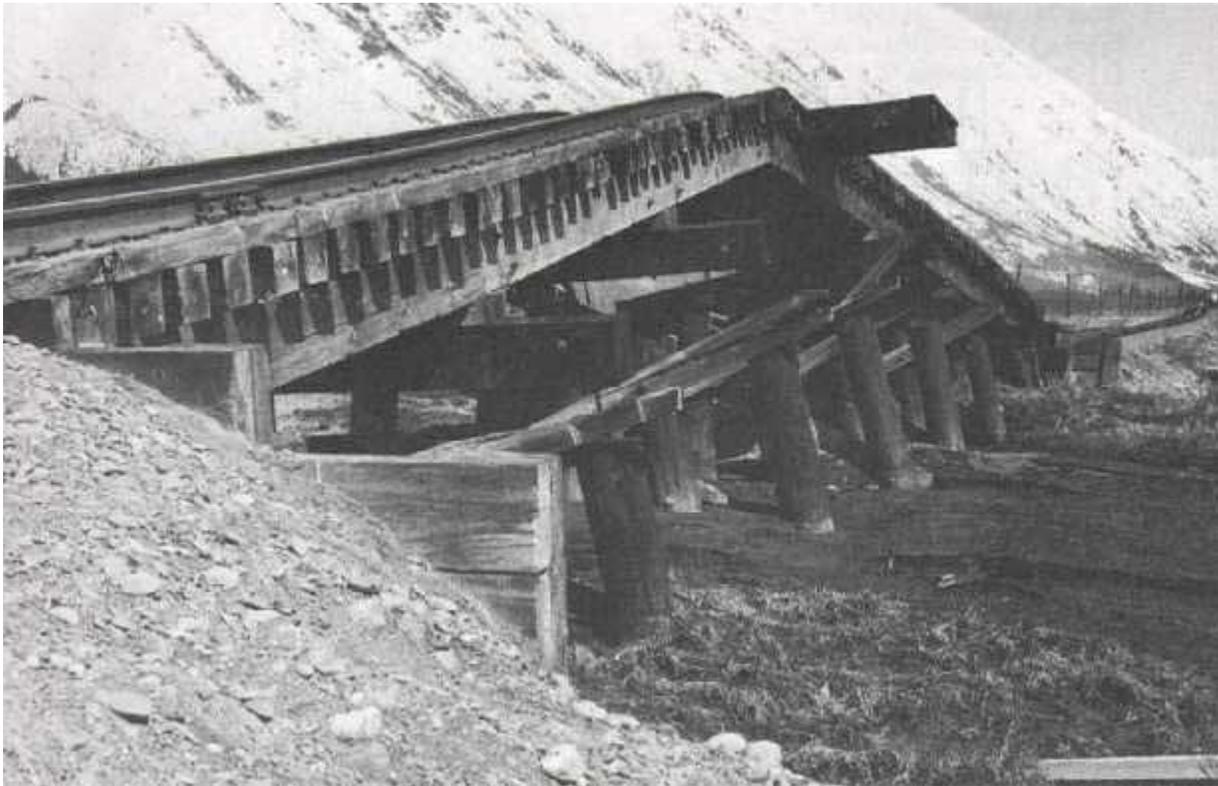
Figure 3. Vertical buckling of trestle caused by lateral spreading.
Figure 13 of McCulloch and Bonilla [1]

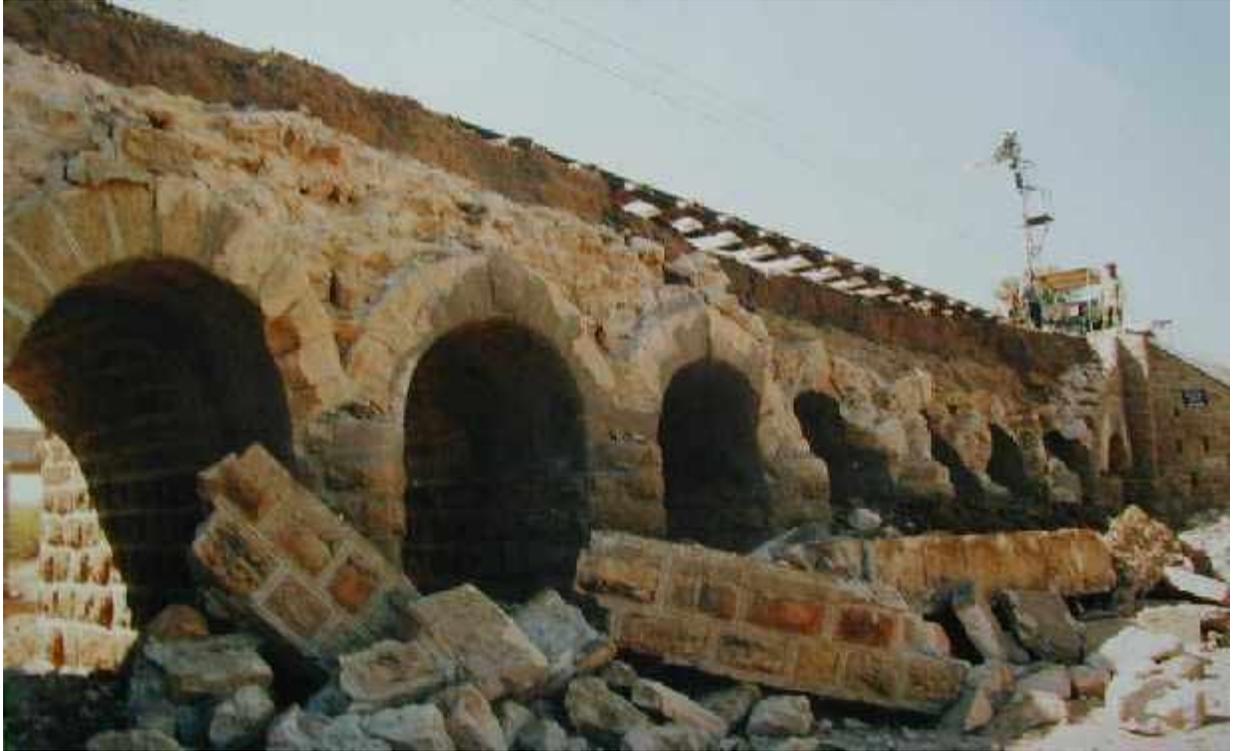
Figure 4. Failed spandrel walls of masonry arch bridge. *Western Railways (India) photo*

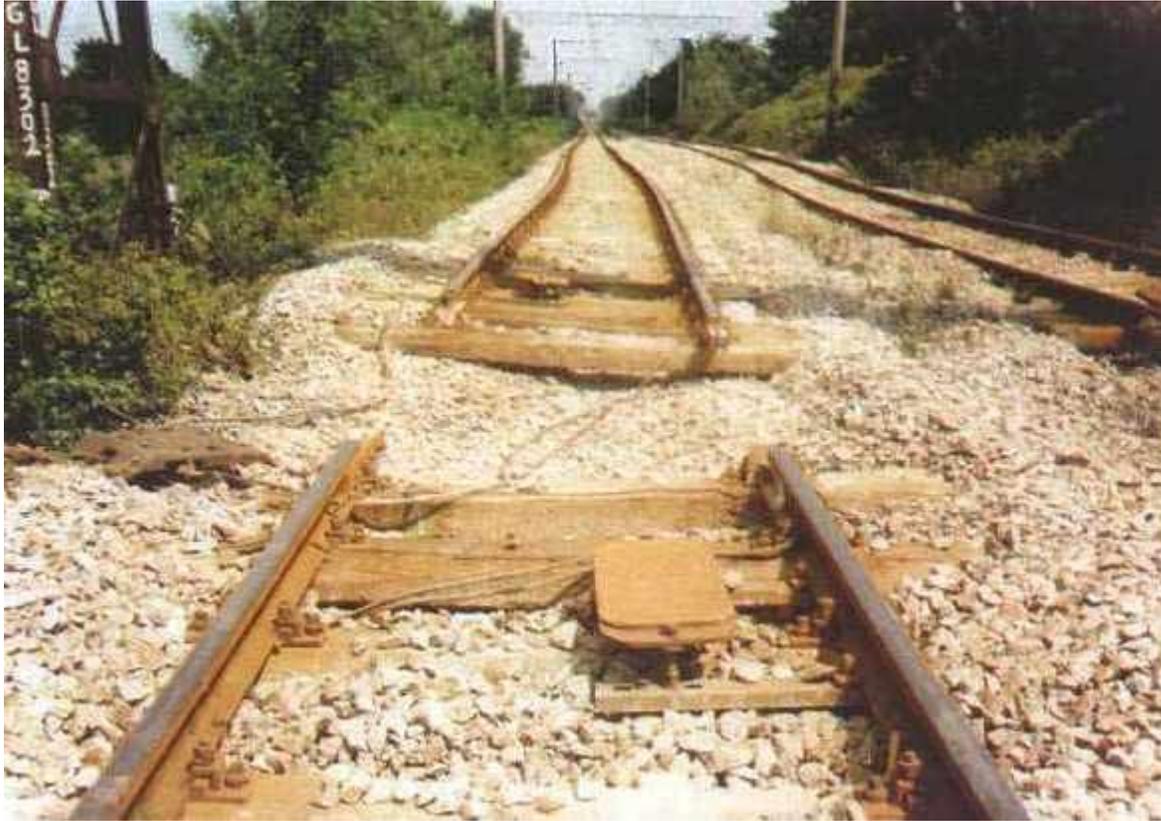
Figure 5. Insulated joints pulled apart by ground motion. *Turkish State Railways photo*

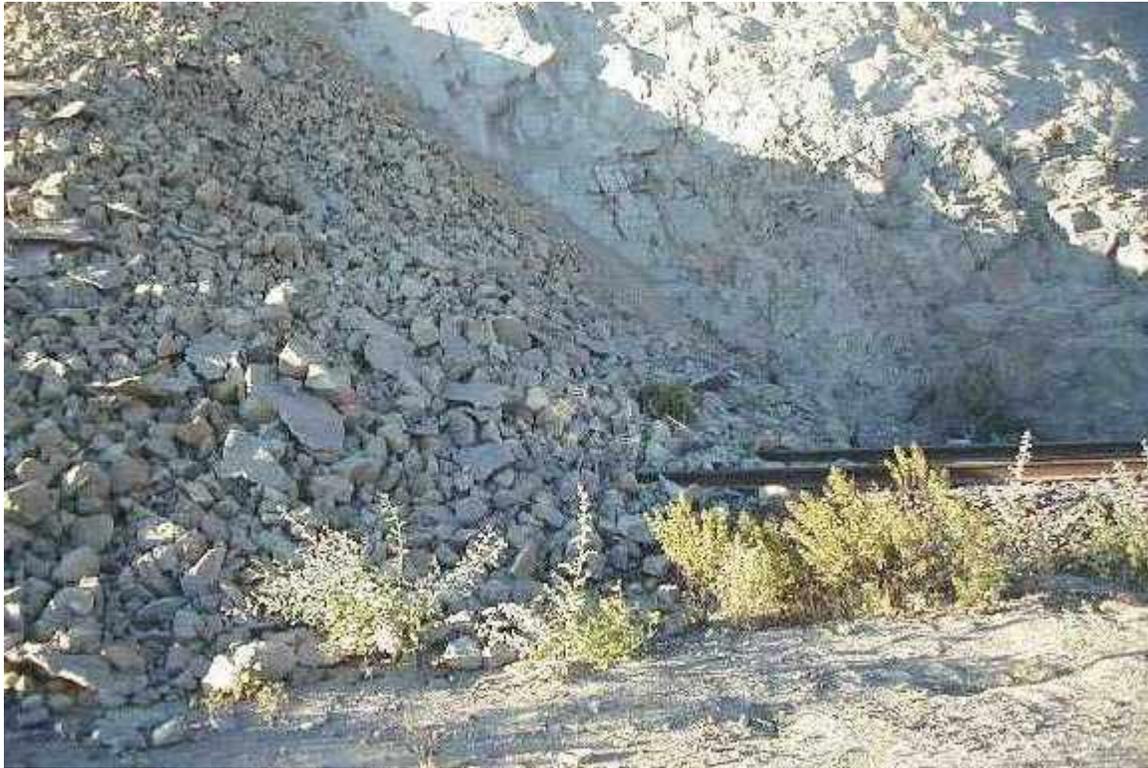
Figure 6. Track buried by rockfall. *Southern Peru Copper Corp. photo*

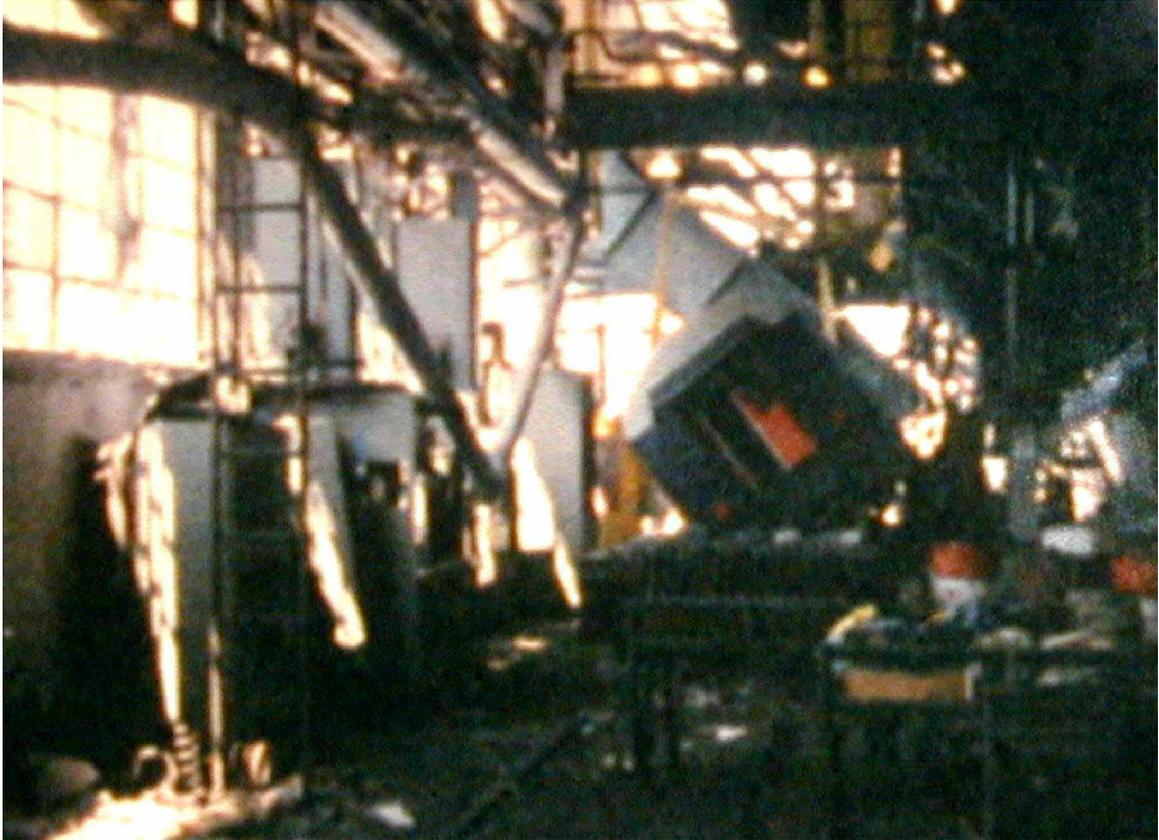
Figure 7. Car partially overturned by failed structure in Adapazari shop.
