## **SEISMIC PERFORMANCE AND CAPACITY OF KOREAN TRADITIONAL WOOD FRAME BUILDINGS**

**Hyeuk Ryu<sup>1</sup>, Jae Kwan KIM<sup>2</sup> and Bong Hee JEON<sup>3</sup>**

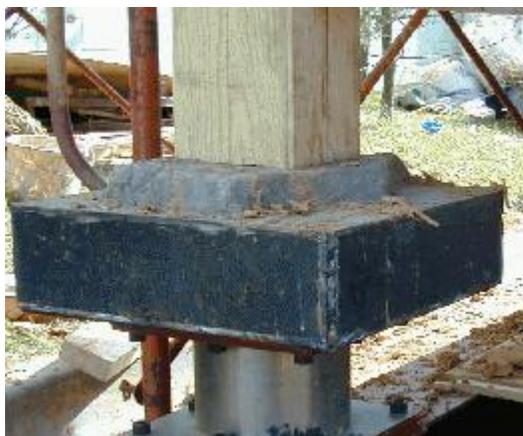
**Figure 4. Foundation stone and column**

**(a) Column on the foundation stone**

**(b) Column base sitting on the foundation stone**

The old tradition of construction method was followed through the whole procedure. Particularly, as shown in Figure 4a, foundation stones were fixed to bottom steel frame to simulate boundary condition of Korea traditional wood frame buildings as closely as possible. As columns were erected on these foundation stones, the bottom surface of the column was trimmed to fit the foundation surface snugly so that the column can stand vertically as shown in Figure 4b. There are no sills or grooves that prevent sliding of column base relative to the foundation stone except friction and interlocking coming from the curved interface. Then the beams and girders were connected using tenon-mortise and angle joints. The roof rafters were placed over the beams and columns. The rafters were covered with wood planks on which muddy clay paste was applied evenly. Then the roof tiles were laid on the clay bed. The last step was construction of wall panels. A couple of lintels connect two columns and no diagonal element is used in the frame of wall. The walls were made of clay mixed with straws and added to the lath skeletons. Figures 5 show the completed models mounted on the shaking table.

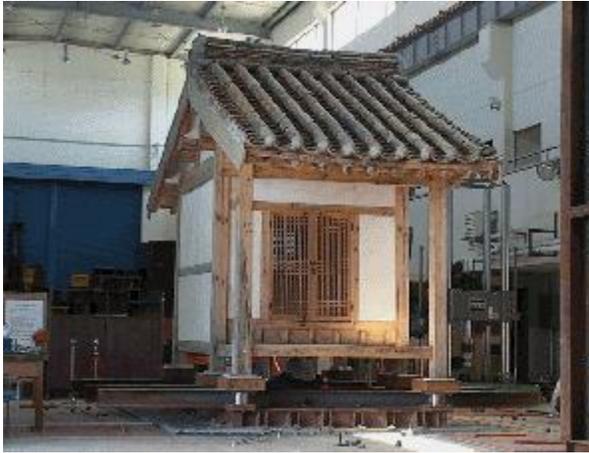
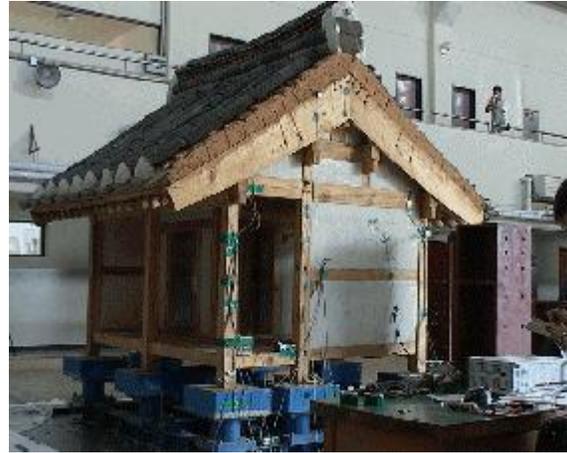
Figure 5. Completed models mounted on the shaking table

(a) Full-scale model

(b) Half-scale model

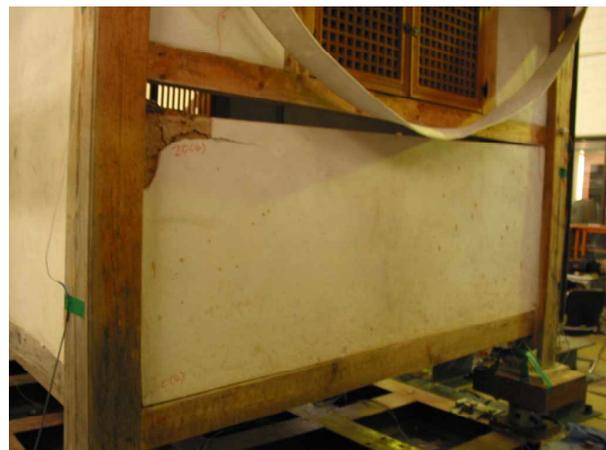
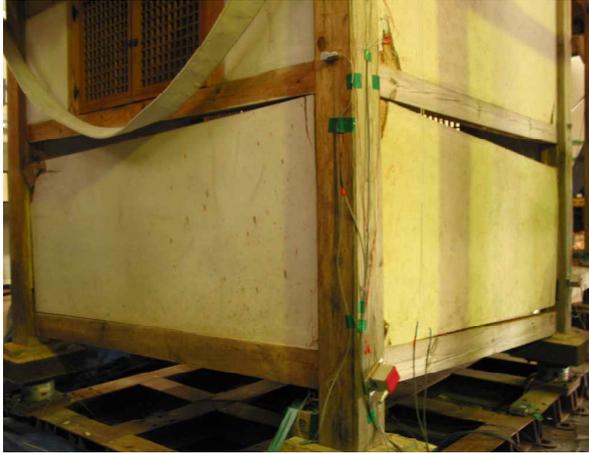
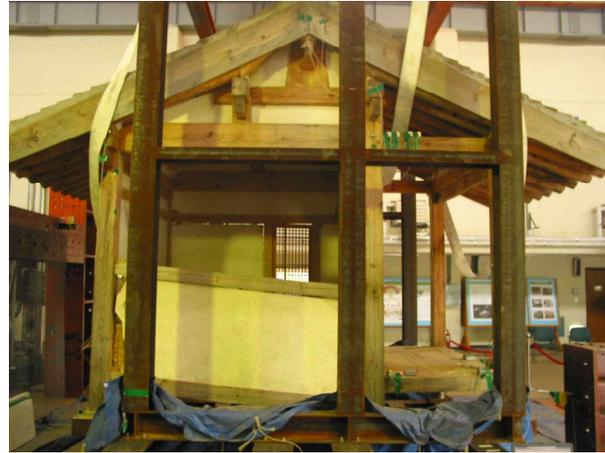
Figure 7. Damage sequence of full-scale model

(a) Crack on a wall panel at 0.12g

(b) Separation of wall panel from frame at 0.24g

(c) Separation of wall panels from frame at 0.28g

(d) Falling down of wall panels at 0.36g

The damage states of the full-scale model at various excitation levels are shown in sequence in Figure 7. Only moderate level of damage was observed at the intensity of EPGA less than 0.2g. Figure 7a shows that cracks began to appear on wall panels at EPGA 0.12g. The real damage was initiated by the sliding of column bases on the foundation stone. The tenons of lower beams began to be pushed out of the mortises in the columns leading to the separation of wall panels. As the intensity increases the lower frame beams separated from the columns first (Figure 7b). Then the beams at the mid height separated from the column (Figure 7c). If the intensity became even higher, the wall panels fell down to the ground along with the beams (Figure 7d). In the course of tests, loud sounds were heard that might be due to fracture of members at the joints. However, the test model maintained its structural integrity or load carrying capacity even at the excitation level as high as 0.36g. The test stopped at this intensity level to avoid damage to the equipment due to the complete collapse of the model. The total collapse of the model might have occurred at the intensity level 0.4g or higher.

The damage sequence and failure mode of the half-scale model was similar to the counterparts of the full-scale model. The complete damage of half-scale model (Figure 8) occurred at the intensity of EPGA 0.36g was almost identical with that of the full-scale model (Figure 7d). However, it has to be pointed out that the roof tiles did not fell down to the ground at all contrary to the initial expectation.

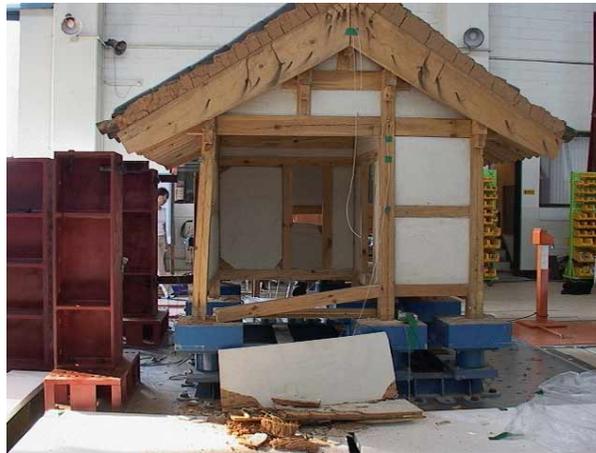
Figure 8. Collapse of wall panel of half-scale model at 0.36g

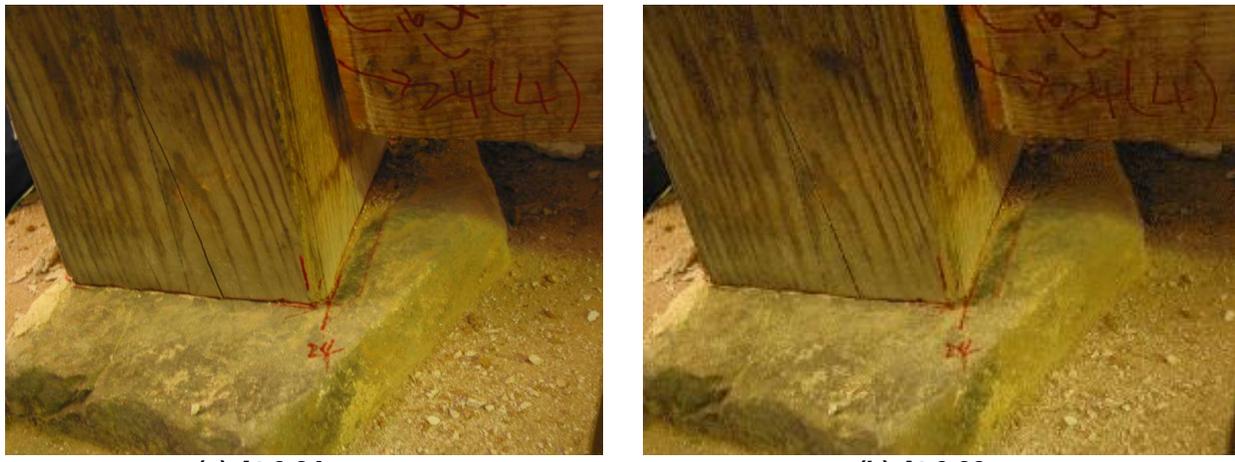
(a) At 0.24g (b) At 0.28g  
**Figure 9. Close-up view of the movement of column base**

The horizontal movement of column bases on the foundation stone and resulting prying action appears to have initiated the damage to the wood frame building. Figure 9a and 9b show the close-up pictures of a column base of the full-scale model at EPGA 0.24g and 0.28g, respectively. The trace of sliding can be clearly visible. The movement of column base occurred in both horizontal directions at EPGA 0.36g as shown in Figure 10. Suzuki et al. [5] observed similar mechanism in the shaking table test of Japanese traditional wood house model.
