ON SEISMIC RETROFIT STRATEGIES OF HIGHWAY BRIDGES - EXPERIENCES LEARNED FROM CHI-CHI EARTHQUAKE

SUMMARY

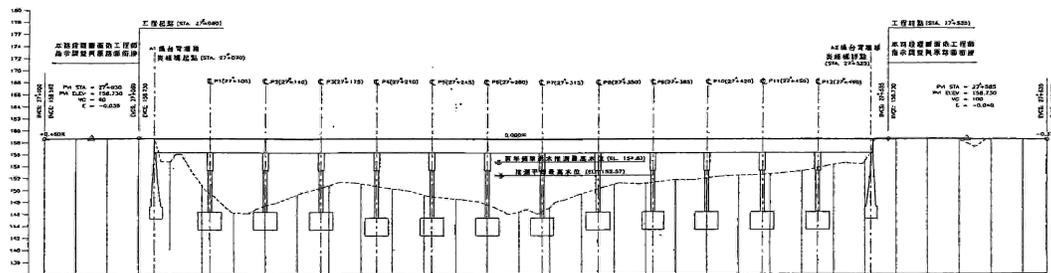
Figure2. Schematic drawing of the bridge

Yen-Feng Bridge, located at the milepost of 26km+937m on Provincial Route 14, is one of the main links connecting Tsaotun and Poli town in Nantou country. The bridge is in between the Chu-Lon-Pu and Shung-Tung fault (approximately 5 km from Chu-Lon-Pu fault and 7km from Shung-Tung fault), as shown in **Figure 1**. It is actually 13-span bridges with a constant span length of 35m and 16m in width. All spans are supported by neoprene bearings at the cap beams. The superstructure is composed of six simple supported, prestressed reinforced concrete girders, and the deck slab has additional 5 cm A.C. on top of the girder. The substructure comprises multicolumn bents (portal frame) on spread footings. At both ends, the bridge girders are supported on the abutments. The schematic drawing and cross section of the whole bridge system are shown in **Figure 2 and 3**, respectively. Two concrete shear keys are installed inside on each cap beam to prevent the girders from unseating in the transversal direction. The Yeng-Feng Bridge is a typical type highway bridges in Taiwan, constructed before 1990's [3].

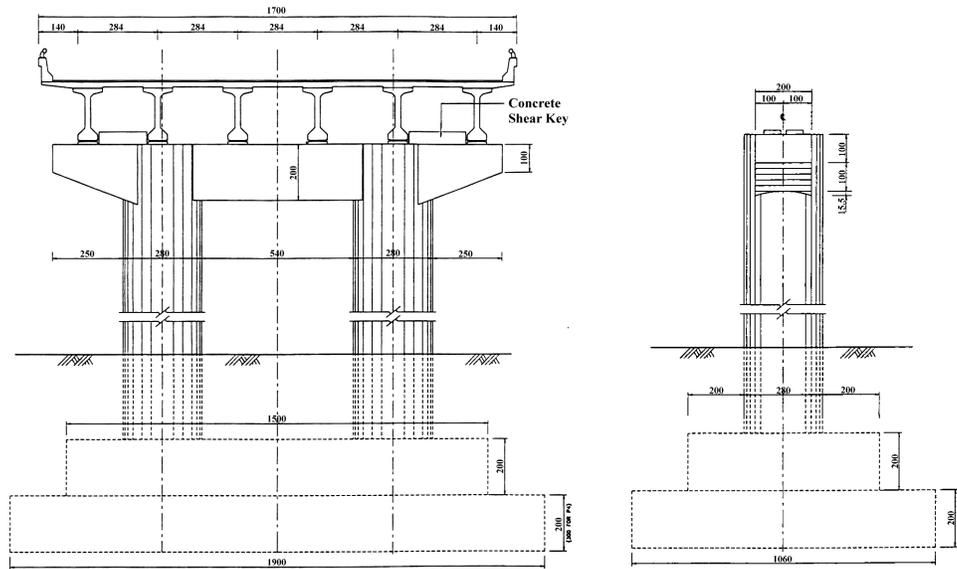
(a) Multicolumn bent

Figure3. Elevation and sectional drawing of Yen-Feng Bridge

Yen-Feng Bridge consists of the prestressed reinforced concrete girders, decks and bearings, as shown in [Figure 3](#). In this study, the superstructure is assumed to remain essentially elastic, limiting the nonlinear modeling considerations to the bearings, concrete shear key, expansion joint, and connection between cap beam and bridge columns. [Figure 4](#) shows the FEM model by SAP2000N [\[6\]](#).

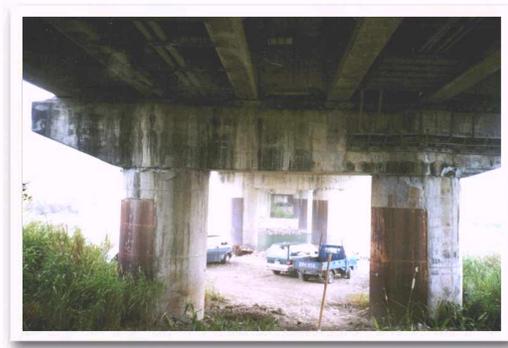
(1)

1. Concrete spalling and cracking on the weak construction joint between cap beam and column top at bents P1 to P12, as shown in **Picture (1)**.
2. Relative movement of cap beams at bents P9, P10 and P11 the in transverse direction, as shown in **Picture (2)**.
3. Several concrete shear keys were cracked.
4. Residual relative displacements occurred at several expansion joints, a typical damage shown in **Picture (3)**. Among many others, at the fourth span, the largest displacement resulted from one outside broken girder moved about 40 cm in transverse direction, as shown in **Picture (4)**.
5. Parts of neoprene bearings had permanent displacement.

Picture(1) Concrete spalling and cracking at pier top; (2) Relative displacement of cap beams at pier top; (3) Residual displacement at expansion joint; (4) Residual movement between two adjacent spans (at the fourth span)

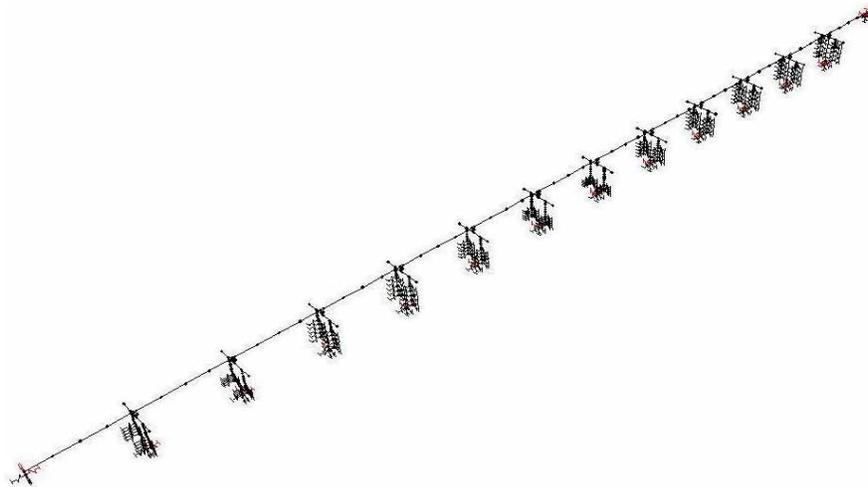
Figure4. Analytical model of the bridge system

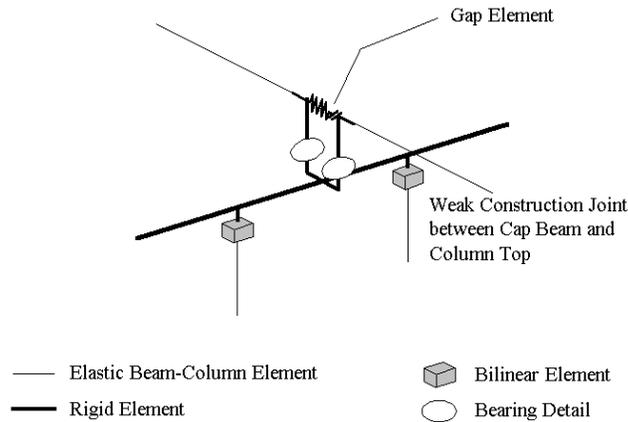
The multi-column bent is modeled as a portal frame along the bent axis, consisting of beam and column elements with effective member properties [7]. Except for properly modeling the columns, cap beams and footings, the effect of soil-structure interaction at the abutment and footing was also considered by equivalent sets of linear springs [8~9]. Furthermore, considering the change of riverbed may affect the effective length, the soil-covered part of the column is also supported by spring elements [7]. The construction joint between the cap beam and column top has been found as weak face with lower shear strength, as observed during this earthquake. In order to understand this phenomenon, the weak construction joint is modeled as a bi-linear element and the shear strength is determined according to the shear friction approach [10], as shown in Figure 5.

Figure5. Non-linear elements of sub-structure

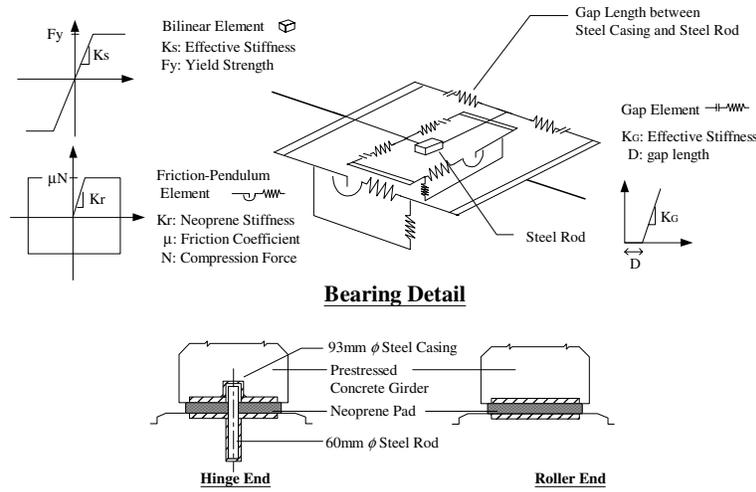
The analytical model of the bearing, including the neoprene stiffness, friction between the beam and concrete surface, and the steel rod are shown in figure 6. The friction behavior between girder and neoprene pad are modeled as friction-pendulum element with an initial stiffness equal to that of the neoprene bearing and zero stiffness after slipping occurs. The friction force is equal to bearing axial reaction force N times friction coefficient μ . The friction coefficient is about 0.15~0.2 [11]. The function of the steel rod is used to limit the displacement of superstructure during small to middle-earthquake. The rod is modeled as a bending short bar with stiffness and yielding shear force equals to $3EI/L^3$ and $0.57Av_f$, respectively. A bi-linear element is used to model the gap elements are considered as the gaps between PCI girder and steel rod. The ratio of gap stiffness to rod stiffness is 1000.

Figure6. Non-linear elements of super-structure

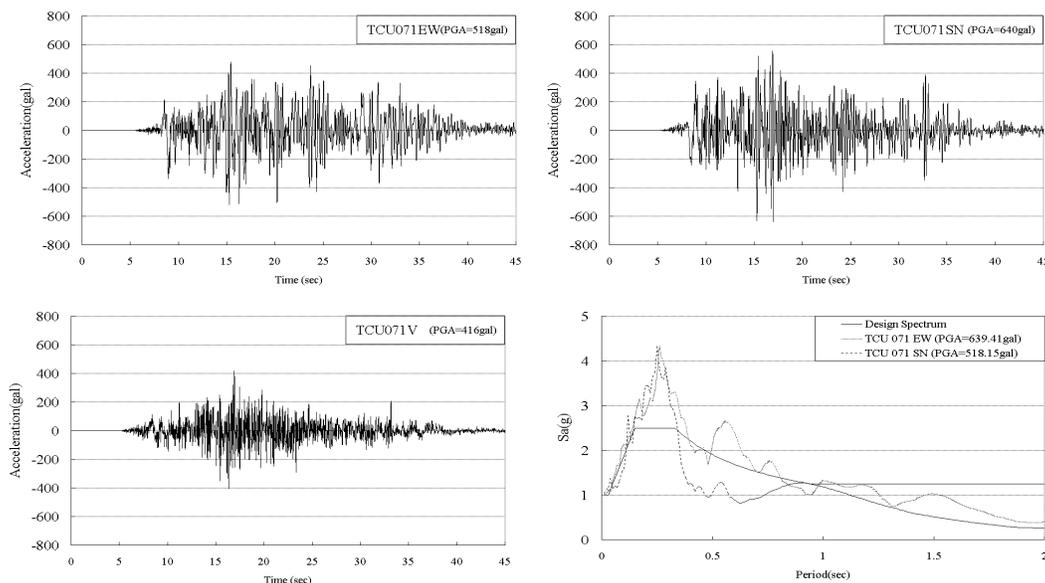
The ground motion used in this study was selected to represent as closely as possible the actual excitation at the bridge site under the 921 Taiwan Chi-Chi Earthquake. The nearest strong motion accelerometer, TCU071 is located approximately 4 km away from this site. Figure 7 is the acceleration records in the east-west, north-south and vertical directions, respectively. The peak values of the ground acceleration (PGA) measured in those recordings are 518 gal, 640gal and 416 gal, respectively, with east-west, north-south and vertical direction. The response spectrum of this earthquake shows that the design response spectrum is not conservative in a few period ranges, such as the short period of 0.16 ~ 0.4 second and the median period of 0.5~0.82 second in east-west, and in short period of 0.15 ~ 0.35 second in north-south directions.

Figure7. Ground Motion Recordings and Response Spectrum (TCU071)
NONLINEAR TIME HISTORY ANALYSES

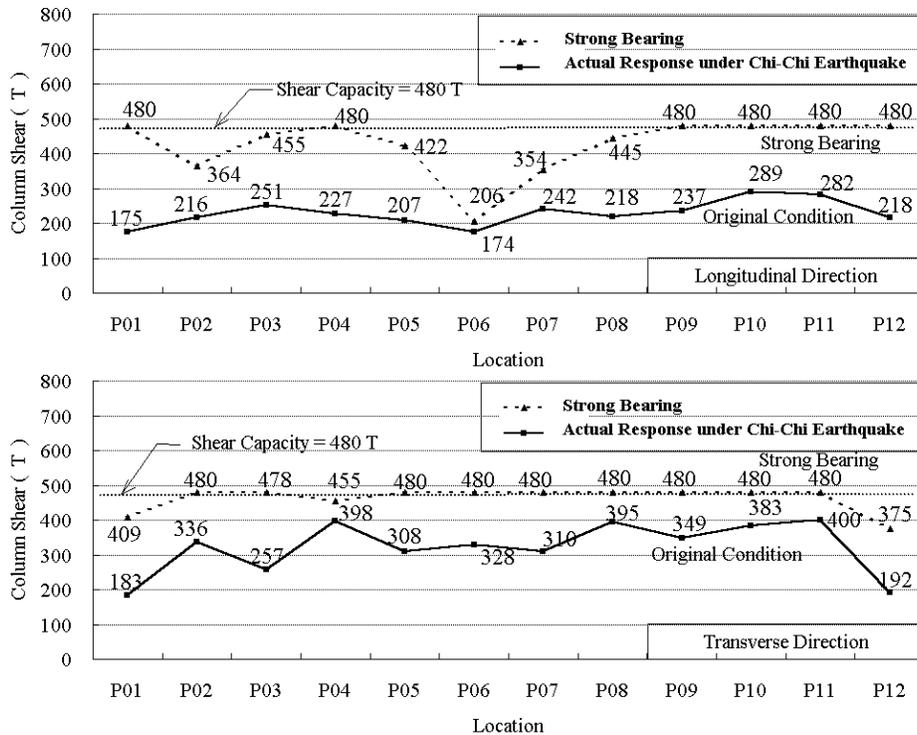
Figure 8 and 9 show the maximum shear force and bending moment of the construction joint between the cap beam and column top, respectively. The dotted line means the analytical results of the bearing strength being reinforced. From shear friction approach in design code [10], the shear capacity of weak joint is about 4708.8kN (480tonf). The weak joints at piers P8 ~ P11 had been yielded, and ones at piers P2, P5 and P8 are almost yielded. While superstructure moved 20 mm and pounded the concrete shear keys, it transferred impact forces to the bridge columns in the transversal direction. In the longitudinal direction, the shear force transferred from the bearing friction and steel rod was minor. The results represent reasonable damages of the bridge. Apparently, after strengthens the bearing shear capacity, the shear force of the construction joint between the cap beam and column top increased and led to larger damage.

Figure 8. Maximum shear force of the construction joints between the cap beam and column top

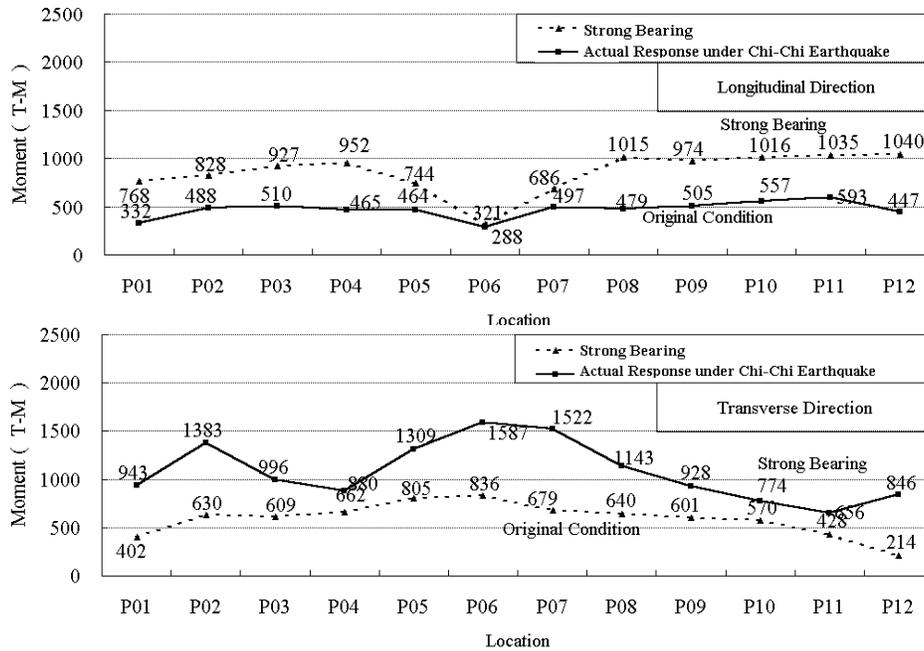
Figure 9. Maximum bending moment of the construction joints between the cap beam and column top

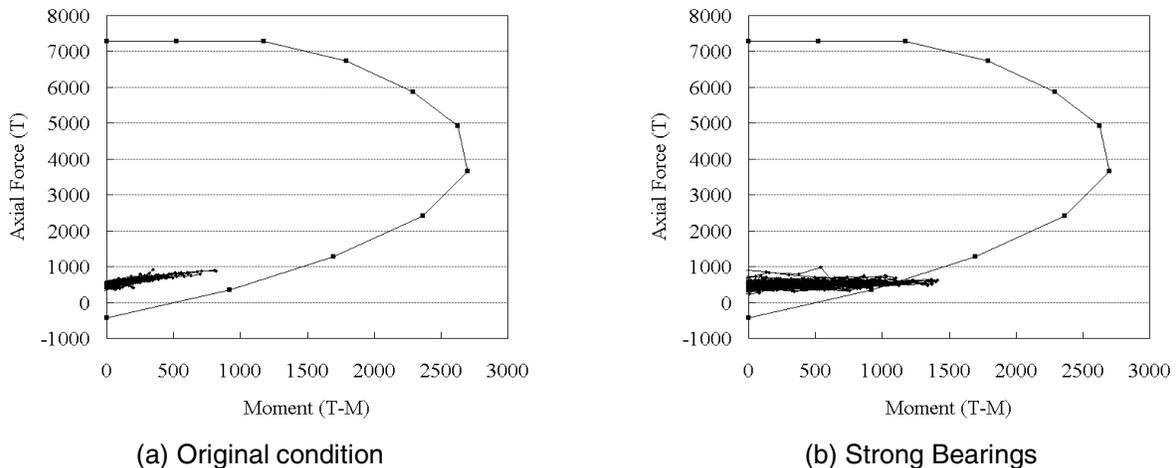
In order to evaluate whether the flexure failure of column occurs or not, the axial load-moment interaction diagram is calculated. Comparing the axial force-moment time history response with axial load-moment interaction diagram, as shown in Figure 10(a), the maximum moment and axial force for P6 did not exceed the axial load-moment interaction diagram that indicates the pier did not have flexure failure. Virtually only damage occurred at the weak construction joint between the cap beam and pier top, no flexure failure is found. Figure 10 (b) shows the results of the bearing strength being reinforced. Apparently the column moment increases and caused damage.

(a) Original condition (b) Strong Bearings
Figure 10. Comparison the P-M time history response with P-M interaction diagram

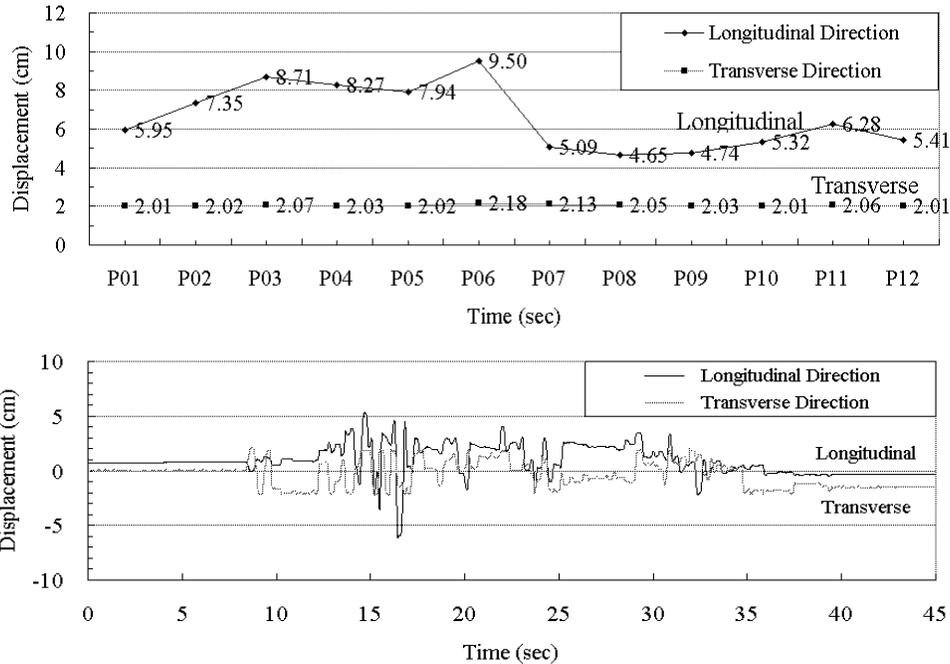
Figure 11 shows the maximum relative displacement distribution of the bearing and displacement time history at bent P1. With little shear capacity force of steel rod, smaller than concrete shear key in the

transversal direction, the longitudinal displacement move larger than one in the transversal direction, and cause a permanent displacement on the superstructure, when bearing moving and steel rod yielding.

Figure11. Maximum relative displacement distribution at bearings and Relative displacement time history at bent P1

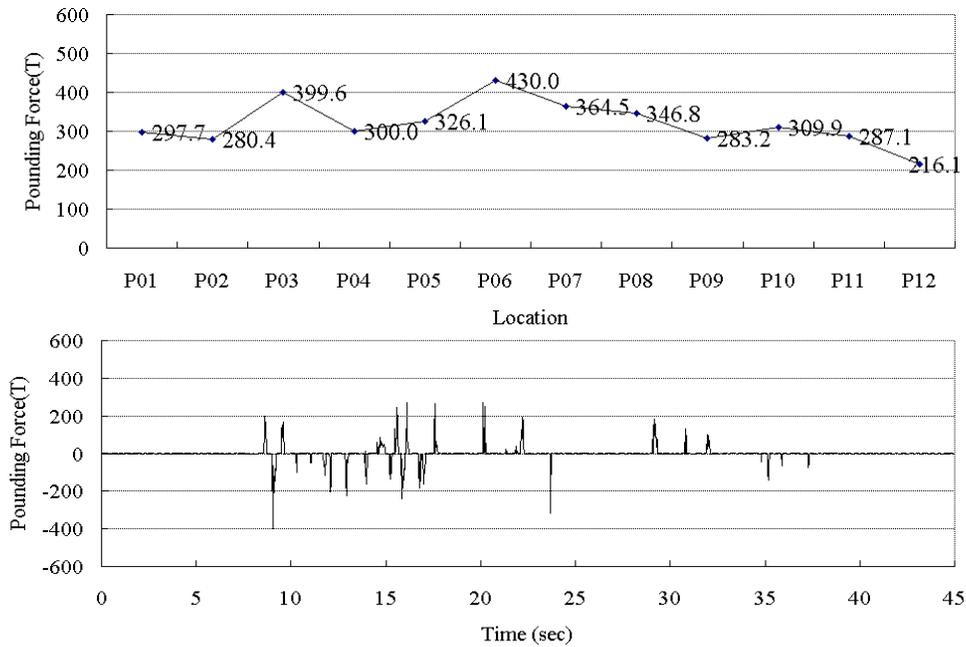
Figure 12 shows the maximum pounding force distribution of the concrete shear keys and pounding force time history at bent P3. When the PCI girders pounded the concrete shear keys, the displacements of superstructure were limited to 20 mm, and the forces were transferred to the substructure. The results of numerical analysis represent that all of the steel rods had been yielded during this earthquake.

Figure12. Maximum pounding force distribution of the concrete shear keys and Pounding force time history at bent P3.

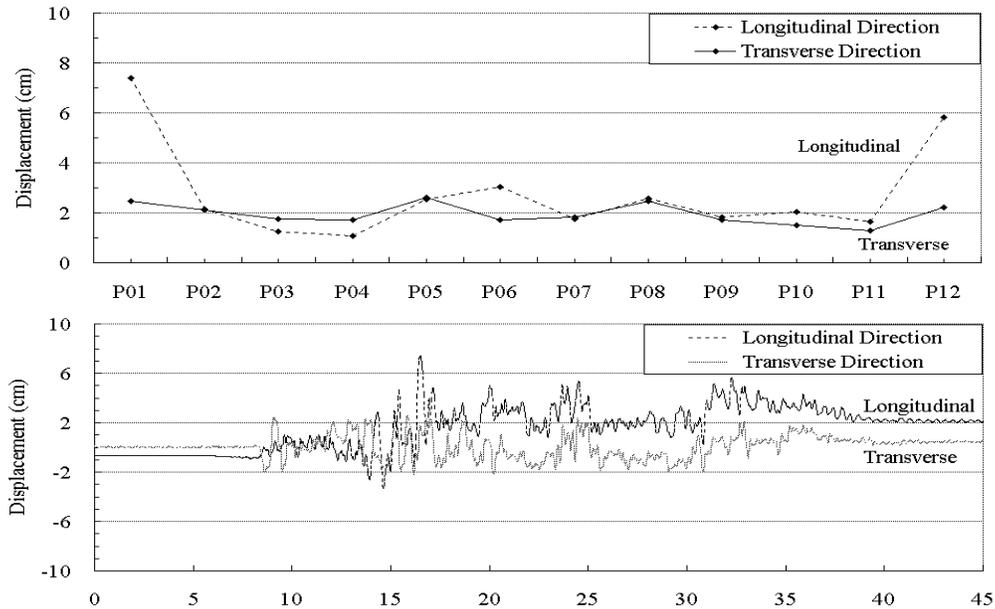
The maximum longitudinal displacement for the expansion joint can be obtained using the nonlinear time history analysis, as shown in Figure 13. Except for the span S1 ~ S2, S12 ~ S13 deck slabs had more than 5cm relative displacement, the rest parts of bridge have less relative movement; therefore, no pounding occurred during this earthquake.

Figure13. Maximum deformation distribution of the expansion joints and Deformation time history at bent P1
