FOR COMPARISON OF VILLAGE HOUSING CONSTRUCTION PATTERNS OF EARTHQUAKE AFFECTED REGIONS IN THE LORESTAN PROVINCE ---BEFORE AND AFTER AN EARTHQUAKE

The objective of this article is a comparison of two traditional and new patterns of village housing construction , before and after the Lorestan earthquake and will be followed by an elaboration on construction methods, components, materials, architectural designs and livelihood values .

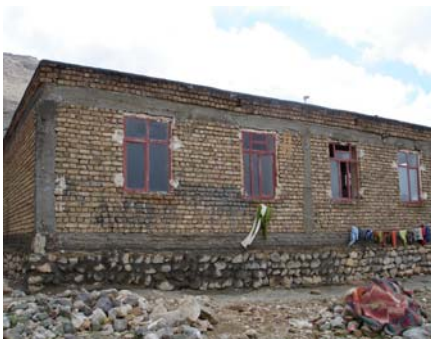
a-Stone Foundation b-Adobe Foundation c- Stone- Brick Foundation

Figure .1 Stone foundations laid under brick walls with chenage are constructed with new material before and after an earthquake

In villages, in the province of Lorestan, with regard to local material that already exists in the region, the foundations of the houses constructed are illustrated in the figures given below :

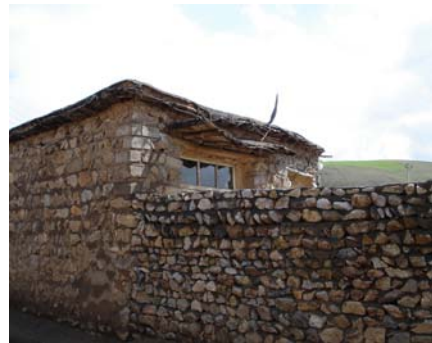
Figure .2 Stone walls are built of stone, sand and cement. These walls, due to climatic conditions should have hooks (chenage), in addition the walls' vertical joints (mortar joints,) should be filled in completely

This type of foundation is exposed to climatic conditions; therefore, in spite of its cohesive appearance, the foundation's vulnerability decreases the building's resistance against earthquakes.

Left side of the wall shows defective construction

- i. Stone wall made of Viking stone(fig.2)
- ii. Walls made from non- rough rubble stone
- iii. Regular stone wall
- iv. Mud wall
- v. Adobe wall
- vi. Brick wa

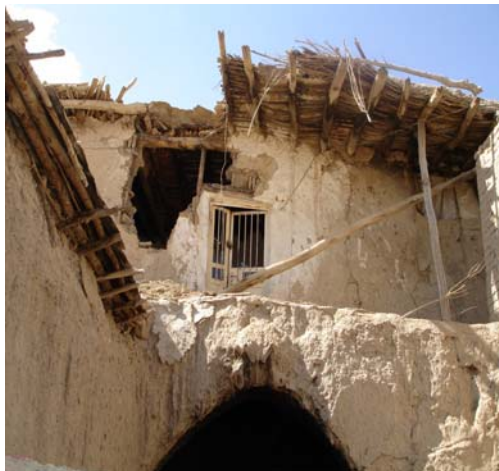
Figure 3 :Sis Roof: This kind of sis roof in the shape of an arch is made of clay and mud. The reason for selection of this kind is due to the suitable nature of the arch in resisting and shifting of pressure. Since these roofs are usually made on the lower floor, the elevation is increased in order to have a flat surfaced ground floor

- i. Roofs with wooden beams : Roofs made of forest wood and roofs made of white wood
- ii. Jack - arched roofs
- iii. Sis roof(fig.3)

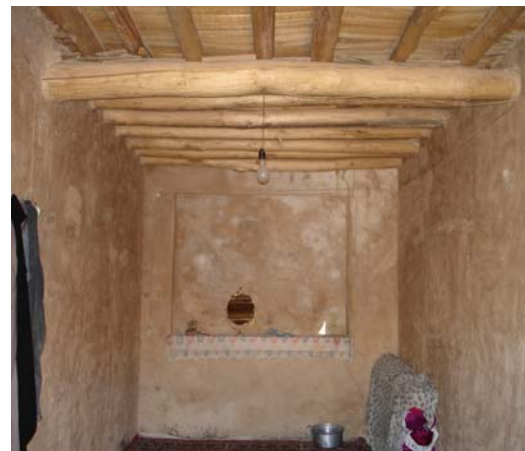
Figure 4: Roofs with wooden beam covering: These are made of straight white wood and are placed in an orderly manner at a measured distance from one another. In this kind, the primary (main) beams are vast in number, whilst the secondary ones are placed cross wise upon them

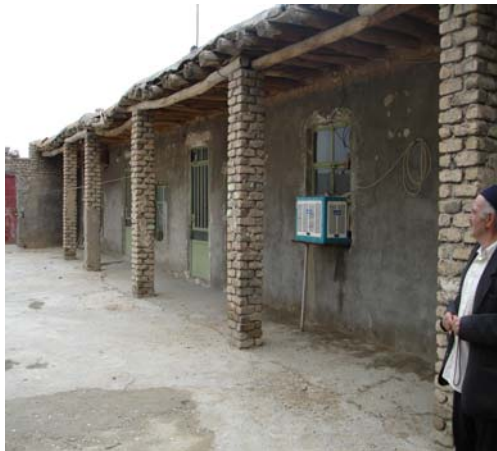
Figure .5 : Brick column in the balcony

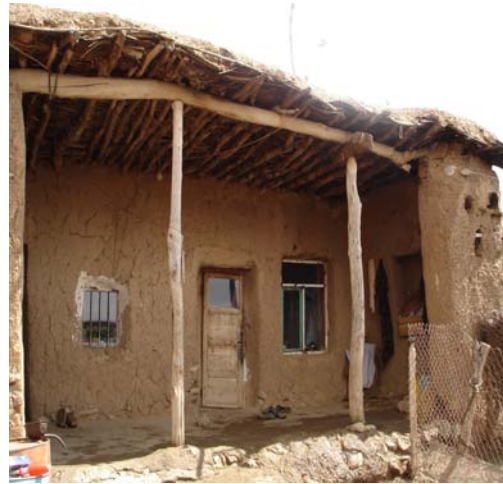
Figure .6: Wooden column

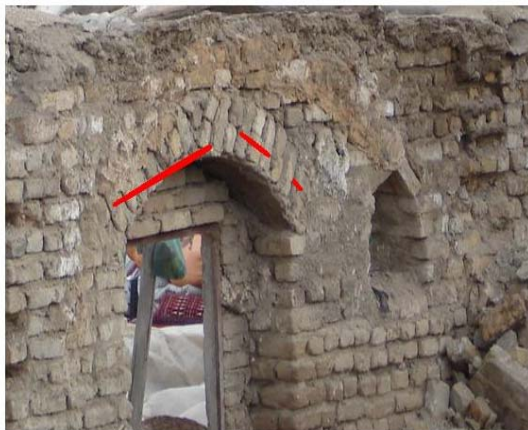
Figure .6: Brick lintel

This Is usually used to cover small openings, shelves, and crevices. Due to the fact that covering of these spaces is a sensitive and important matter, utmost care needs to be taken to make sure that the weight of the ceiling and that of the upper wall is shifted to the side wall in a suitable manner. In addition to this, it should be able to provide a correct contiguity between the two parts of the wall to one another.

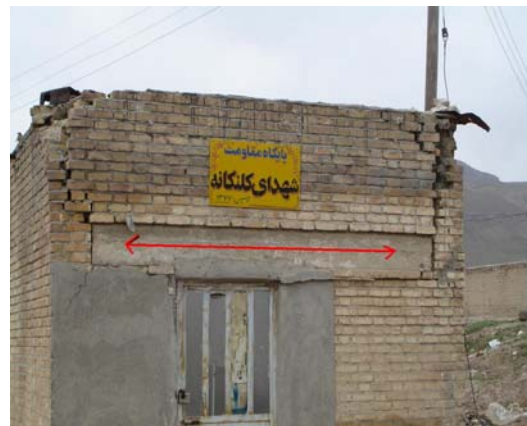
Figure .6: Concrete Lintel

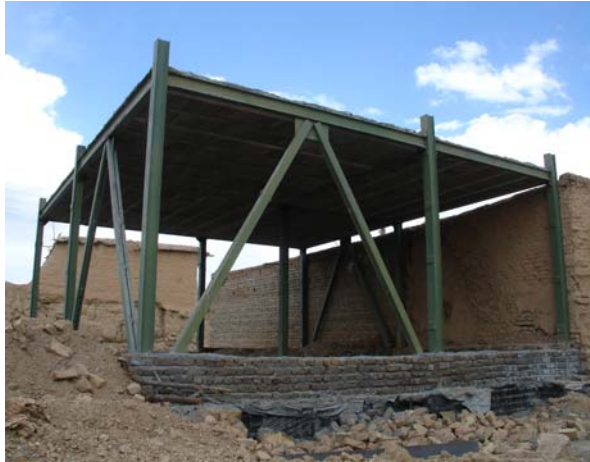
Figure 7: Reconstruction / Renovation design of a single floor in a rural area

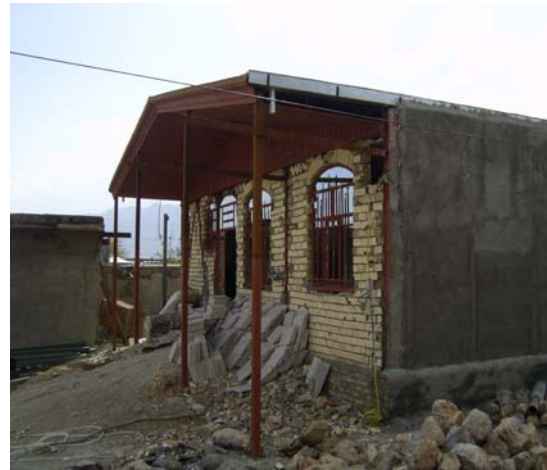
Figure 8: Reconstruction/Renovation design with a sloping roof & terrace

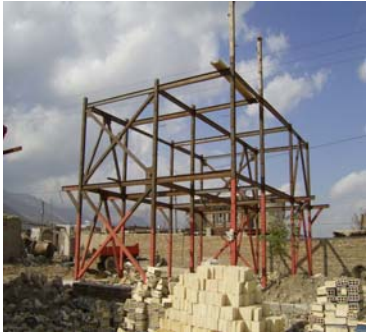
Figure 9 : Pattern of new building using new material – renovation after Earthquake

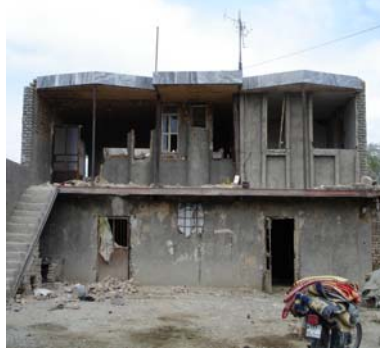
Figure 10 : Traditional building pattern using new material before an Earthquake

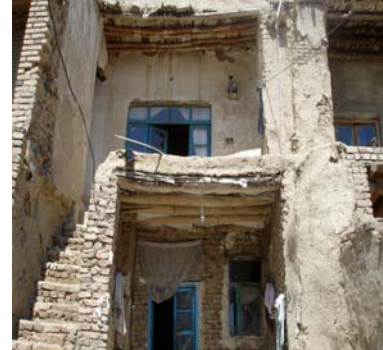
Figure 11 : Traditional building pattern using local material – before an Earthquake
