## LEARNING FROM RECENT INDONESIAN EARTHQUAKES: AN OVERVIEW TO IMPROVE STRUCTURAL PERFORMANCE

K.S. Pribadi<sup>1</sup>, D. Kusumastuti<sup>1</sup>, and Rildova<sup>1</sup>

<sup>1</sup>*Faculty of Civil and Environmental Engineering, Institut Teknologi Bandung, Bandung, Indonesia  
Email: ksuryanto@si.itb.ac.id*

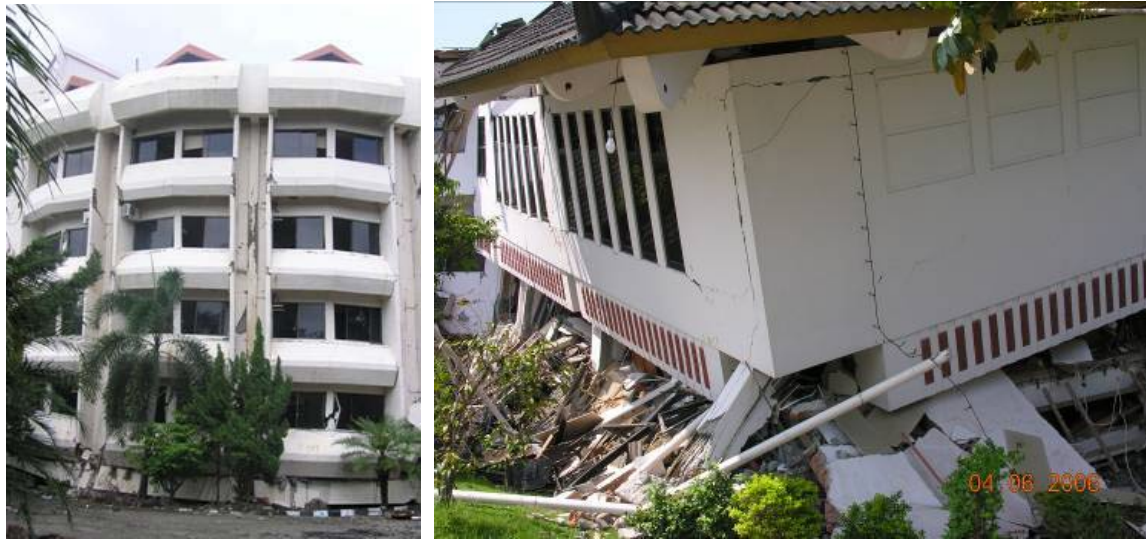
Figure 2 shows examples of buildings having soft first story which were completely collapse during Yogyakarta earthquake. This type of damage was quite common in structures subjected to earthquake excitation. Other common damages are due to poor connections and improper detailing, as shown in Figures 3 and 4.

Figure 2. Soft story and weak story effects causing total collapse of structures

From damages shown above, the problems can be analyzed from several aspects. First, the design of buildings often caused problems for the structure to perform satisfactory under earthquake loading. Conformity to building codes remains a critical issue in ensuring the structural performance. Improper detailing and structural configuration often become major causes in poor performance of structures. Moreover, the detailing in the structural drawing and building specifications sometimes were unclear, leaving the construction workers to improvise the parts. It is common to find buildings designed with structural irregularities, thus resulting in force concentrations and disruptions in load transfer elements. The lack of concern for the placement of openings and non structural elements also caused problems, as in the case of soft story effect and short column behavior.

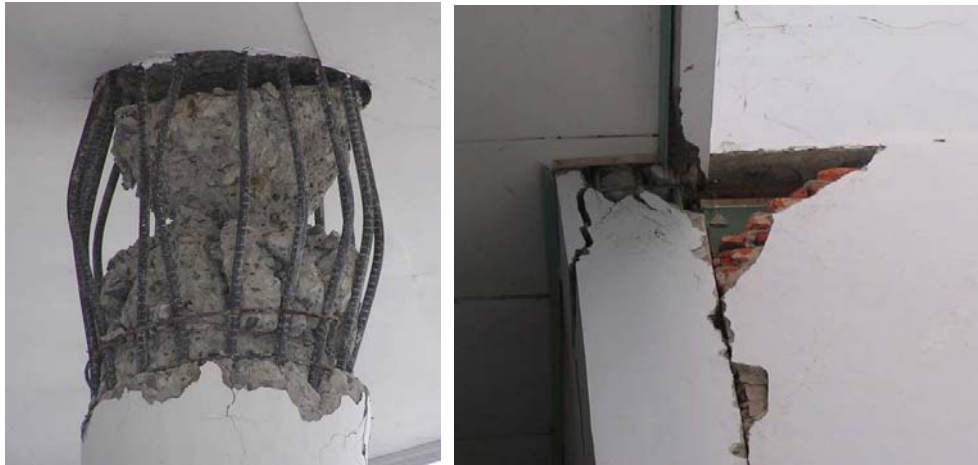
Figure 3. Failed elements and connections.

The results from problems discussed above are structures that are vulnerable to earthquakes. These structures usually lack in structural integrity, since they have insufficient connections and anchorage between each structural components. For example, beam-column connection did not comply with the requirements in the codes, no seismic hook supposed to be provided by a 135 degrees bending was used in the stirrups, and no anchorage was provided from walls to columns and ring beams, leading to collapse of walls during earthquakes.

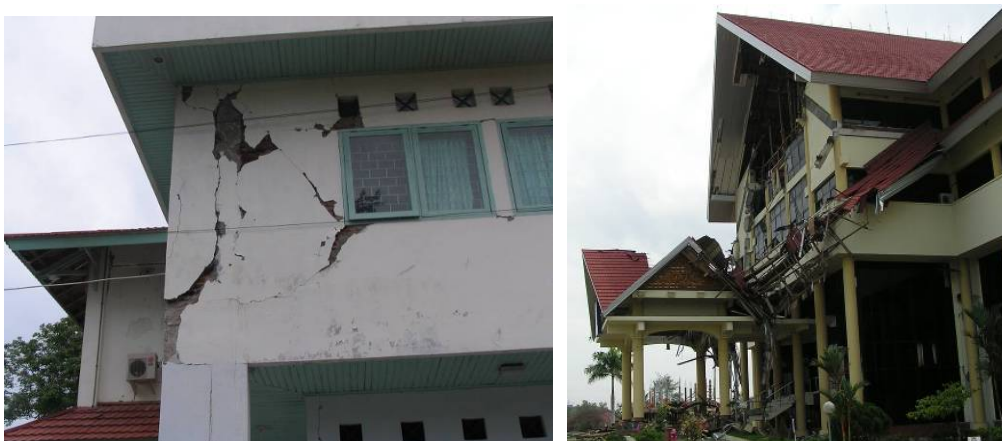
Figure 4. Failed elements and connections.

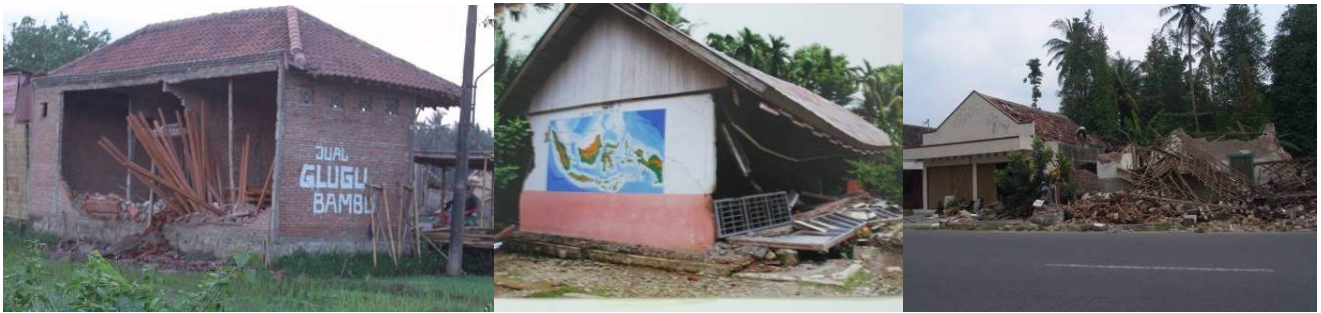
Figure 5 shows damages occurred on non-engineered structures. These damages usually caused by improper detailing and lack of structural integrity of various components in the building. These problems created separations of structural elements and partial collapse, or total collapse. Most damage occurred on the walls, as these elements were often left unconnected to beams and columns.

Figure 5. Damages in non-engineered buildings

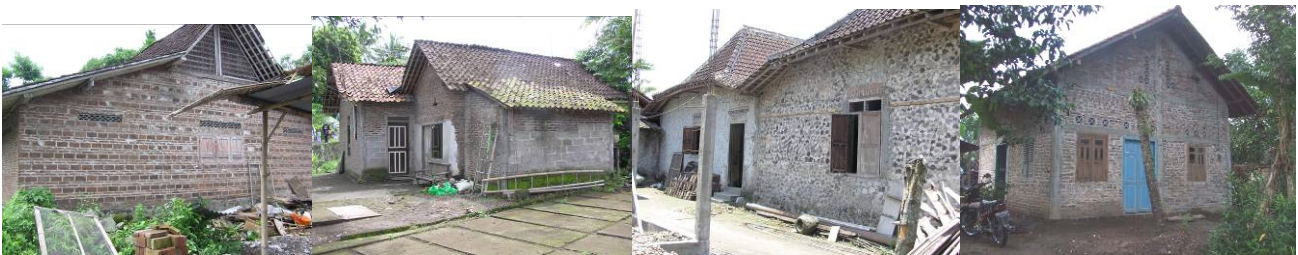
Non-engineered structures face many problems during earthquake in Indonesia. Many of these structures have been evolving from vernacular buildings, which used to have good performance in earthquake, toward more common masonry structures such as those found in urban areas. These structures often do not follow minimum requirements for a good confined masonry building, and many of them use locally available materials to give a “masonry-like” features, which are in fact very vulnerable to ground shaking (Boen and Pribadi, 2007). Typical non engineered structures in Indonesia using different types of materials are shown in Figure 6. The picture on the far right shows non engineered structure with good feature of confined masonry.

Figure 6 Non-engineered ordinary houses in Indonesia.

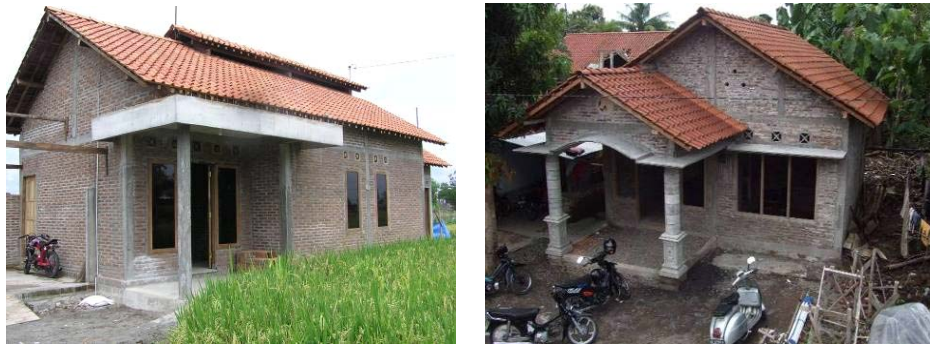
It is interesting to also note that efforts to imitate the concept of traditional houses in terms of building shapes and ornaments can also create unnecessary loads for roof systems, and combined with minimum vertical elements in non-engineered houses, leading to more vulnerable structures. Falling front canopies in the Aceh region are examples of this problem. In the old days, the canopies were built using timber for roof and façade supported by wood columns, while newer structures have these canopies made of bricks and concrete supported by small columns that could not resist lateral loads (Figure 7).

Figure 7 Good masonry houses with heavy canopy.

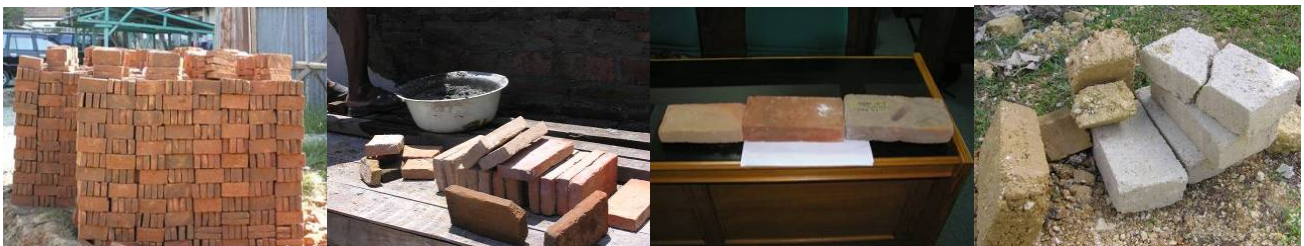
Construction materials may contribute to the vulnerability of the structures. From the procurement aspect, the lack of availability of qualified construction materials sometimes leads to substitution using any available resources. In the case of Aceh, poorly graded sand and gravels coming directly from the river are often used as concrete aggregates. The use of plain rebars for longitudinal and transversal reinforcement are common, whereas Indonesian seismic code clearly states that plain rebars can only be used for spirals and tendons. The size of rebars used is also a typical problem. Although minimum dia. 12 mm of deformed bar for column longitudinal reinforcements, dia. 10 mm of deformed bar for beam longitudinal reinforcements, and dia. 8 mm plain bar for stirrups are specified in the Indonesian concrete code, smaller diameter bars are often found in practice. Non standardized brick size and quality add problem to the vulnerability of masonry buildings (see Figure 8).

Figure 8 Different types of local bricks

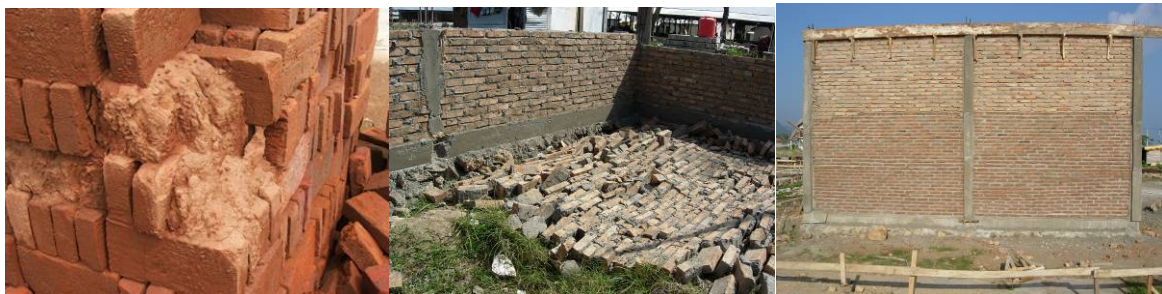
In the post recovery efforts, the problems in material aspects are related to the high demand and short supply situation. For instance, 'half-baked' bricks were found to be used in the construction in Aceh. These bricks were poorly built and fell below the minimum strength level of bricks, showed by their inability to be tested for their strength and 'melt' if soaked with water (Figure 9). Another typical problem found was the quality of the concrete mixture. The gradation of aggregates did not comply with the standard material gradation used for concrete mixture. Large aggregates were found in the mixture. Sand was not washed thus silt or clay could be mixed with it, leading to a very poor mixture. Moreover, excessive amount of water also used in the concrete mixture for higher workability, which leads to high water content and low strength concrete.

Figure 9. Poor material quality and workmanship, variation of brick quality found in Aceh reconstruction.

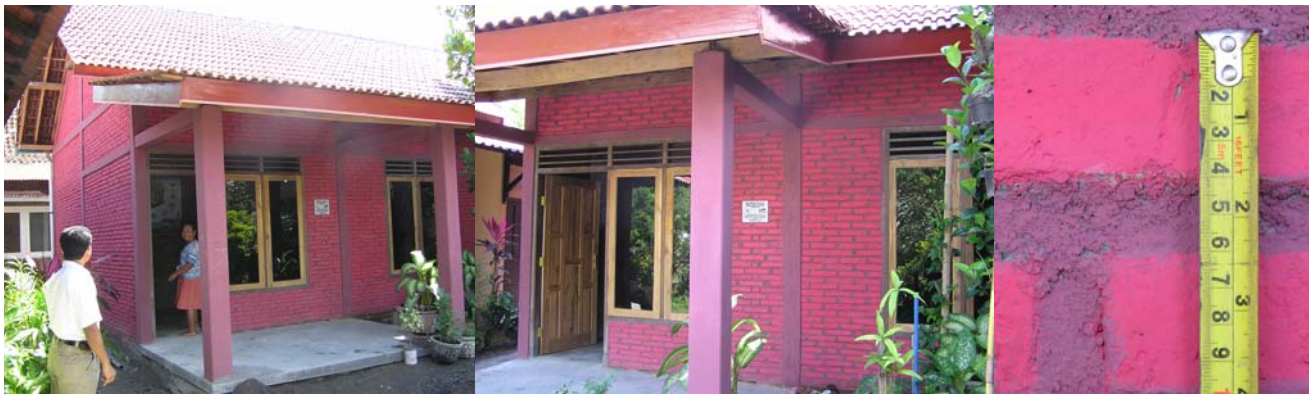
Figure 10. BARRATAGA model houses with adequate structural components and proper brick layering.

Efforts have been made by various institutions to rectify these problems. For example, trainings were conducted in Aceh for construction workers and masons to equip them with the necessary skills. These trainings usually include hands on practice works so that the workers had an experience of working with proper materials and tools/equipment for producing qualified structures. The dissemination of construction of earthquake resistant structures were also conducted with training participants including local government officers, building inspectors, and house owners. In Yogyakarta, a local university produced a manual of BARRATAGA (earthquake resistant people house) and disseminated this manual to the communities, conducted training for

masons and built model houses (Sarwidi, 2007). The trained masons were then served as trainers for other masons, thus the concept and knowledge of earthquake resistant structure can be widely spread among the workers.
