SEISMIC EVALUATION OF 300 DAMAGED BUILDINGS IN DARB-E-ASTANEH, IRAN EARTHQUAKE OF MARCH 2006 FOR THEIR REPAIR DESIGN

Hossein Aghabeigi¹, Mahmood Hosseini² and Farid Sharifi Boroojerdi³

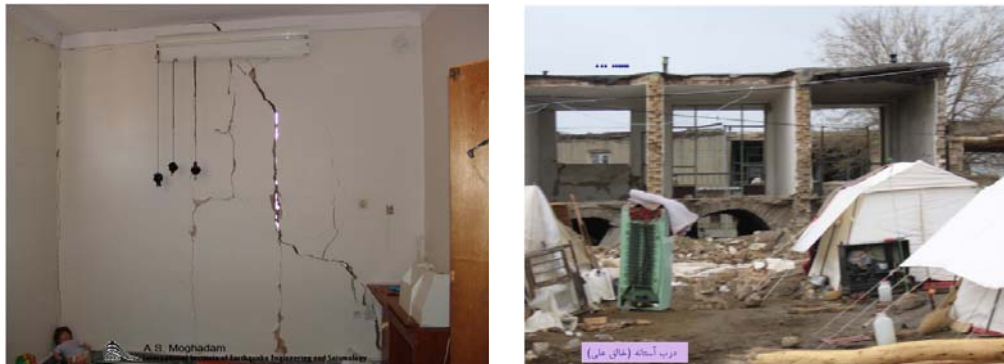
Figure 1. Samples of damages to city buildings (left) and village buildings (right) (IIEES, 2006)

In 31st March of 2006 an earthquake of 6.1 magnitude hit the Silakhor region (Epicenter close to Darb-e Astaneh), Lorestan Province, Iran, which affected cities of Boroojerd and Dorood, killed 66, injured 1289, and damaged hundreds of building, including houses in these two cities and their neighboring villages (Figure 1).

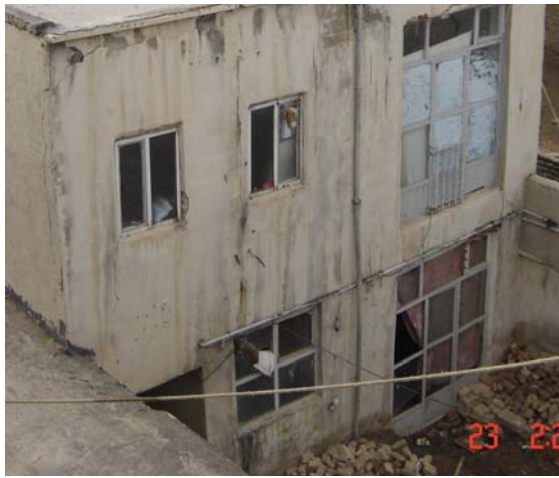
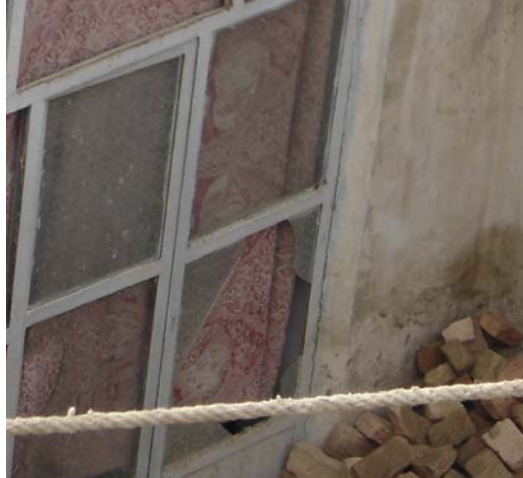
Table 3. Sample of qualitative evaluation of buildings

The evaluation of a 2-story building, with residential use for around 10 people, is presented here as a sample. This building does not have horizontal and vertical ties, and just its walls provide the load paths. The calculation of seismic forces for this building is given in Table 2. The visual inspection of the building, as presented in Table 3, showed that the building needs further investigations, and therefore quantitative evaluation was also performed for it.
