## FLANGE EFFECTS OF AN UNREINFORCED MASONRY WALL SUBJECTED TO PSEUDO-STATIC IN-PLANE SEISMIC FORCES

A. P. Russell<sup>1</sup> and J. M. Ingham<sup>2</sup>

### ABSTRACT :

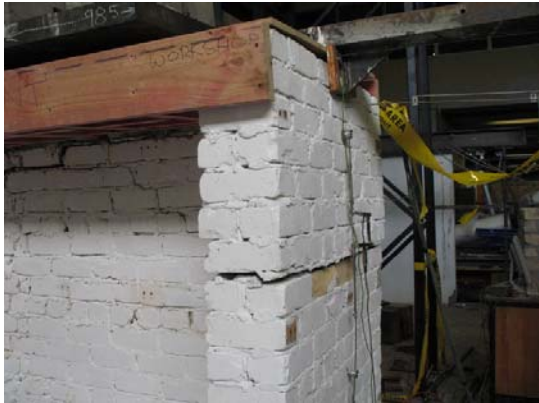
(a) crack in flange wall

Figure 5: Shear failure of test wall

The wall was pushed to a displacement of 0.4 mm and a large crack suddenly occurred. The occurrence of the crack corresponded with a force of 66 kN. The 0.4 mm of displacement was between the bricks in the top course and the instrumentation column used for measuring the displacement. This displacement was different than the displacement measured between the steel loading beam and the instrumentation column. The displacement of the wall was used as the control, and the imposed displacement was applied until this displacement reached 0.5 mm. The shear crack occurred when this displacement was at 0.4 mm, but the displacement of the loading beam was much higher, approximately 8 mm, see Figure 6. This difference in displacement was attributed to slip between the steel loading beam and the timber diaphragm, that is in the coach screws, or between the timber diaphragm and the wall, or it can be attributed to the flexibility of the timber compared with the masonry. The development of the crack was very sudden, and initiated at the location of the joist at the end of the wall, refer to Figure 5. It continued along the wall and into the flange, 4 courses below. The load was then released and the crack closed up and the wall returned to its original state, albeit with a crack in it.

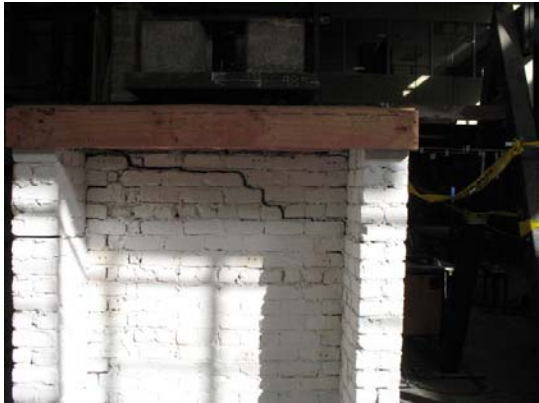
(b) shear crack push cycle

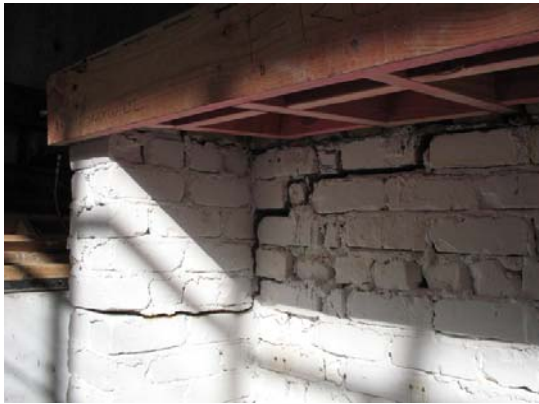
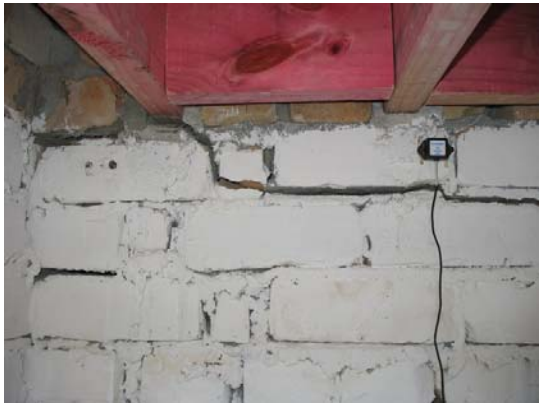
(c) shear crack pull cycle

(d) shear crack pull cycle

The load was then applied in the pull direction. When the load from the push cycle was released there was a residual displacement of 1 mm. The wall was pulled and a crack opened up in a similar manner to what happened in the push cycle. This crack occurred when the control displacement was reading 0.67 mm, so there was a net pull of 0.33 mm before the crack occurred. Again, this was the displacement of the bricks, and the displacement of the loading beam was much larger, approximately -7 mm, resulting in a net displacement of 8 mm. The crack was almost identical to the one which opened up on the push cycle, in reverse, and initiated at the point where the first joist was in the wall.
