## AVAILABLE LOW-COST TECHNOLOGIES TO IMPROVE THE SEISMIC PERFORMANCE OF EARTHEN HOUSES IN DEVELOPING COUNTRIES

M. Blondet<sup>1</sup>, J. Vargas<sup>2</sup> and N. Tarque<sup>3</sup>

**KEYWORDS:** Earthen, construction, adobe, earthquake, reinforcement.

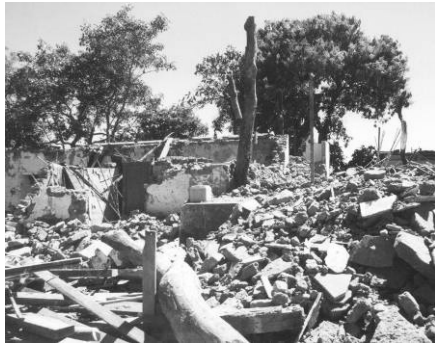
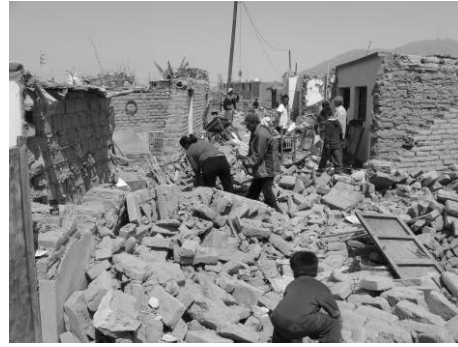
Figure 1 Destruction of adobe houses in El Salvador (2001) and Pisco (2007)

The high seismic vulnerability of earthen buildings is due to a perverse combination of the mechanical properties of their walls: earthen walls are dense and heavy, have extremely low tensile strength and they fail in a brittle fashion, without any warning. As a consequence, every significant earthquake that has occurred in regions where earthen construction is common has produced tragic loss of life and considerable material damage (Fig. 1).

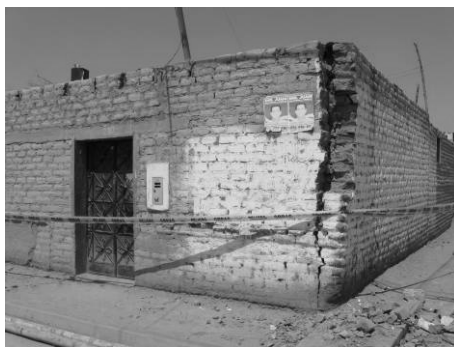
Vertical crack at corner of front wall

Figure 2 Seismic cracks in adobe houses (Pisco earthquake 2007)

During earthquakes the ground shakes in all directions and generates inertia forces that the construction material should be able to withstand. Since the tensile strength of adobe masonry is very low (and much lower than its compressive strength), significant cracking starts in the regions subjected to tension. Seismic forces perpendicular to the walls produce out-of-plane bending, and vertical cracking starts at the lateral corners of the walls, where the tensile stresses are higher. Large vertical cracks that separate the walls from one another are thus produced (Fig. 2, left). Front walls are usually the first to collapse in an earthquake, overturning onto the adjacent street. Lateral seismic forces acting within the plane of the walls generate shear forces that produce diagonal cracks, which usually follow stepped patterns along the mortar joints. The diagonal cracks often start at the corners of doors and windows, due to the stress concentration at these locations (Fig. 2, right). If the seismic movement continues after the adobe walls have cracked, the wall breaks in separate pieces, which may collapse independently.

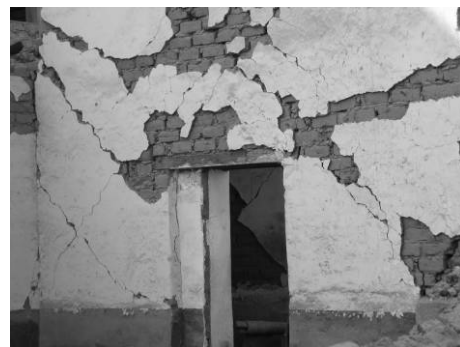
Diagonal cracks

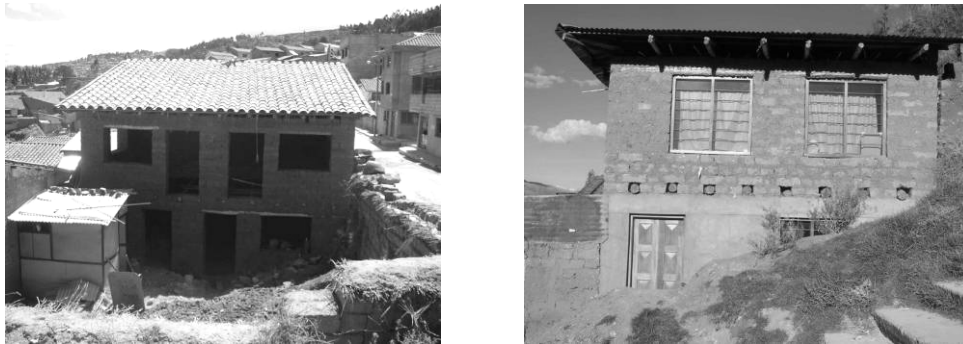
Figure 4 Contemporary adobe houses in Cusco, Peru

Most vernacular earthen houses are built without any professional intervention, and thus with poor construction quality. Furthermore, they tend to imitate the architectural features of clay masonry houses. Therefore, most present-day earthen houses are built without any structural reinforcement, with several stories, thin walls, large window and door openings and irregular plan and elevation configurations (Fig. 4). These buildings are extremely vulnerable and suffer significant damage or collapse during earthquakes.

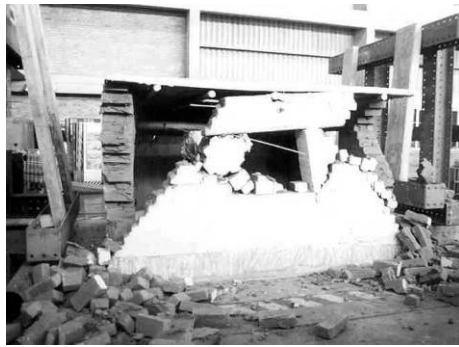
Figure 6 Adobe models after seismic tests. L: Unreinforced. R: Reinforced with cane

This reinforcement system has demonstrated excellent response in full-scale shaking table tests (Blondet et al. 1988). Figure 6 shows the collapse of a full scale adobe house model subjected to simulated seismic motion (left). During a similar test, the model reinforced with an internal cane mesh suffered significant damage, but did not collapse.

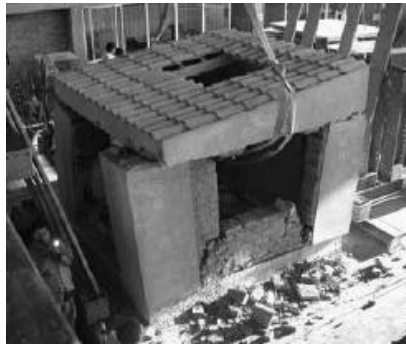
Reinforced model after seismic test

Figure 8 Adobe buildings with external wire mesh reinforcement

This reinforcement system provided significant additional strength to adobe models under earthquake simulation tests. The performance of the model was adequate during moderate and severe shaking. However, the mode of

failure was brittle during a strong event (Fig. 8, left). During a moderate earthquake in Peru, while surrounding houses were severely damaged or destroyed, houses reinforced with this system did not suffer any damage and were used as shelters (Zegarra et al. 1997 and 2001) as shown in Fig. 7 and 8, right.

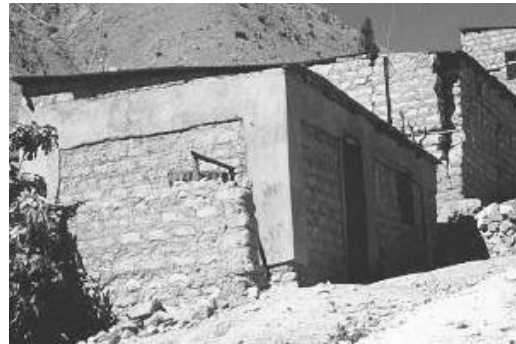
Reinforced house (Arequipa earthquake 2001)

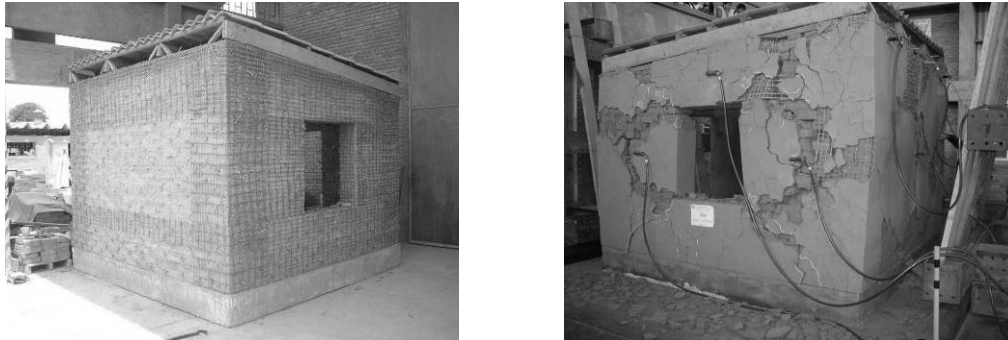
Figure 10 Adobe model reinforced with plastic mesh

Since geogrid polymer mesh is quite expensive in Peru, it was decided to study the use of a cheaper plastic mesh, usually employed as a soft safety fence in construction sites. The adobe model shown in Fig. 10 was reinforced with bands of plastic mesh located in the regions where most damage was expected on the adobe walls. The plastic mesh bands were tied to the walls with plastic string placed across the walls during construction. After a strong shaking test, the adobe walls were broken into several large pieces, which were held together by the plastic mesh. The mesh was deformed and broken in several places, indicating that the amount provided was barely adequate. It is clear, however, that although the building suffered significant damage, collapse was

averted.
