EXPERIMENTAL ASSESSMENT OF A SEISMIC STRENGTHENING SOLUTION FOR STONE MASONRY WALLS USING A WOODEN STRUCTURE

ABSTRACT :

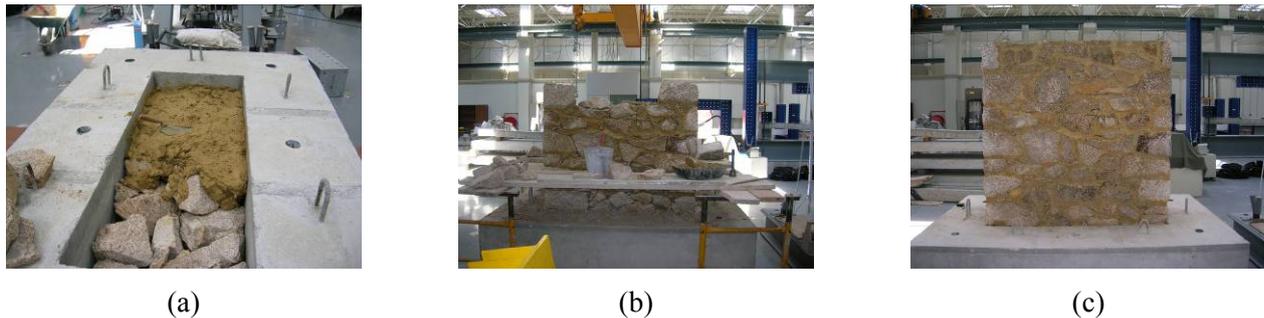
Figure 1 Construction stages of stone masonry walls

The experimental study was based on two irregular stone masonry wall panels (PA1 and PA2) built at the LESE - of FEUP. Figure 1 includes views of some construction stages of one of the walls.

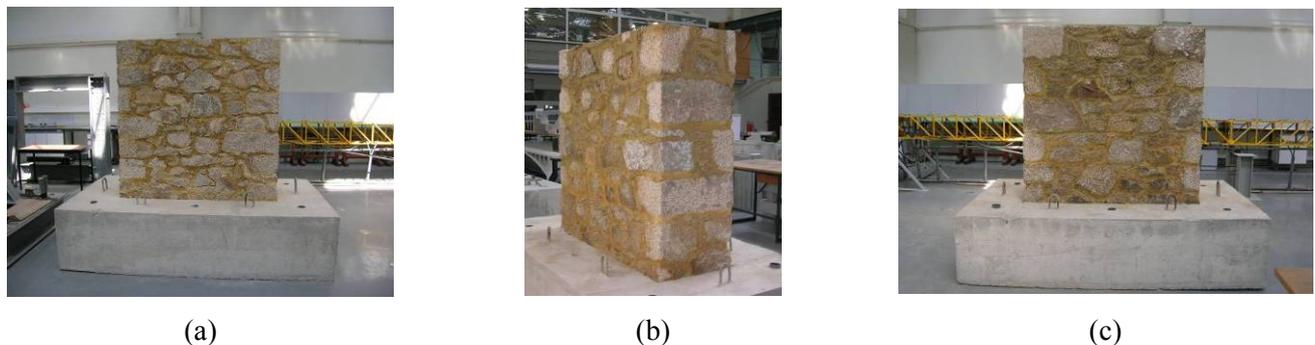
Figure 2 Tested walls. (a) PA1 – lateral view. (b) PA1 – side view. (c) PA2 – lateral view.

The tested specimens consisted of two-leaf irregular masonry wall panels, 1.6m long, 1.6m high and 0.6m thick. The wall leaves are made of good quality granite stones placed in layers along both sides of the wall and using lime mortar in between the stones. Some of the stones were positioned along the transverse direction of the walls in order to connect the leaves as commonly found in some types of multiple-leaf walls. The walls were built on a $1.6 \times 2.6 \times 0.6 \text{ m}^3$ reinforced concrete base in order to simulate a rigid foundation as shown in Figure 2. In their original conditions, i.e. before testing, walls were designated as PA1_NR and PA2_NR.

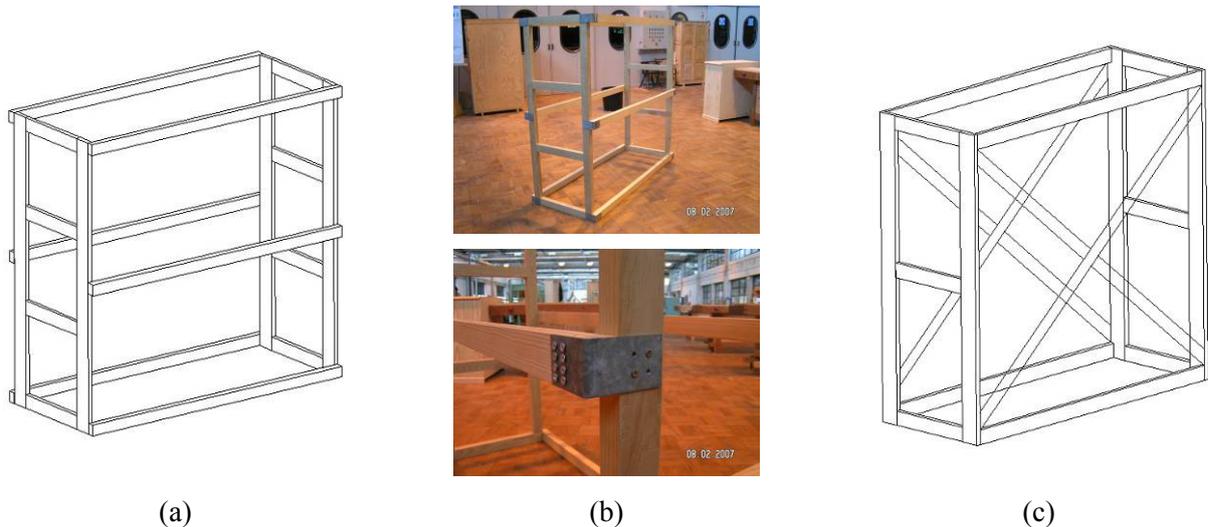
Figure 3 Wood reinforcement. (a) PA1_RM1. (b) Wood members and connection details. (c) PA2_RM1.

After the first tests on each of PA1_NR and PA2_NR walls, the specimens were repaired by placing again the blocks in original positions using new mortar with the same characteristics of the original one. In addition, each panel was strengthened with wood members around the wall according to the configurations shown in Figure 3, mainly aiming at improving the panel confinement. For that reason the new wood bars were not directly fixed to the wall. After strengthening, the walls were designated by PA1_RM1 and PA2_RM1.

For wall PA1_RM1 three horizontal wood bars were adopted on each face and attached to lateral grids, each one made of two vertical and four horizontal bars. All members have cross-section dimensions: 0.04m x 0.06m. Connections of horizontal members of wall faces to lateral grids were made with metal plates (3mm thick) and screws (5mm diameter).

As for wall PA2_RM1, only two horizontal wood bars were used, along with two crossed bars on each face with 0.026m x 0.065m cross section dimensions. These members are also attached to lateral grids as in PA1_RM1 wall, but in this case with just three horizontal bars; all the bars of these grids have 0.020m x 0.065m cross section dimensions. Connections of wall face bars to the grids were made using screws (4 mm diameter).

The lower efficiency of the strengthening scheme based on diagonal wood bars as adopted in PA2_RM1, when compared with PA1_RM1, is related with the following reasons: *i*) the lack of longitudinal bars to link the opposite side grids, that have proved to be essential to ensure the masonry integrity, in the middle zone where dilation effects are more pronounced; *ii*) more reduced bar thickness compared with that of PA1_RM1; *iii*) the absence of steel angle plates in the connections of longitudinal bars to side grids that, in the case of PA1_RM1 case, played an important role in dissipating energy, confirmed by the plastic deformations observed in the plates.

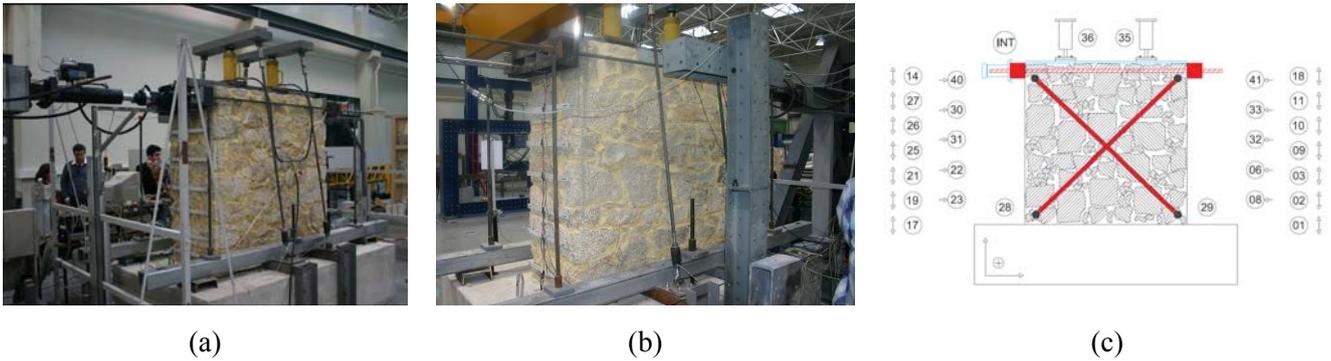
Figure 4 Test setup. (a) North-west view. (b) South-east view. (c) Positions of LVDTs on West face.

The walls were tested under a constant vertical load of 50kN corresponding to a compression level of approximately 52kPa and cycled under controlled in-plane horizontal displacements. The horizontal load was applied at the top of the walls by means of a hydraulic actuator (100kN capacity, +/- 100mm stroke and hinged at extremities) and using a steel reaction frame (Figure 4 (a)). The vertical force was applied to the top section of the walls by means of two other hydraulic jacks (Figure (4a)) and the corresponding total force was measured with load cells. Each pair of jacks was reacting against a steel beam connected to the concrete foundation block by means of two steel rods where load cells were installed. The foundation block was attached to the laboratory reaction floor using four high-strength pre-stressed rods in order to minimize displacements of the block during the test; these rods were monitored by means of glued strain gauges to check possible fluctuations of vertical load. Displacements were measured using classical LVDTs (Linear Variable Displacement Transformers) with different ranges (from +/- 10mm to +/- 100mm) depending on the expected motion of measurement point. Horizontal displacements were measured near the lateral force level and in-height along both wall sides (north and south) to obtain the deformed profile of the wall. In addition, vertical opening/closing motions in horizontal joints of wall sides were measured using short range LVDTs and another pair of transducers was also placed orthogonal to the East wall face to monitor any possible out-of-plane displacement or rotation. Figure 4 (c) provides the general layout scheme of displacement transducers, some of which can be seen in Figure 4 (b); in total, 29 LVDTs were used for PA1_NR wall tests and 26 for the PA2_NR panel.

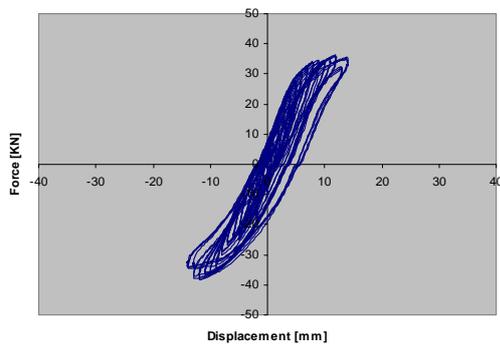
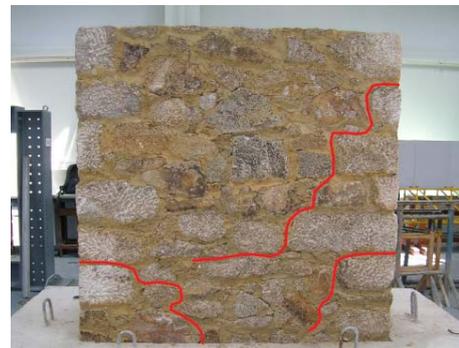
Figure 5 PA1_NR. (a) Force-Displacement curve. (b) Final damage in West face.

Results for the original walls evidenced shear-controlled responses as confirmed by the damage patterns where diagonal cracking/joint opening became quite visible. Due to unavoidable construction differences, wall panel PA1_NR exhibited better response than PA2_NR, not only because a slightly larger strength was reached (for the same vertical load in both walls) but also because the final damage distribution was found less strong. For these first tests, imposed displacements were limited to about 14mm for PA1 and 11mm for PA2, which was not *a priori* defined but became necessary in order keep wall damage within acceptable limits to allow subsequent wall repair and testing under strengthened conditions.

Despite the fact that drifts were not pushed further (maximum imposed about 0.9% for PA1_NR), the response diagrams of the non-reinforced walls clearly show the onset of strength degradation in both loading senses; however, this effect is more evident for negative sense, i.e. towards the north (actuator) side as shown in Figures 5(a) and 7(a). This means that, should larger displacements be imposed, wall strength would have dropped fast and complete failure would have occurred. Detailed analysis of non-strengthened walls is provided by Silva (2008).

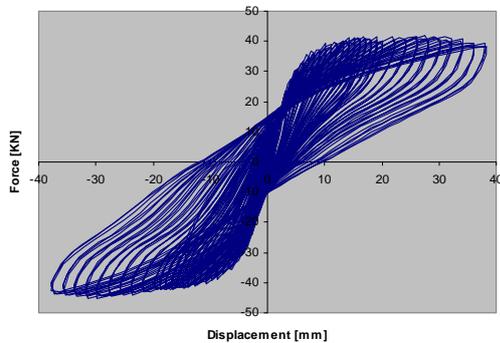
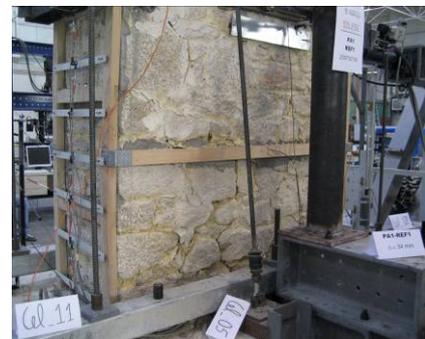
Figure 6 PA1_RM1. (a) Force-Displacement curve. (b) Final damage in East face.

Focusing now on the results of tests after strengthening as previously described, the force-displacement diagrams shown in Figures 6(a) and 8(a), for strengthened wall panels PA1_RM1 and PA2_RM1, respectively, clearly show an impressive increase of ductile capacity of that “confined masonry”. Visual inspection of the response curves show that global ductility factors between 7 and 8 can be found, even for the case of PA2_RM1 where more pronounced strength degradation was observed. Again, this is consistent with the evolution of dissipated energy (Figure 9) that shows increasing rate for increasing amplitude of cyclic displacements.

Concerning the PA2_RM1 specimen, somewhat opposite conclusions can be drawn. Although the strengthening outcome was clearly advantageous, both in terms of available ductility (Figure 8(a)) and energy dissipation capacity, the performance was not improved for the first displacement cycles when compared with the non-reinforced PA2 wall. In fact, energy dissipation was lower for the PA2_RM1 test than for PA2_NR, particularly for the negative sense; similarly, the strength for PA2_RM1 degrades much more than PA1_RM1 and, again for the negative sense, it dissipates energy less efficiently. This agrees with the fact that PA2 was of worse quality than PA1 (essentially concerning stone block arrangement) and with the observed final damage shown in Figure 8(b) when compared against that in Figure 6(b).

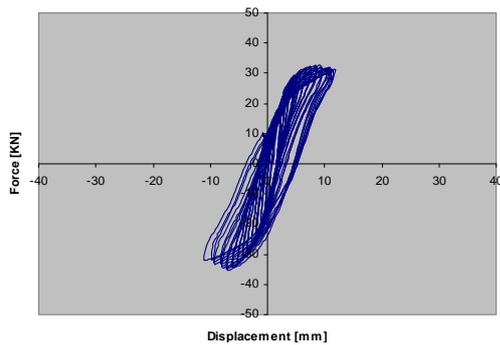
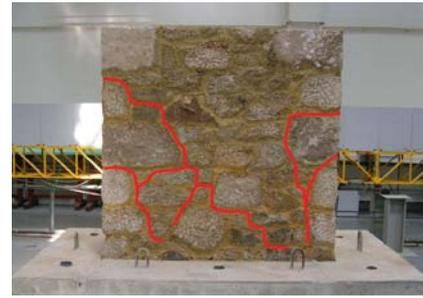
Figure 7 PA2_NR. (a) Force-Displacement curve. (b) Final damage in West face.

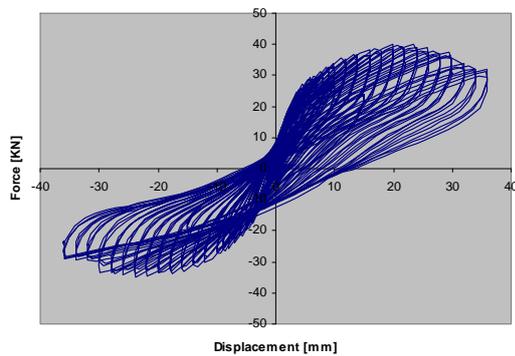
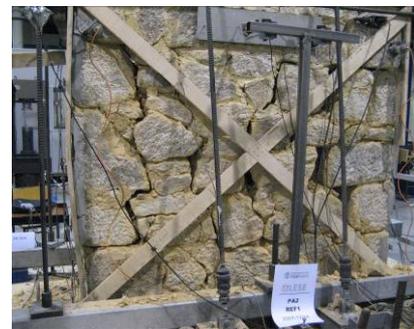
Figure 8 PA2_RM1. (a) Force-Displacement curve. (b) Final damage in East face.

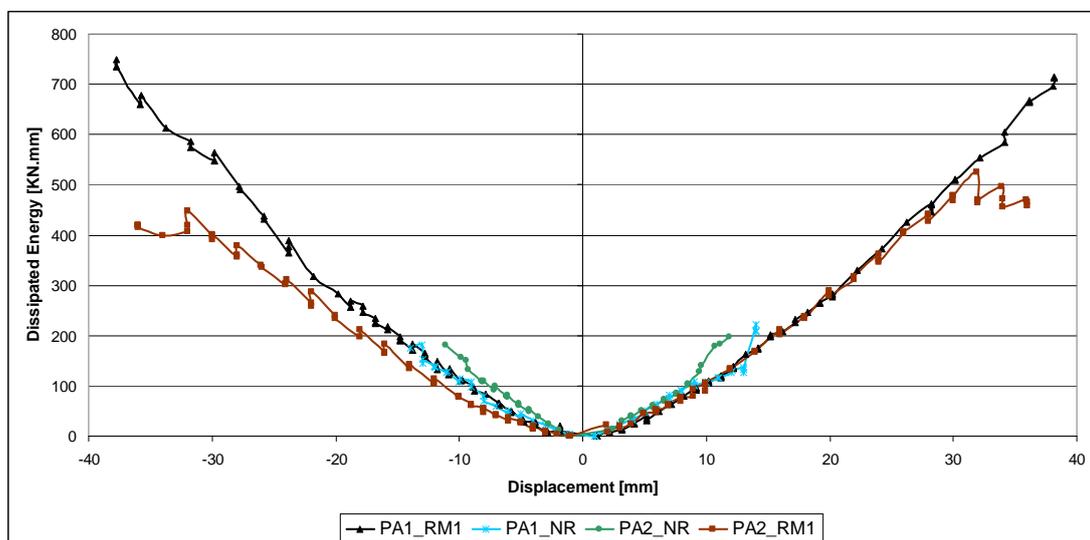
Figure 9 Energy Dissipation

Notwithstanding this pre-failure stage, energy dissipation was found significant and developing at a stable rate (and even slightly increasing) as shown in Figure 9 where the evolutions of dissipated energy are plotted for all tested specimens. These plots have been divided in correspondence with positive and negative half-cycles and, therefore, allow evaluating the amount of energy dissipated up to a given value of positive or negative displacement. It is particularly relevant that this type of walls, made of quite irregular stone masonry and poor mortar, exhibits such regular and well proportioned force-displacement loops responsible for interesting energy dissipation, even slightly larger than the strengthened wall for the case PA2 (Figure 9). This evidence is clearly related with internal friction between adjacent stone blocks (and surrounding mortar, as well) that provides an excellent means of energy dissipation as long as the whole wall aggregate keeps working together. In a word, this is the basic idea of the proposed strengthening scheme that seeks for a suitable external confinement effect to prevent masonry from disaggregating.

It is noteworthy that panel PA1 exhibited almost the same energy dissipation before and after repair and strengthening during the first cycles with the same displacement levels (PA1_NR and PA1_RM1 curves almost coincide for positive and negative senses in Figure 9). This means that, on the one hand the masonry repair was efficient enough to replace the wall capacity; on the other hand, it shows that the wood strengthening only became effective for larger displacement levels, once the masonry reached sufficient dilation and started to mobilize the wood cage confinement effect. Finally, the symmetry of force-displacement diagram for PA1_RM1 (Figure 6(a)) is also reflected in the almost identical evolution of dissipated energy for both displacement senses (Figure 9), which is consistent with the final damage observed in the wall.

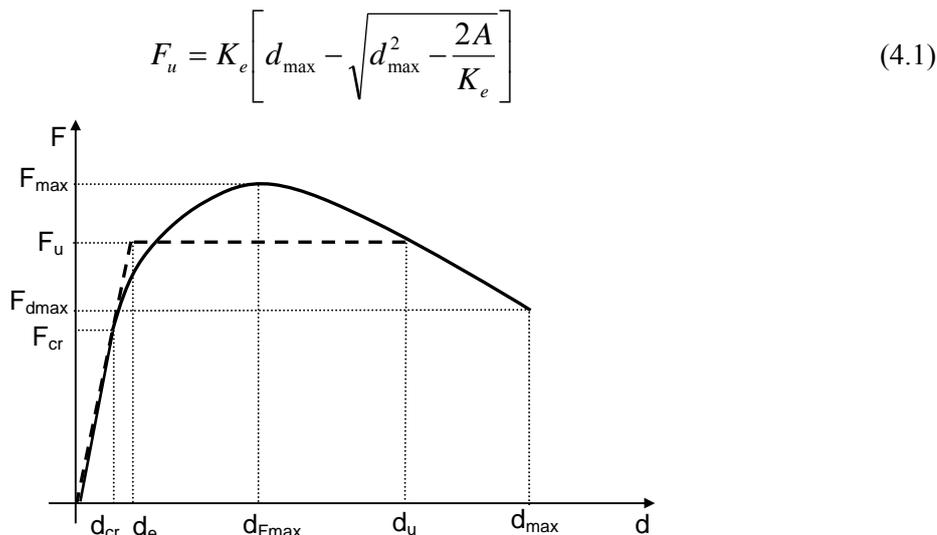
Figure 10 Bilinear approximation to the diagram envelope

Attempting to quantify the behavior improvement due to the wood strengthening process, and resorting to Tomažević proposal (Tomažević, 1999), a bilinear approximation was made to the envelope of the hysteretic force-displacement response curves (assuming the envelope as representative of the monotonic response diagram). As shown in Figure 10, by considering equal energy dissipation both in experimental envelope curve and in the idealized bilinear diagram, it is possible to calculate F_u according with Eqn. 4.1, where A is the area below the experimental curve, corresponding to dissipated energy, K_e is the initial stiffness estimated from that curve upon adequate selection of the cracking point (F_{cr}, d_{cr}) and d_{max} is the maximum displacement reached in the experimental curve.

The experimental envelope curve was defined by considering the positive force sense and the maximum displacements points of each hysteresis loop. Adopting this procedure for the four tested walls, leads to the results presented in Table 4.1 that allow estimating available ductility defined as the ratio between the ultimate idealized displacement, d_u , and the displacement at the idealized elastic limit, d_e (according to Figure 10).
