PSEUDO-DYNAMIC TESTS ON REPAIRED AND RETROFITTED BRIDGE COLUMNS

T. Albanesi¹, D. Lavorato², C. Nuti³, and S. Santini⁴

This research aims to study the seismic performance of existing r.c. bridge piers specimens heavily damaged after previous pseudodynamic tests and actually repaired and upgraded by using self compacting concrete, stainless steel rebars and CFRP wrapping. Pier specimens are representative of tall and squat circular r.c. piers designed according to Eurocode 8 and Italian Code before 1986. The study comprehends preliminary tests carried out on self compacting concrete and stainless steel bars, as well as pseudodynamic tests in order to evaluate the effectiveness of adopted repairing and upgrading techniques to increase both ductility and shear strength.

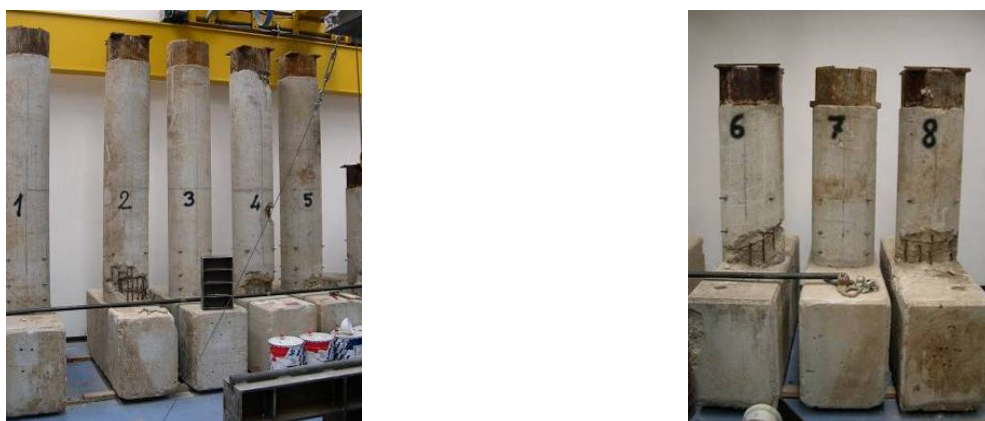
Figure 2. Current specimens state: tall (1, 2, 3, 4, 5) and squat (6, 7, 8) specimens

Piers 2 (tall DM), 4 (tall DM), 5 (tall EC8), 6 (squat DM) and 8 (squat DM) were tested until collapse in previous pseudodynamic tests (De Sortis & Nuti, 1996) thus they are damaged while piers 1 (tall DM), 3 (tall DM) and 7 (squat EC8) have not been subjected to tests and are intact (Figure 2). Detected damages include cover spalling, longitudinal bar buckling and rupture, yielding in transverse reinforcement and concrete core crushing.

By analyzing pier characteristics (Table 1), piers 2 and 6 seem to be the most representative for retrofitting design of slender and squat piers respectively. Detected damage state clearly shows that tested squat and tall piers suffered shear and flexural failure respectively. These failure mechanisms were also analytically proved by comparing shear strength with shear at resisting bending moment.

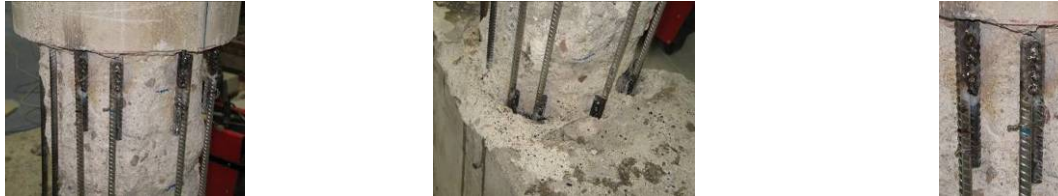
Figure 3. Welded joints (a) top (b) bottom (c) detail.

Austenitic stainless steels combine very good corrosion behavior with excellent mechanical properties (strength and toughness). Although initially more expensive, it offers cost savings in the long term because of reduced maintenance and protection operations and increasing life of the structure. These characteristics make it suitable for restoration of existing damaged reinforcing bars and for seismic retrofitting. Stainless steel (AISI304) Ø12 bars were used for damaged reinforcing bar substitution. First, the spiral reinforcement was cut and removed; the ends of embedded hoop were welded to remaining longitudinal bars. Yielded and buckled longitudinal rebars were cut and removed too. Remaining rebars were cleaned, by mean of a metallic brush, to eliminate rust layers and residual concrete, plaster and resin. Single new bars were placed aside the existing ones trying to keep inner lever arm and cover thickness equal to the original ones: it was impossible to apply them in pairs to avoid asymmetries because of the congested reinforcement of the foundation. Welding was performed away from the potential plastic hinge (Figure 3): since the portion of damaged bar often extends into the foundation, it was necessary to dig it (at least 70-80 mm deep) around the bar before welding.

Welding was the only practicable solution since the congested reinforcement of the foundation did not allow to perform holes deep enough and in the right position to guarantee effective bond even using resin.

Practical difficulties in welding due to reduced space around the bars made it necessary to realize two 50 mm weld puddles (the design length of a single puddle was 35 mm only). Removed spiral reinforcement was replaced with circular stainless steel $\varnothing 5$ stirrups; spacing was calculated to assure the original design ratio $f_i A_s/s$ (A_s =hoop cross section, s =spacing, f_i =peak strength). Stirrups were fixed with intercrossed metallic fastenings to avoid welding that could produce dangerous local deformation in bars with such a small diameter. Anyway, 20 mm length welding was necessary to close stirrups (Table 2: phase 3).

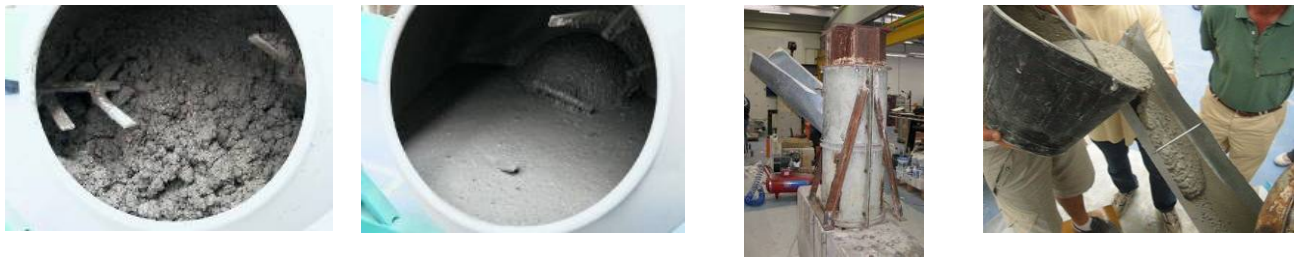
Figure 5. (a) SCC production (b) formwork (c) SCC jet process.

restoration. SCC with addition of an expansion anti-shrinkage agent is suitable to this purpose. Cast-in-place SCC seemed the most adequate solution for the piers under consideration; it includes, in addition to substrate preparation, formwork construction, concrete production (Figure 5a), its application and ageing. Formwork originally used to build the specimens was opportunely modified to include a metallic groove (Figure 5b) allowing SCC pouring without interruptions from a single hole in the formwork (Figure 5c). The final result was generally good although superficial imperfections were present after formwork stripping (Table 2: phase 4). SCC filled up all available spaces even the upper part, opposite to pouring position. Concrete restoration results in a SCC jacket 50-90 mm thick and 550 mm high.

A 35 MPa mean cubic strength is required as the most similar value to that of the original piers achievable with SCC. The main aims of the SCC mix design were: high fluidity, small diameter (<12 mm) aggregate (to easily fill up the space between reinforcement and concrete core), shrinkage offset adding conveniently measured out expansive agent. The latter was essential to guarantee complete filling and thus continuity at the interface between existing and new material. Resulting SCC mix was made of grit, sand, calcareous filler, cement expansive agent, superplasticizing and water with water-cement content equal to 0.48.
