## STUDY OF THE ANCHORAGE OF CARBON FIBER REINFORCING PLASTICS (CFRP) UTILIZED TO UPGRADE THE FLEXURAL CAPACITY OF VERTICAL R/C MEMBERS

G. C. Manos<sup>1</sup>, K. Katakalos<sup>2</sup>, V. Kourtides<sup>3</sup>  
Department of Civil Engineering, Aristotle University,  
Thessaloniki 54006, Greece  
[gcmayos@civil.auth.gr](mailto:gcmayos@civil.auth.gr)

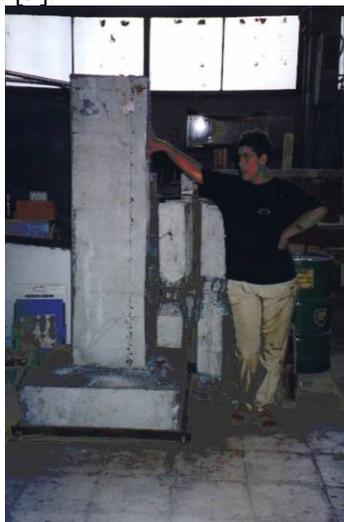
Figure 2a. Pier A

This specimen is shown in figure 2a with a rectangular cross-section of 200 mm x 500 mm and height  $h = 1815\text{mm}$  (from its top to the upper surface of its foundation).  $8\Phi 6$  was the longitudinal reinforcement and  $\Phi 6/100$  closed stirrups the transverse reinforcement [1]. The detailing of the cross-section is shown in figure 2b. The selected longitudinal and transverse reinforcement together with the loading arrangement, will cause the behavior of this virgin specimen to be dominated by the flexural rather than the shear mode of failure. More details are given in references [1] and [3].

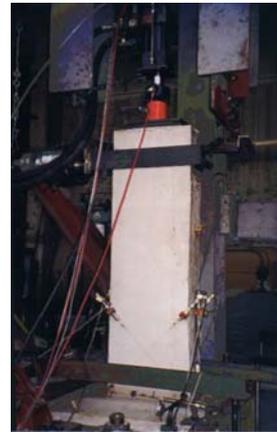
**Figure 5.** Pier A placed at the strong reaction frame

Figures 4 and 5 depict this experimental setup. As can be seen the specimen was placed in the strong reaction frame, having its foundation block, with dimensions in plan 1000mm by 1000mm and 300mm height, fully anchored to the strong floor. The horizontal and vertical actuators, as part of this strong reaction frame, applied the loading sequence described above. Instrumentation was provided in order to measure the variation of the applied horizontal and vertical loads as well as the most important aspects of the displacement field that resulted from the application of these loads to the specimen. The horizontal displacements of the specimens at the top were monitored as well as the displacements of the specimen at the region near the foundation block in order to

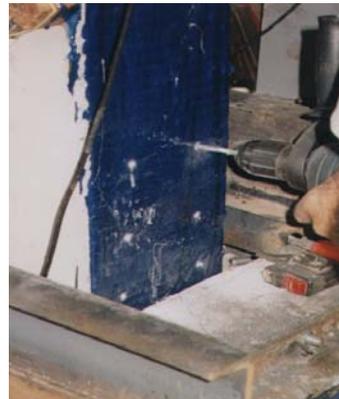
**Figure 9a.** The repair of specimen Rep-1 Pier A      **Figure 9b.** The repair of specimen Rep-1 Pier A

The damaged Rep-1 Pier A was repaired again in a way which is shown in figures 9a,b. The CFRP layers that were separated from the concrete at the right side of Rep-1 Pier A was reattached, apart from the appropriate resin, with additional 2mm diameter small bolts having 35mm length; these bolts were spaced at regular 50mm intervals along all the height of the CFRP layer at both sides. Moreover, the edge of the double T steel section neighbouring the location of the CFRP layer at the pier-foundation joint was machined to form a curvature so that it provided a relatively uniform contact between the steel section and CFRP layers at this location. The locations of the bolts were first marked and drilled and then the bolts were applied including the corresponding

plastic anchoring inserts. The specimen repaired in this way is designated as Rep-2 Pier A.

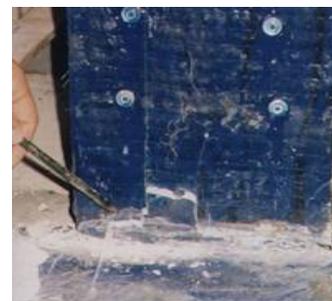
**Fracture of CFRP at the joint between the pier and the foundation**

**Figure 10b.** Fracture of CFRP for specimen Rep-2 Pier A

The loading sequence, described in section 2, was also applied for this repaired specimen. During the increasing of the imposed horizontal displacement the fracture of the CFRP layers at the right side of the pier occurred as depicted in figure 10b. This fracture occurred at the location where the pier joins the foundation block. The obtained flexural behavior is depicted in figure 10a in terms of applied horizontal load against the imposed horizontal displacement at the top of the pier. The plastic hinge, which was formed during testing specimen Rep-1 was not repaired in any other way, but with the means described in section 4. The fracture of the CFRP layer depicted in figure 10b took place at the same cross section. The bending moment capacity remains approximately at the same levels, as deduced from the variation of the horizontal load (figures 10a and 11).

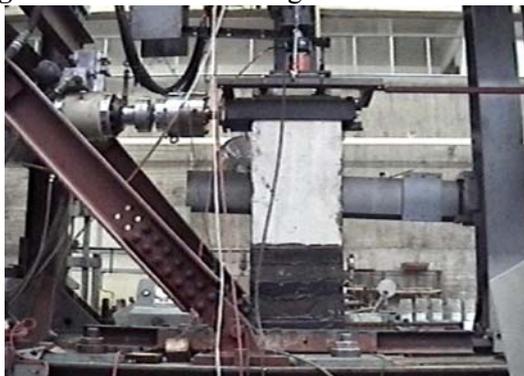
Figure 13c. Specimen Rep-3 Pier A

Figure 13a depicts the outline of this anchoring scheme and figure 13b depicts the application of this anchoring scheme for repair specimen Rep-3 Pier A, whereby the CFRP layers are folded around a cylinder that is anchored to the foundation. Moreover, in order to avoid the separation (detachment) of the CFRP layers from the sides of the specimen, as observed in specimen Rep-1, the bolting scheme that was used in specimen Rep-3 was further improved by using bolts and washers of larger size. In addition, to avoid the development of shear failure at the bottom part of the pier, three horizontal CFRP closed hoops were attached in this region of the specimen (figures 13c,d and [4]).

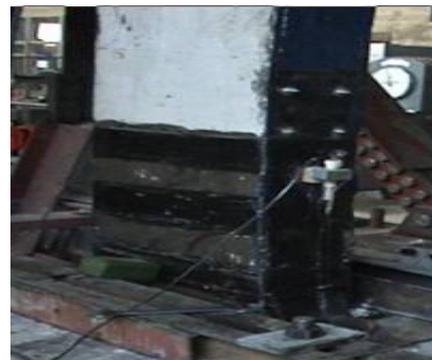
Figure 13d. Specimen Rep-3 Pier A
