The Rehabilitation of the Deficient RC Exterior Beam-Column Joints Using Cement Based Composites

M. Gencoglu¹ and B. Mobasher²

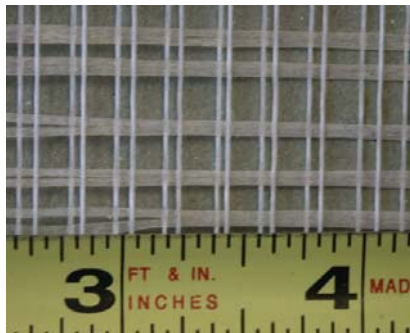
AR Glass Fabric

Saint Gobain Technical Fabric (SGTF)

Figure 1: The fabric types used in strengthening of the exterior beam-column joint specimens

The concrete used in constructing the specimens was tested under the uni-axial compression loads and had compressive strength of 30 MPa. The steel used for longitudinal reinforcements was Grade 60 with average yield stress of 525 MPa. Stirrups were Grade 40 with average yield stress of 290 MPa. The AR Glass used in this study is bounded fabric. In this fabric, a perpendicular set of yarns (warp and weft) are glued together at the junction points and is coated with epoxy during fabric production. The bounded fabric was made from multifilament AR with 4 yarns per cm in both directions of the fabric. The number of filaments in a bundle of fabric is 400 and bundle diameter is 0.27 mm. The AR Glass Fabric was manufactured by NEG Glass using yarns of filament diameter of 13.5 microns, tensile strength of 1270-2450 MPa, and modulus of elasticity of 78,000 MPa. The other fabric used was provided by Saint Gobain Technical Fabrics (SGTF). Both of fabric types are shown in *Figure 1*. This fabric has 2 rovings per linear inch width or 78.74 rovings per linear meter. There are approximately 1579 filaments per roving where average diameter of a filament is 19 microns. The young's modulus of AR glass is given to be around 72 GPa. The machine direction strands go over the cross machine direction strands. Therefore, cross machine direction strands are straight and machine direction strands have a slight curvature.

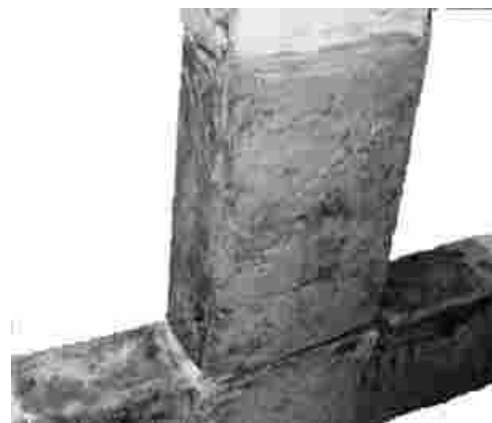
Figure 3: The view of specimen strengthened by FRCC made from AR Glass fabric

Fabric “L” shaped and wrapping cement based composite segments were used in strengthening of two joint specimens. “L” shaped segments were laid out on the top and bottom of beam section for tensile surfaces of beam varied with respect to the direction of cyclic loads. AR Glass fabric had six layers “L” shaped segments while “L” shaped segment made from SGFT was four layers. The specimen strengthened by FRCC made from AR Glass fabric is shown in *Figure 3*. The “L” shaped segments were completely wrapped by transverse cement based composites.

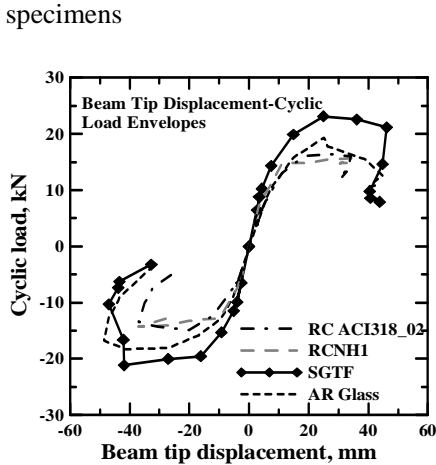
Figure 7: The envelopes of beam tip displacement

The beam tip displacement-reversed cyclic load hysteretic loops for all joint specimens are presented in *Figure 6a-d*. The envelopes of cyclic load-beam tip displacement of joint specimens were obtained from the peak values of each cycle of cyclic load-displacement curves for each specimen and are shown in *Figure 7*. When the cyclic load-beam tip displacement envelopes of the strengthened exterior beam-column joint specimens are compared with those of RCACI318 and RCNH1 from viewpoint of the cyclic load carrying capacity and beam tip displacement capability, it is seen that all of the strengthened specimens have higher displacement-cyclic load responses than RCACI318 and RCNH1. The hysteretic loops of beam-column joint specimens which dominate shear damages in the joint are pinched toward origin. The last three cycles of RCNH1 and the strengthened specimens which diagonal shear cracks were observed in the joint were pinched toward origin (see in *Fig. 6b, c and d*). Although X shear cracks dominated in the joints of these two specimens, these beam-column joint specimens failed due to the widening of flexural cracks at the column face of beam. Any diagonal shear crack in the joints of RCACI318 and RCCFRP2 didn't occur during reversed cyclic loadings. RCACI318 joint specimen failed due to widening the flexural crack at the column face of beam. The failure section of RCCFRP2 was moved from column face to beam mid-span unlike other specimens. Whereas, for RCCFRP2, the bending moment at the failure section of beam was half level of bending moment at the column face. However L segments were not wrapped over the distance of 0.38m from column face and widening of flexural crack at this region of beam was caused to failure of RCCFRP2. Although any process was not done to strengthen the joint, any diagonal shear crack was not occurred in the joint of RCCFRP2 and also the loosening of the steel angle beam pieces at the corner of beam and column were not appeared at the end of test. Because of that, it can be assumed that these steel angle beam pieces help to the load carrying capacity of the joint as an additional strengthening element and are effective on that behavior of the RCCFRP2 specimen. This failure mode is remarkable for improvement of behavior of strengthened beam-column joints subjected to reversed cyclic loads such as earthquake motions. So, it might be yielded that the main objective of strengthening the beam-column joints was achieved. CFRP sheets did not separate from concrete surface and did not bulge at the corner of beam and column at the end of test. The damages of all test specimens are shown in *Figure 9 a-c*. It was observed that the connection manners of the steel angle beam pieces at the corner of beam-column joint were effective on the former results.

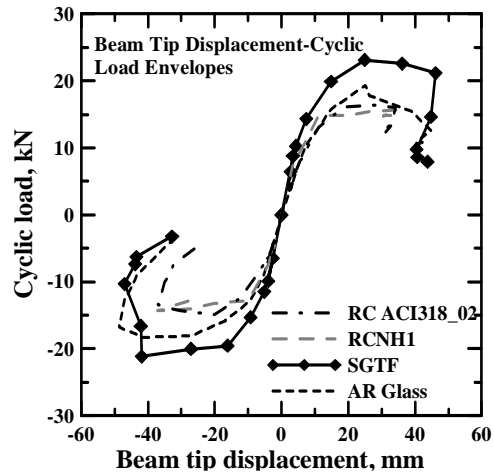
Figure 8: The envelopes of beam tip displacement-cyclic loads of beam-column joint specimens.

The total energy amount of joint is accumulation of the areas under the curves of force-displacement hysteretic loop up to peak loads in cases of both pushing and pulling of cyclic loads and is a cumulative value. The total energy amounts of each specimen are shown in *Figure 8*. The beam-column joint specimens strengthened using CFRP have more higher total energy amounts than those of RCACI318 and RCNH1. It can be denoted that RCCFRP2 specimen is stronger and more ductile than other specimens because this specimen absorbed the highest total energy amount. Moreover, the test results indicate that the strengthening technique used CFRP sheets improve the behavior of beam-column joints over deficient beam-column joint and the joint built according to seismic codes such as ACI 318-02 from view point of strength and ductility. Variations of initial stiffness-max deflection at each loop are presented in *Figure 5a and b*. These figure indicate that the

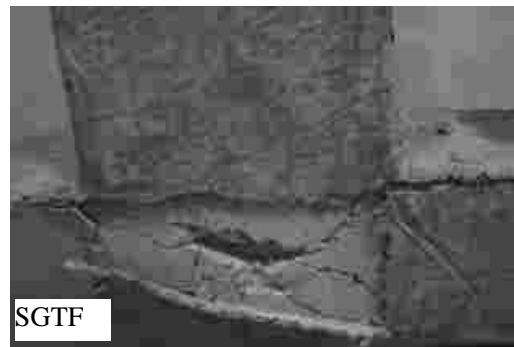
Figure 9a-c: The damage views of the beam-column joint specimens after tests for non-retrofit specimen (RCNH1) and retrofitted specimens by cement based composites respectively
