ORDER OUT OF CHAOS: APPLICATION OF EARTHQUAKE DAMAGE ASSESSMENT AND REPAIR GUIDELINES

J.D. Osteraas¹ and A. Gupta²

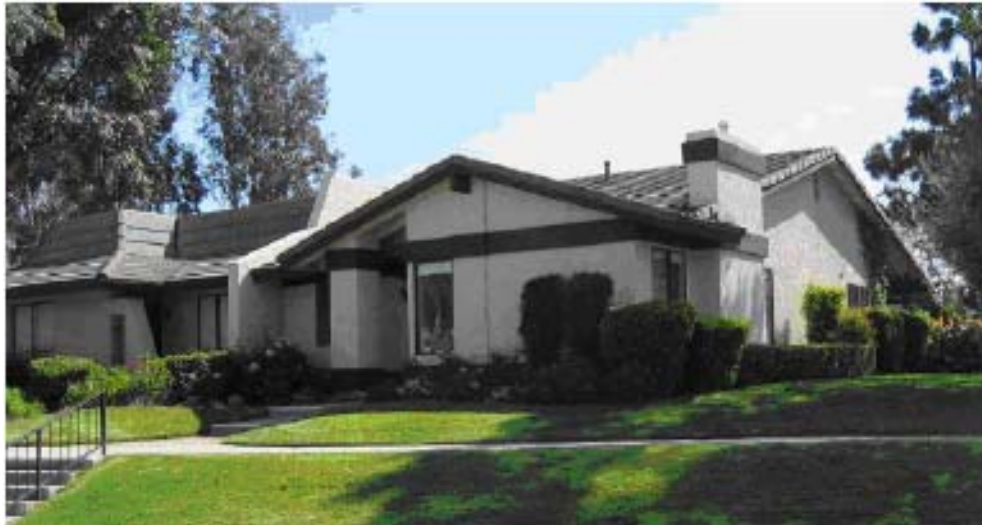
Figure 1. Subject building: typical 1970s construction in southern California

As an example, consider the building shown in Figure 1; a one-story, duplex constructed in the 1970s in southern California. Exterior and interior finishes are stucco and gypsum wallboard, respectively. The sloped roof is weatherproofed with heavy clay tile, and the building is constructed with shallow footings and a slab-on-grade floor. The building is located on essentially flat, geotechnically stable lot and is free of design or construction defects that would significantly affect its seismic performance. In other words, it is a typical California residential woodframe building with no major seismic vulnerabilities. The building is located in an area that experienced an Instrumental Intensity of 7 and a peak ground acceleration of 0.3g during the 1994 Northridge Earthquake. Thus, given the construction features and moderate ground shaking the expectation of damage would, at worst, be nonstructural damage. Following the Northridge Earthquake the building was inspected by two different teams of engineers, contractors, and adjusters. One team found only non-structural damage with an estimated repair cost less than the deductible while the other team projected the cost of earthquake damage repair of the duplex at approximately \$500,000.

Detailed inelastic time history analyses of the building structures were carried out, which indicated that the maximum story drift ratio was on the order of 0.0019 for the ground motions representative of the site for the Northridge Earthquake. In other words, the calculated transient drift was in line with expectations given the building construction and ground shaking intensity at the site. Furthermore, the analysis clearly indicated that the response of the building elements (stucco and gypsum sheathed walls) was essentially elastic. Expectations of wall

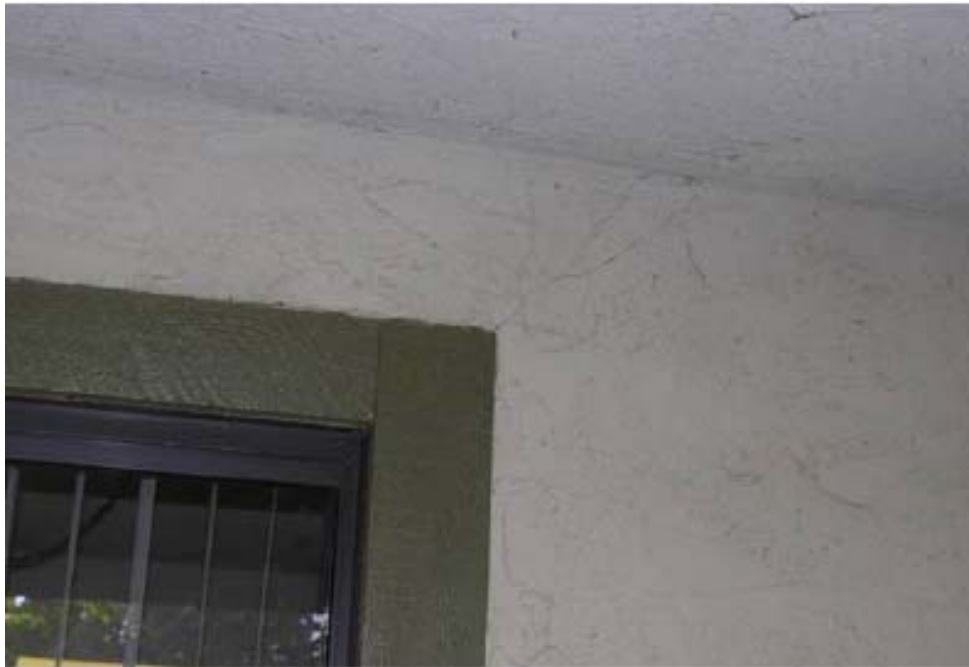
Figure 3. A typical damage observation: minor cracking in the stucco finish.

finish performance at the calculated drift levels can be based on research, such as that referenced above, which indicates minor cosmetic cracking at corners of wall finishes (Figure 2). A typical damage observation, minor cracking in the stucco finish is as shown in Figure 3.

Thus, a rational investigation of the performance of the building using elements of the developed *Guidelines* indicated a near elastic response of the building, with no structural damage and very minor nonstructural damage that could easily be addressed through cosmetic patching and painting. Costs associated with such repairs would be minimal as a percentage of the replacement value of the property. The particular property, however, was the subject of multiple investigations and litigation wherein the difference between actual repair costs (to address the nonstructural damage) and the erroneous hypothetical repair costs were on the order of the replacement values of the building and then some to account for engineering and litigation fees. A simple, rational application of the *Guidelines* in the first go around should have resulted in all interested parties arriving at the same result that the damage was minimal. Such information, which would be consistent with analytical expectations, could then easily form the basis of fragility functions that would be used to project future losses and rate setting. The understanding and acceptance of the *Guidelines* by the community holds the potential for improved damage assessment, repair development, loss mitigation, and loss assessment.
