## CHALLENGING APPLICATIONS OF SEISMIC DAMPERS FOR RETROFIT OF TALL BUILDING

Hitoshi Ozaki<sup>1</sup>, Hiroaki Harada<sup>1</sup>, Katsuhide Murakami<sup>1</sup>

<sup>1</sup> Chief Structural Engineer, Structural Engineering Department, Nikken Sekkei Ltd., Tokyo, Japan  
Email: ozaki@nikken.co.jp, haradah@nikken.co.jp, murakamik@nikken.co.jp

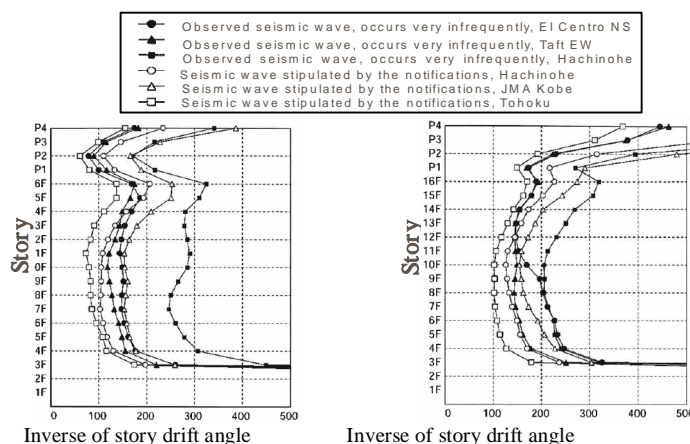
Fig.2 Before the seismic retrofit

Fig.3 After the seismic retrofit

For this renovation project, it was decided to use buckling restrained braces to increase damping force, primarily in order to improve the earthquake-resistant performance of the structure in the event of a large earthquake. Buckling restrained braces are designed to yield during a medium-intensity earthquake or greater, thereby absorbing energy and reducing the load on the existing columns and beams. The target values after retrofitting were to keep maximum story drift angle to 1/100 or less and to keep the maximum ductility factor of the members to 4.0 or less (ultimately max. 1.7). Figure 3 shows the maximum story drift angle following retrofitting.
