## HISTORY OF GEOTECHNICAL EARTHQUAKE ENGINEERING IN JAPAN

I. Towhata<sup>1</sup>

<sup>1</sup> Professor, Dept. of Civil Engineering, University of Tokyo, Tokyo, Japan  
Email: Towhata@geot.t.u-tokyo.ac.jp

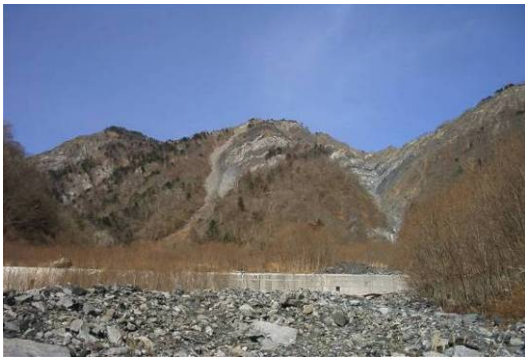
Figure 1 Ohya landslide

Landslides have been other important seismic problems. Fig.1 illustrates the Ohya Landslide which was triggered by the 1707 Hiei gigantic earthquake. This example shows today the problem of long-lasting slope instability that continues even now and requires lots of efforts to prevent debris flow upon heavy rainfall.

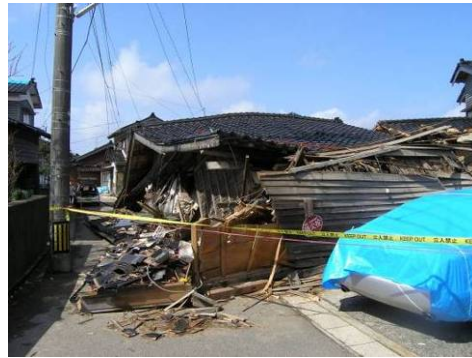
Figure 2 Damaged wooden house (2007 Noto earthquake)

Similar to other countries, most earthquake victims in Japan were killed by collapse of traditional houses. In western Japan, particularly, houses are covered by a heavy tile roof as a provision against strong typhoon wind. This heavy roof generates significant seismic inertia force during shaking and destroys easily the soft columns and walls that support the roof (Fig.2). Noteworthy is the resonance of the houses, which have long natural period, and the earthquake shaking on soft alluvium whose predominant period is long as well. This fact is important because most Japanese cities have been traditionally located on soft alluvial planes.

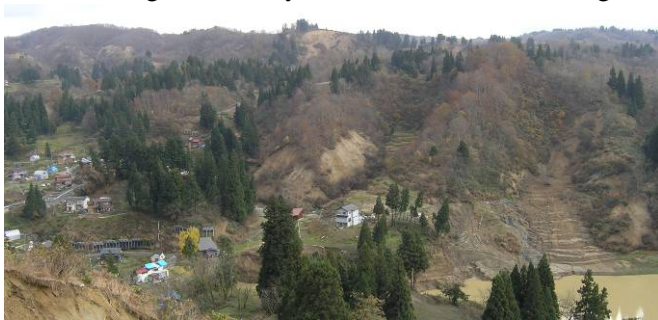
Figure 3 Location of houses and slope failures  
 (2004 Niigata-Chuetsu earthquake)

It seems that people in mountain areas empirically learnt to locate their houses in landslide-free places. Fig.3 shows houses in Yamakoshi Village after the 2004 Niigata-Chuetsu earthquake. While many weathered slopes failed due to shaking, houses in the figure were located on flat lands in front of ridges and were not affected. Although this is the case in many places of the village, local trunk roads were totally destroyed by landslides and people had to be evacuated for a long time. In spite of such situations, the understanding of earthquakes and related damages were not scientific in the modern sense. People believed that earthquakes were caused by catfish action and, after damaging quakes, people tried to punish catfish in order to avoid further nightmares (Fig.4).

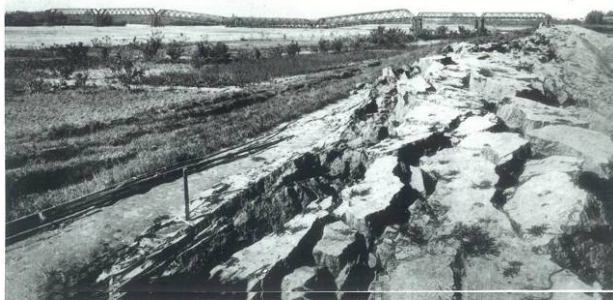
Figure 5 Damaged river dike (1891 Nobi earthquake)

The 1911 Nobi earthquake was of the magnitude of 8 and destroyed many structures in Nagoya and surrounding areas. This earthquake is famous for creation of a fault cliff. Moreover, Fig.5 shows longitudinal cracks along the Nagara River dike. They were probably caused by subsoil liquefaction and the consequent lateral expansion of the dike. After this devastating earthquake, the government decided to establish the Earthquake Disaster Prevention Investigation Council in 1892 and initiated both scientific studies on earthquakes and development of engineering for damage mitigation.

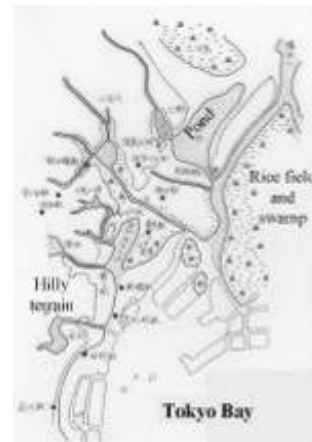
Figure 10 Original topography of Tokyo before AD 1600 (after Murai, 1994)

The 1923 Kanto earthquake totally destroyed Tokyo and Yokohama. Fig.9 shows the distribution of damage rate of wooden houses in Tokyo. Apparently, greater rate of damage occurred in the east part of Tokyo where a big river eroded the original ground during the era of low sea level in the Pleistocene period and that valley was filled with soft soils later in the Holocene period. It should be noted, furthermore, that there is another area of high damage rate near the Imperial House. To understand this situation, the original topography around AD 1600 when urbanization of Tokyo started is illustrated in Fig.10. It is seen therein that the eastern part of Tokyo used to be a rice field and swamps owing to the very soft subsoil. It is important that there is a small inlet to the east of the Imperial House, suggesting that there is likely soft soil deposit therein as well. Moreover, a big pond in the upper half of Fig.10 corresponds to another area of high damage rate in Fig.9. Thus, the experience in 1923 (Fig.9) implies the amplification of earthquake motion due to soft subsoil in the present sense.

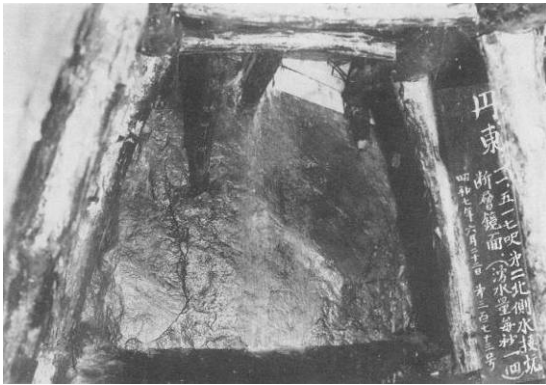
Figure 11 Fault plane that appeared in ongoing Tanna Tunnel project (Atami Construction Office, 1933)

Important knowledge on faults and tectonic actions were obtained in the first half of the 20th Century. The first example is the appearance of a strike-slip fault that appeared in an ongoing tunneling project (Fig.11) at the time of the 1930 Kita Izu earthquake. Since the tunnel was not damaged by this significant fault effect, people came to believe that tunnel is safe during earthquakes. Although this idea was correct in hard rocks, the 1995 Kobe earthquake and the 2004 Niigata-Chuetsu earthquake showed that tunnels in soft soils and rocks are not very safe.

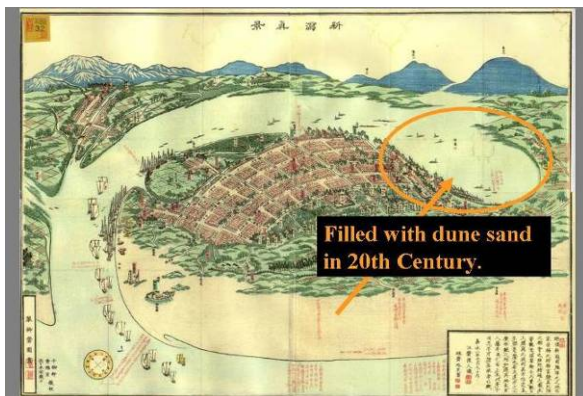
Figure 13 Former topography of Niigata in 1849

The 1964 Niigata earthquake was characterized by subsoil liquefaction. Although it had been known in former earthquakes, liquefaction came to be recognized as one of the earthquake-induced disasters after this quake. The reason for this is that urban development and human activities extended to a liquefaction-prone geology in 1964. For example, Fig.13 shows there used to be a big cove on the left bank of the Shinano River in Niigata City. This water area was filled with dune sand in middle 20th Century by transporting abundantly available dune sand in the coastal area. Since no compaction effort was required in those days, a young and water-saturated loose deposit was formed by clean fine sand. This area was named Kawagishi-Cho, which meant a town beside a river, and, upon the 1964 earthquake, liquefaction occurred significantly, causing tilting of apartment buildings (Fig.14). Other striking events were falling of brand-new Showa Bridge (Fig.15) and subsidence of new Niigata Airport Terminal Building.

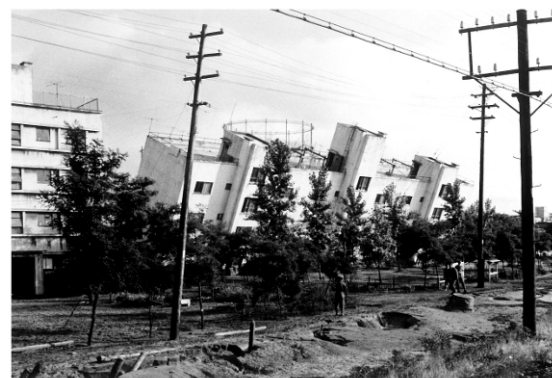
Figure 14 Tilting of Kawagishi-Cho Apartment buildings

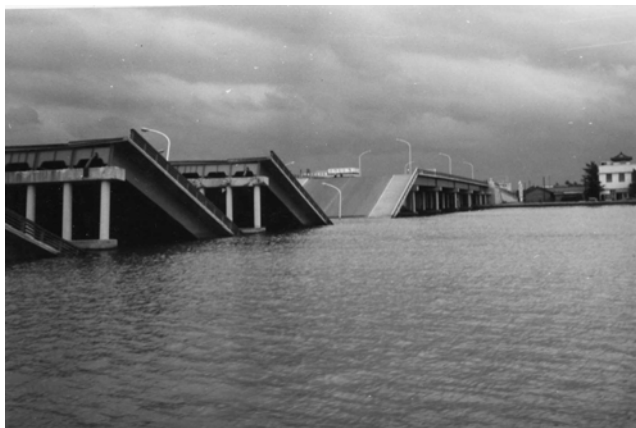
Figure 15 Liquefaction-induced collapse of Showa Bridge

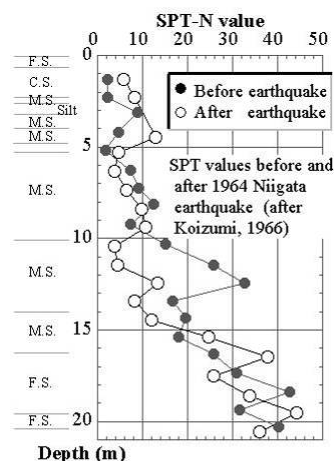
Figure 16 Variation of SPT-N due to liquefaction (Koizumi, 1966)

After this earthquake, intensive efforts were initiated to understand the mechanism of liquefaction, to assess the liquefaction potential of given subsoil conditions, and to mitigate the risk. It is important to say that those efforts were based on case history studies, field investigations, and laboratory soil tests as well as shaking model tests. This point is significantly different from the way of studies in previous times in which theoretical and analytical studies had been considered important; see Mononobe-Okabe earth pressure studies. Fig.16 is an example in which the variation of *SPT* blow counts due to shaking is plotted. It is therein seen that the blow counts increased at the depth of 3-5 meters, implying densification of sand due to liquefaction. In contrast, the blow counts at 10-15 meter depth decreased, probably because sand was loosened by strong shaking. It was thus concluded that there is a critical *SPT-N* value that borders liquefiable and unliquefiable sands. This idea of critical *N* value led to early design codes for assessment of liquefaction risk.

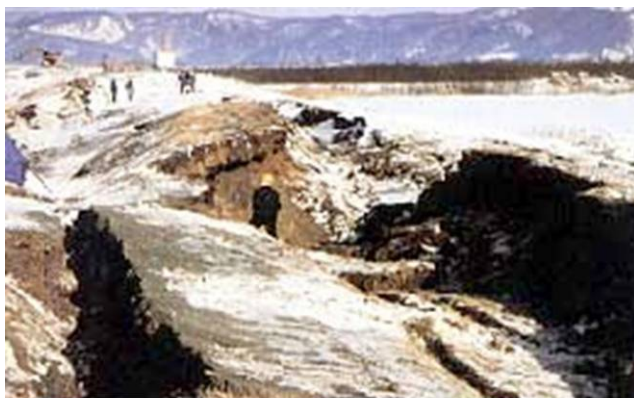
Figure 19 Damage of Tokachi River dike during 1993 Kushiro-Oki earthquake (Ministry of Construction)

The conventional idea against liquefaction was modified due to damages in river dikes. Figs.19 and 20 demonstrate subsidence during the 1993 Kushiro-Oki and 1995 Kobe earthquakes, respectively. Because of the remarkable length of existing dikes on potentially liquefiable subsoil, complete prevention of liquefaction is financially impossible. On the other hand, the function of river dikes is still achieved even if the height is reduced to a certain extent. Hence, measures that allow subsoil liquefaction but avoid extreme subsidence came into reality. This idea is in line with performance-based earthquake-resistant design.

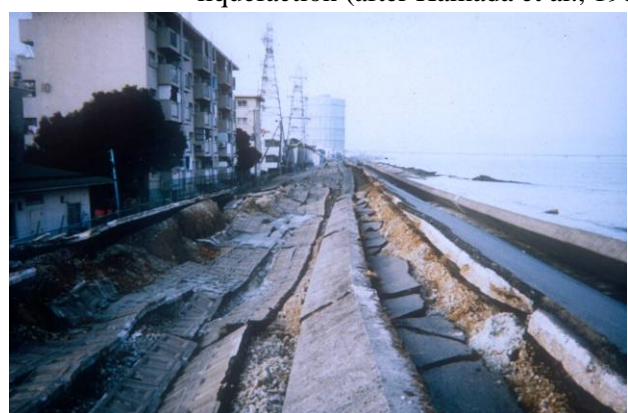
Figure 20 Damage of Yodo River dike during 1995 Kobe earthquake (Fudo Construction)

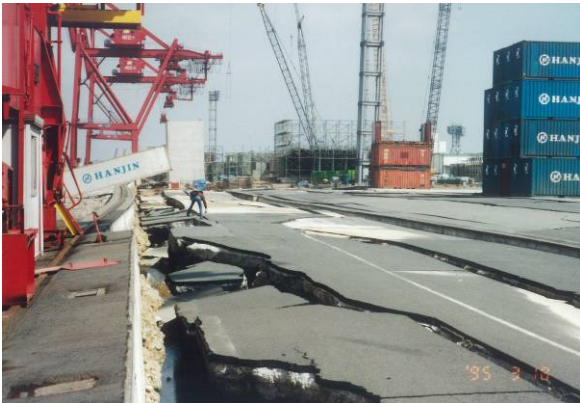
Figure 21 Liquefaction in Kobe Port Island

The 1995 Kobe earthquake is characterized by the strong acceleration records and the devastating damage that affected local economy. Fig.21 shows liquefaction in Kobe Harbor. Due to this, the operation of the harbor stopped for two years and many clients left this harbor. Thus, design of seismic resistance of important infrastructures should take into account the economic aspects. The strong acceleration destroyed many structures such as buildings and a subway station. On the other hand, this extent of shaking was considered extremely rare, and increasing the intensity of design earthquake was considered uneconomical.

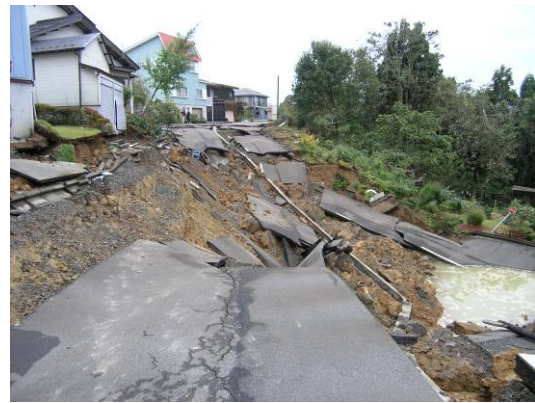
Figure 22 Collapse of fill on former valley topography  
(2004 Niigata Chuetsu earthquake)

Recent geotechnical problems occur in hilly and mountainous areas where many fills and embankments rest on unstable surface soil or valley deposits. Fig.22 is an example during the 2004 Niigata-Chuetsu earthquake. Earth fill

in valley topography collects ground water and becomes heavy. Moreover, it is often the case that soft valley deposits are not removed prior to earth filling. These situations reduce the seismic stability of a fill. On the contrary, sufficient budget is not always available for good seismic resistance of structures in mountainous areas. Once collapse occurs, road transportation stops and emergency rescue becomes very difficult. This situation occurred during the 2008 Wenchuan earthquake of China as well. No definite solution is available yet to this problem.
