PROTECTION OF MEDITERRANEAN HISTORICAL STRUCTURES AGAINST EARTHQUAKES USING FRAGILITY CURVES

C.A. Syrmakelis¹ and M.T. Kosta¹

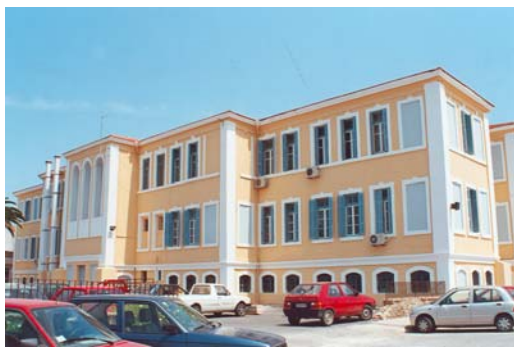
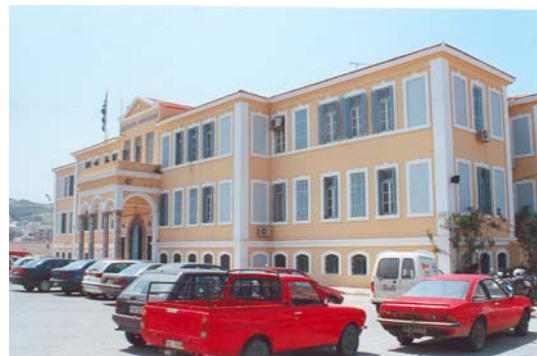
Figure 1 Views of the Prefectorial edifice in Rethymno

The Prefectorial edifice in Rethymno was constructed between 1844 and 1847 by the provincial governor of the city. In 1994 and until today, the building becomes headquarter of the prefectorial self-government in Rethymno. The building has three stories and its total length is 50.55 meters with a width that varies between 18 and 28 meters. The total area of the edifice is 3.175 m². The stories and the roof are wooden and its floor plan is organized through two perpendicular axis of symmetry.

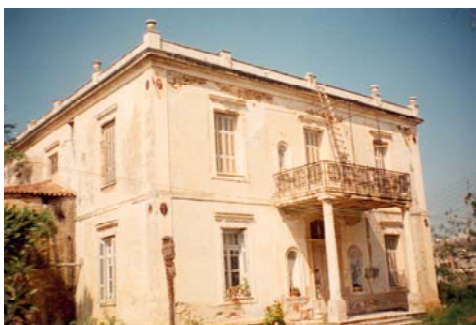
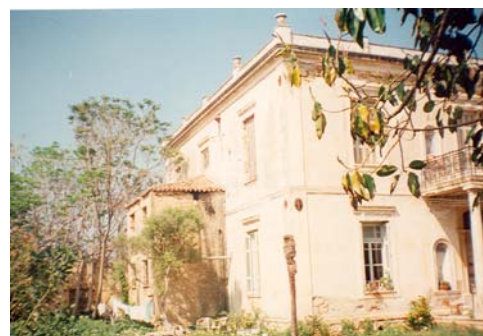
Figure 2 Views of the neoclassical residence of Prince George in Chania

This residence was built in 1882 by the architect Nikola Magouzo to accommodate Prince George. When he resigned, it was used as military hospital, as a shelter and finally during 1968 and 1982 as offices of Crete's historical and archeological company. This building has a ground floor, a first floor and a basement. The total area of the edifice is 293.85 m² and its maximum height is 10.87 meters. Its roof and stories are wooden and also has some elements of reinforced concrete. Although the tractors placed at the four building's corners have been corroded, they still hold the masonry satisfyingly.

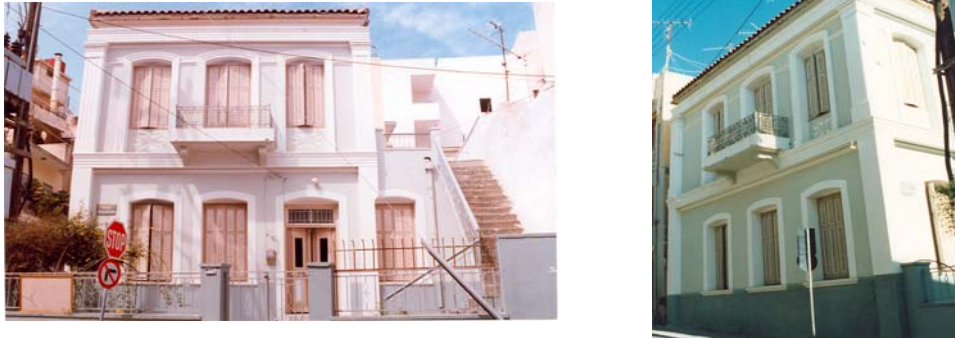
Figure 3 Views of the two stories Building in Kazantzaki Street in Sitia

This residence was built around 1900 and has two stories with a yard and an exterior staircase, which facilitates the access of the upper floor with the outdoors. The building's maximum height is 8.86 meters, the roof is wooden and the stories are made of reinforced concrete. Moreover, in the interior, the ground floor has symmetry through a main axis that divides the building.

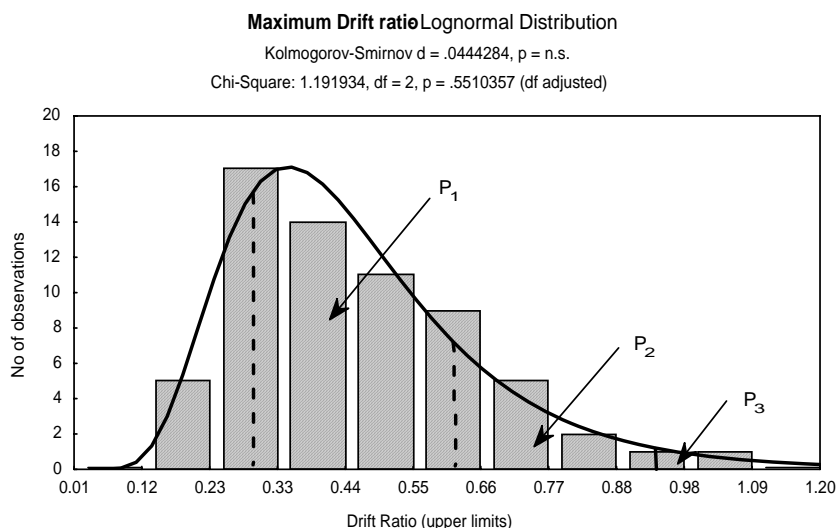
By processing the data that come from the FAILURE program, the fragility curves can easily be formed. After defining the areas that fail, the percentage of the total surface's damage is proposed to be calculated by the ratio $A_{\text{damage}} / A_{\text{total}}$ (where A is the surface), and after the elaboration of the statistical results comes out the probability-density function, which indicates the possibility of the quotient's certain value by the given PGA.

Figure 7 Diagram of density - Lognormal Distribution

The possibilities P_1 , P_2 and P_3 are the areas between the failure limits that define the damage levels of the construction through the probability-density function: for random values the possibility that the building's response is between the values of the damage level's rate, is being expressed. Using fragility curves, one can distinguish the possibility of exceeding certain damage levels, as shown in table 1.
